**Mooray Avenue
Housing Complex
PRO 0310**

**Detailed Engineering Evaluation
Quantitative Assessment Report**

**23 and 25 Mooray Street, Bishopdale,
Christchurch 8051**

Date: December 2013
Reference: 6-QC382.00
Status: Final

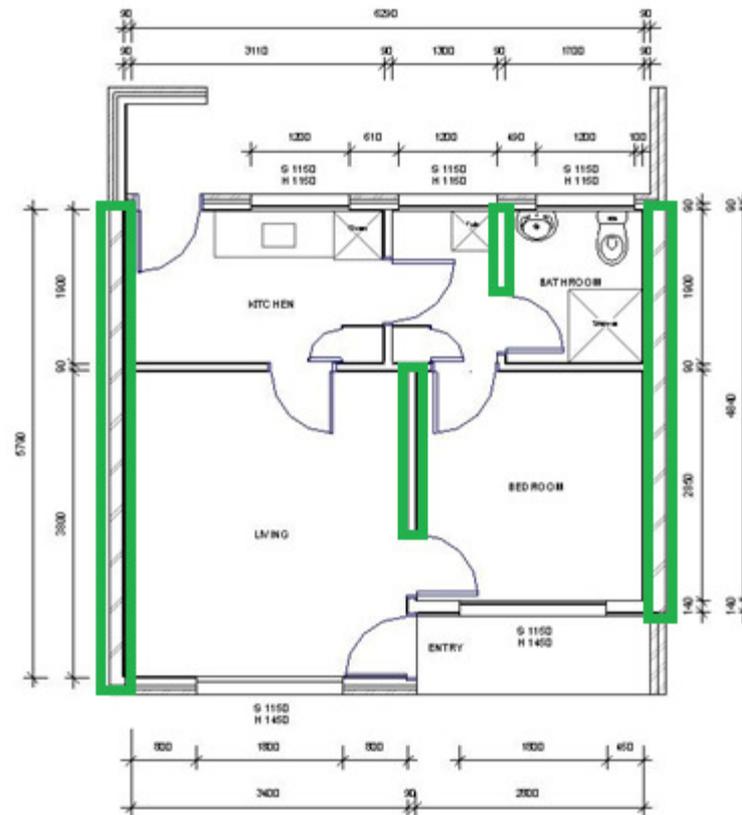
Figure 7: Walls used for bracing in the transverse direction.

Hand calculations were performed to determine seismic forces from the current building codes. These forces were applied globally to the structure and the capacities of the walls were calculated and used to estimate the %NBS. The walls, highlighted in Figure 6 and Figure 7, were used for bracing in their respective directions.
