Christchurch City Council

PRK_1475_BLDG_001 EQ2

Toilets - Nicholson Park

QUALITATIVE ASSESSMENT REPORT

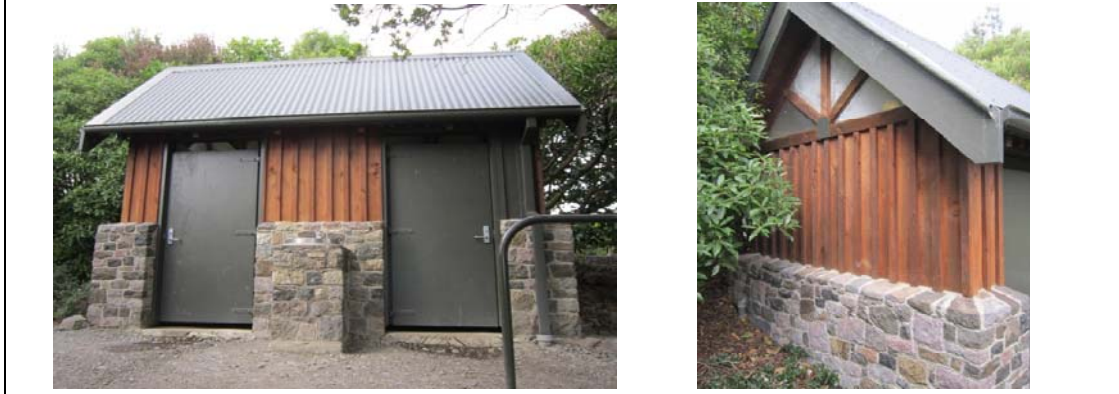
1.1 Photos (attach sufficient to describe building)

The structures design period has been assumed to be 1992 to 2004 as no structural drawings were available. The structure consists of light metal cladding on a tongue and groove timber roofing supported by six timber roof trusses spaced at approximately 800mm centres an example of these trusses is shown above in the right hand photo. The exterior walls are light timber framed from 2.2m down to 1m with weatherboard exterior and plasterboard interior, below the timber walls are Stone masonry walls. The internal dividing wall is full height light timber framed with plasterboard lining both sides. The foundation is a concrete pad across the entire footprint.
