**North Beach Community Crèche**  
**BU 2191-001 EQ2**  
**Detailed Engineering Evaluation**  
**Quantitative Report**

Date: 26 October 2012  
Reference: 6-QUCCC.87  
Status: Final

Detailed Engineering Evaluation  
Quantitative Report - SUMMARY  
Final

24 Rookwood Avenue, New Brighton, Christchurch

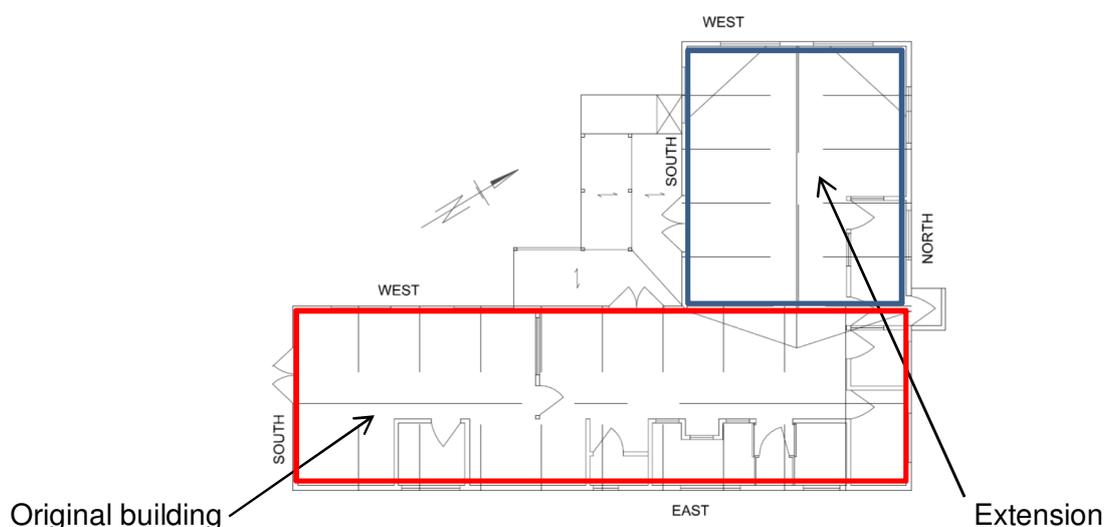
Figure 2 - Sketch to indicate layout

The original building and the extension are connected by an opening across the full width of the extension. The original building is approximately 18.5m long and 5.5m wide, and the extension is approximately 7m wide and 8m long. The intersecting elevations of the building parts form two sides of an enclosed veranda structure which is constructed using timber rafters and purlins supported on timber posts.

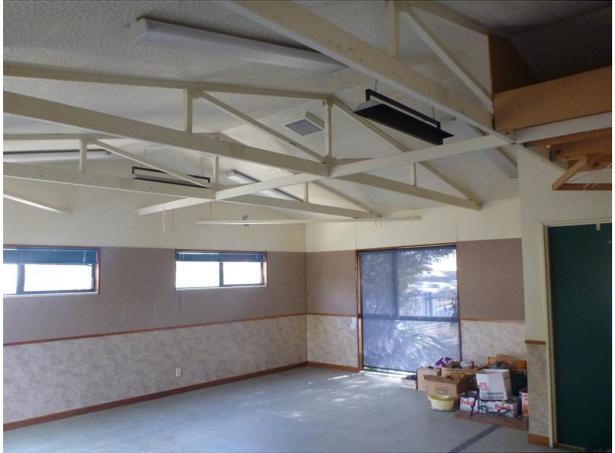
<b>12.</b>	Extension (looking north-west showing bottom chord ties)

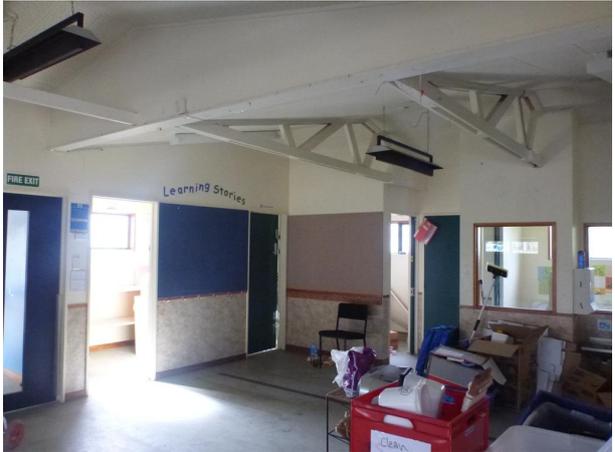
<b>13.</b>	Original Building (looking north-east) clad double roof truss forming full width opening

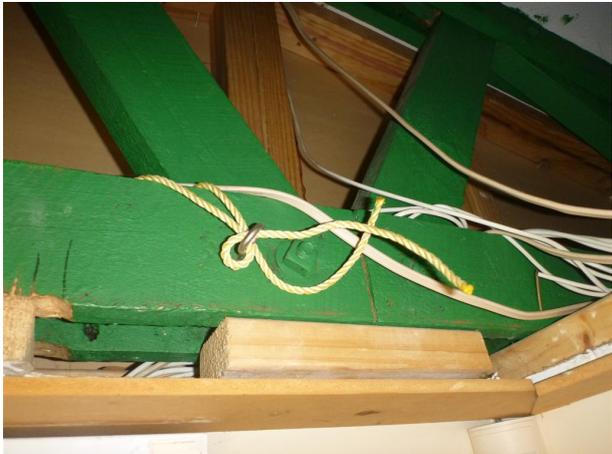
A photograph showing a white door with a wooden handle and a red fire extinguisher mounted on the wall to the left. The door is slightly ajar, revealing a wooden structure above it, which is the loft access hatch.
<p><b>24.</b></p>	<p>Double truss forming the opening between the original building and the extension, as exposed within the roof void adjacent to the loft access hatch.</p>

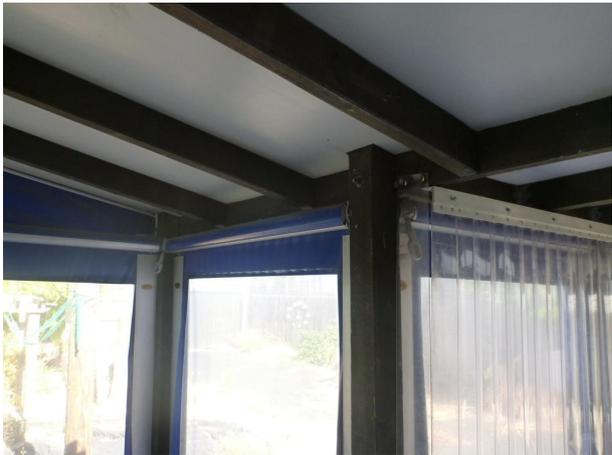
A close-up photograph of a wooden double truss structure. The trusses are painted green and are supported by wooden beams. A yellow rope is tied around one of the trusses.
<p><b>25.</b></p>	<p>Timber construction of the enclosed veranda</p>
