**Pioneer Recreation and Sports Centre
Detailed Engineering Evaluation
Stage Two Quantitative Assessment Report**

**75 Lyttelton Street, Somerfield, Christchurch
Christchurch City Council**

Date: 18 November 2011
Reference: 6-QUCCC.29
Status: Final

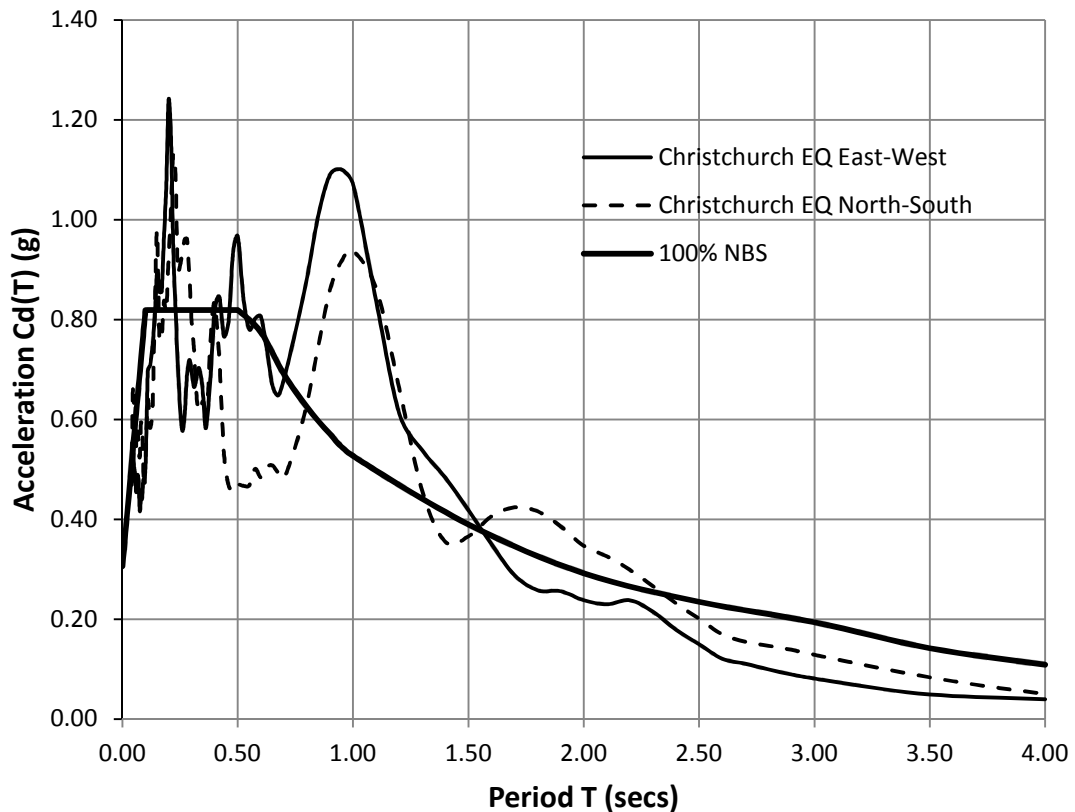
Figure 2: Acceleration response spectra from ground motions recorded by Geonet station (CMHS) near to Pioneer Recreation and Sports Centre, compared with the current design standard 100%NBS (IL 3) acceleration spectrum for the site

It can be seen that the North-South and East-West loads experienced by the site are generally of the same magnitude as 100% of the New Building Standard. The building sustained minor structural damage in the Christchurch earthquake comprising some cracking of masonry to the Stadium and minor horizontal separation of the Foyer ground level slab at the junction of the original building and 1999 Administration extension. The performance of Pioneer Recreation and Sports Centre under these quite severe loads is an indication that it is of generally robust, earthquake resistant construction
