R&R Sport

BU 2677-005 EQ2

Detailed Engineering Evaluation

**645 - 647 Colombo Street, Christchurch
Christchurch City Council**

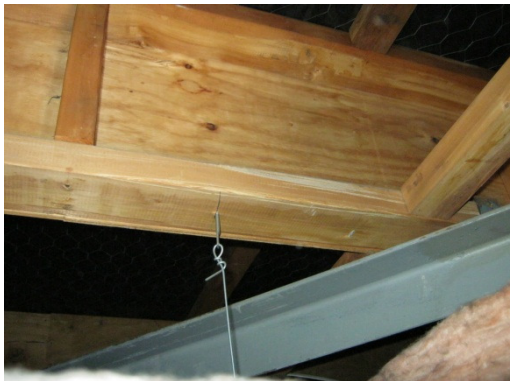
11.	Roof bracing connection to precast column

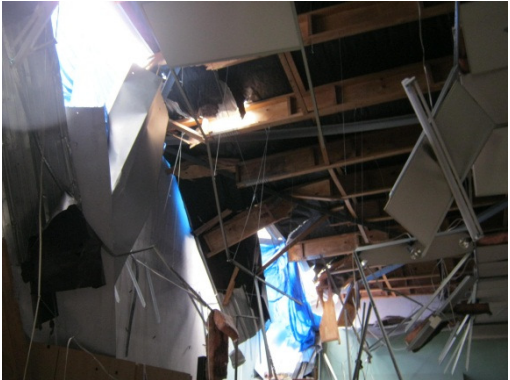
16.	Penny Lane records interior

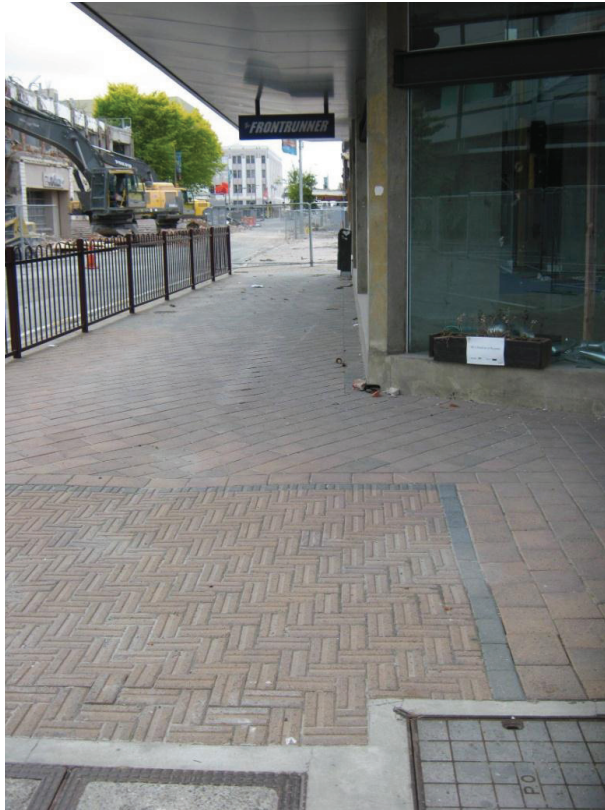
- Minor settlement (<10mm) and movement of the footpath flagstones in isolated locations along the north side of Lichfield Street and the Eastern side of Colombo Street (Photograph 1, Photograph 5, Photograph 6).

Photograph 1 – View East along Lichfield Street from east Corner with Colombo (24 January 2012).

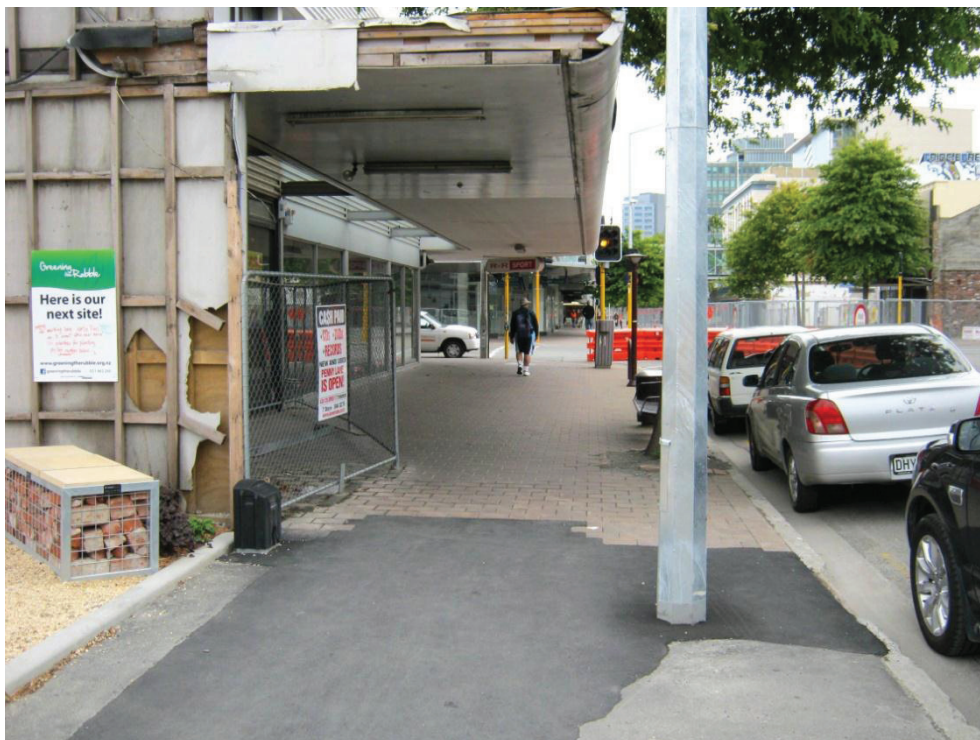
Photograph 8 – General view looking north along Colombo Street from ~ 10m south of “Penny Lane” (24 January 2012).

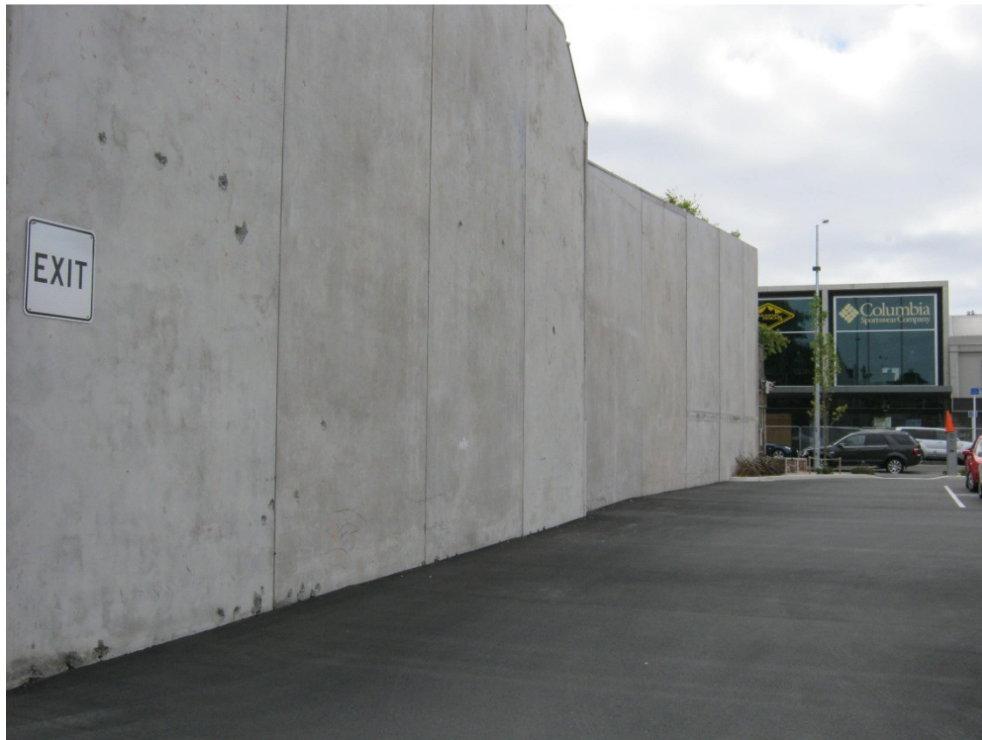
Photograph 9 – General view looking east toward Colombo Street from the south corner of the Rhotis buliding (24 January 2012).

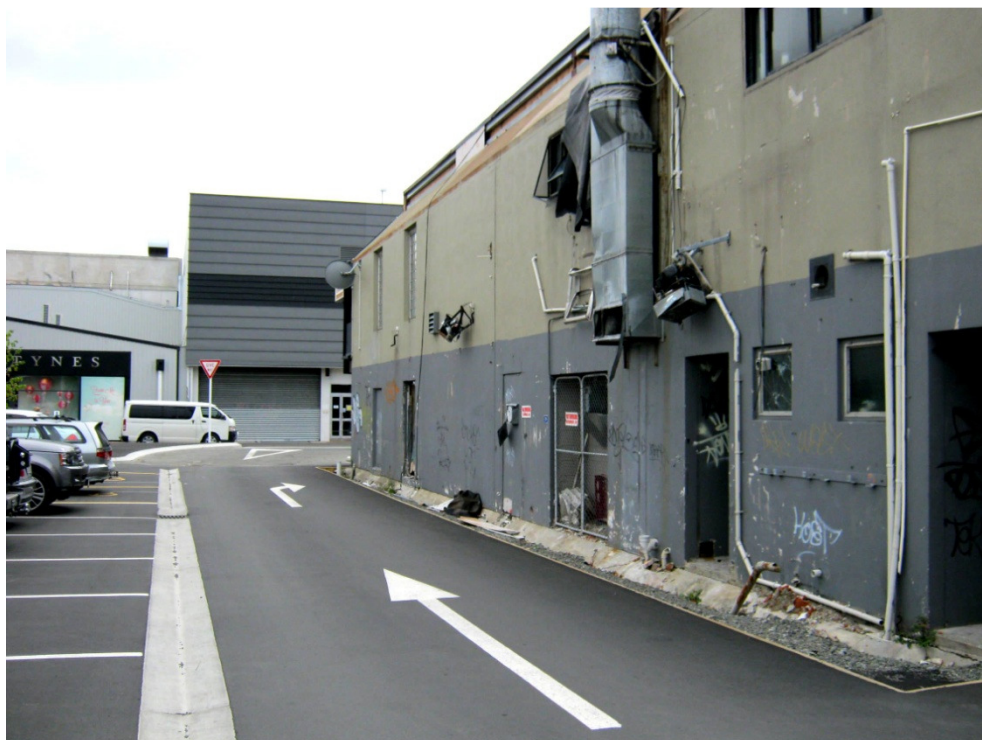
Photograph 10 – General view looking north along the west side of the Rohits building toward Lichfield Street (24 January 2012).

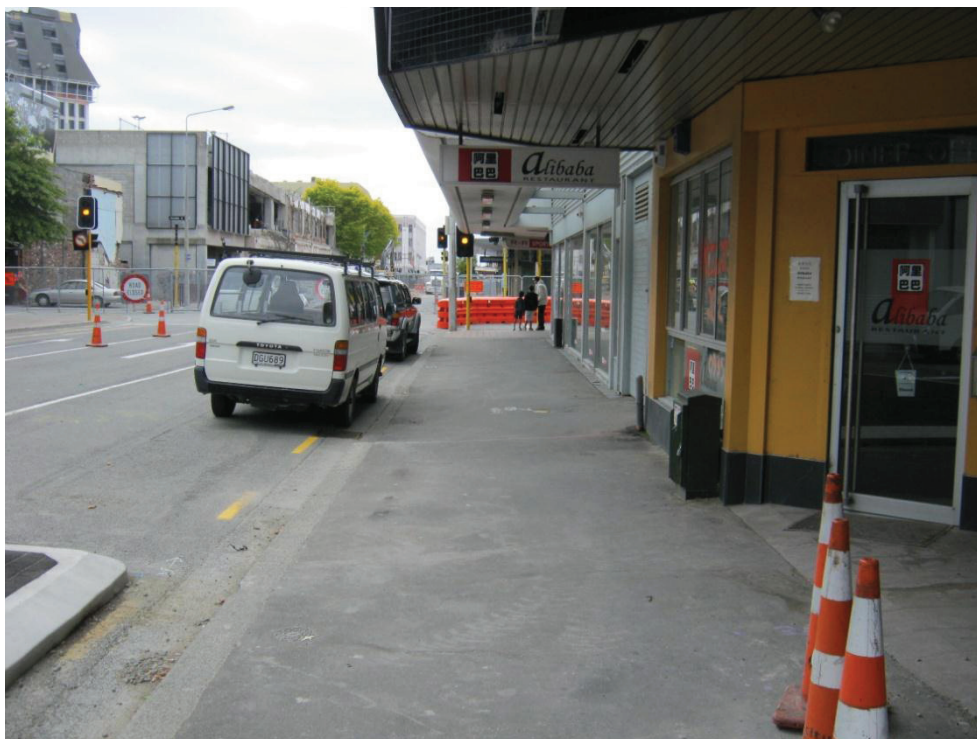
Photograph 11 – General view looking east along Lichfield Street from the west corner of the Rhotis building (24 January 2012).
