# Rohit's Indian Restaurant Detailed Engineering Evaluation Quantitative Assessment Report

56 – 58 Lichfield Street, Christchurch Christchurch City Council

Date: Reference: Status: September 2012 6-QUCCC.55 Final

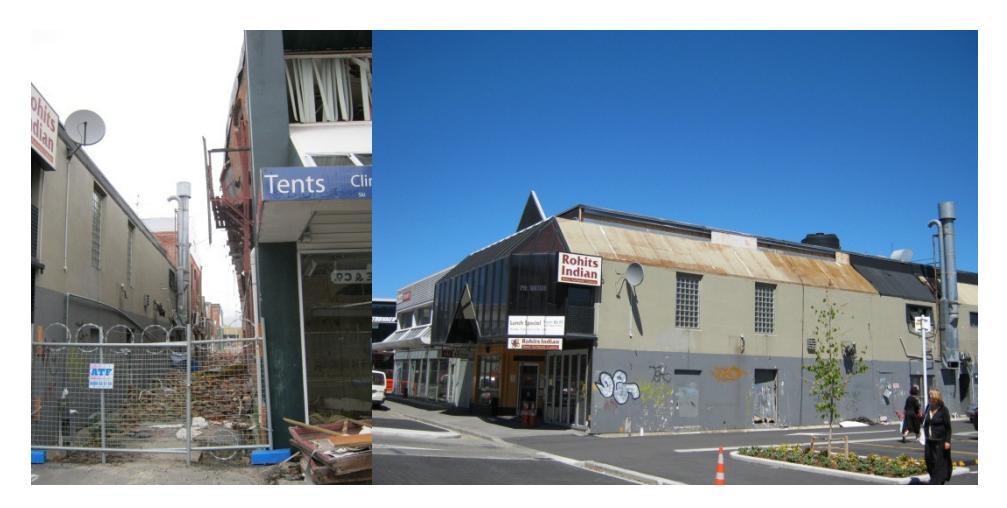
## Western Elevation

- Cracking in the precast wall panels on the west elevation at roof level
- Superficial damage to the western wall from adjacent building collapse
- Damage to non-structural elements was also observed.

Cracking has been observed on the top of the western wall at the connections between the steel frames and panels P11 and P12. This is consistent with the lateral roof loads being transferred into the wall panels at the weld plate connections. Inspection of the eastern wall panels of the building has been limited to the interior walls due to proximity of the neighbouring building.

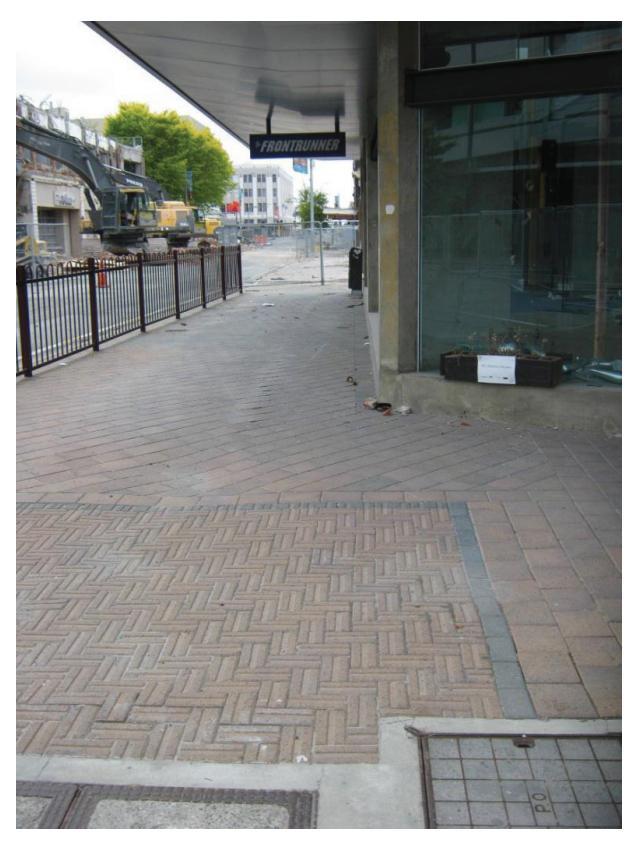
- Minor settlement (<10mm) and movement of the footpath flagstones in isolated locations along the north side of Lichfield Street and the Eastern side of Colombo Street (Photograph 1,Photograph 5,Photograph 6).

**Photograph 1** – View East along Lichfield Street from east Corner with Colombo (24 January 2012).

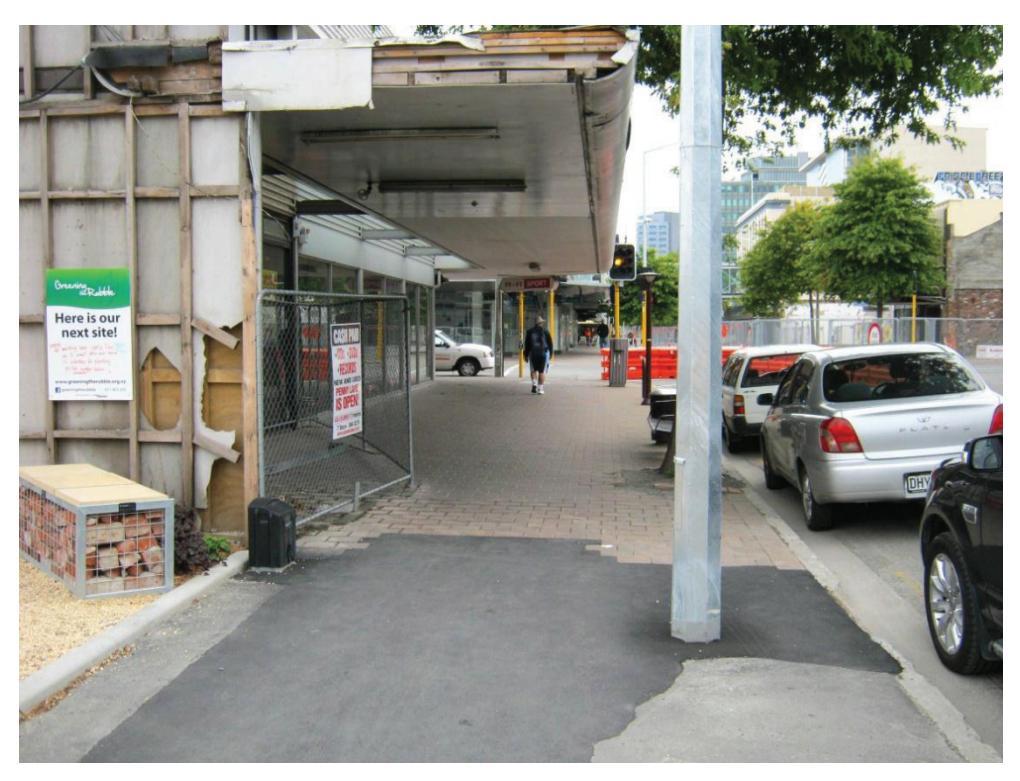
Photograph 8 – General view looking north along Colombo Street from ~ 10m south of "Penny Lane" (24 January 2012).

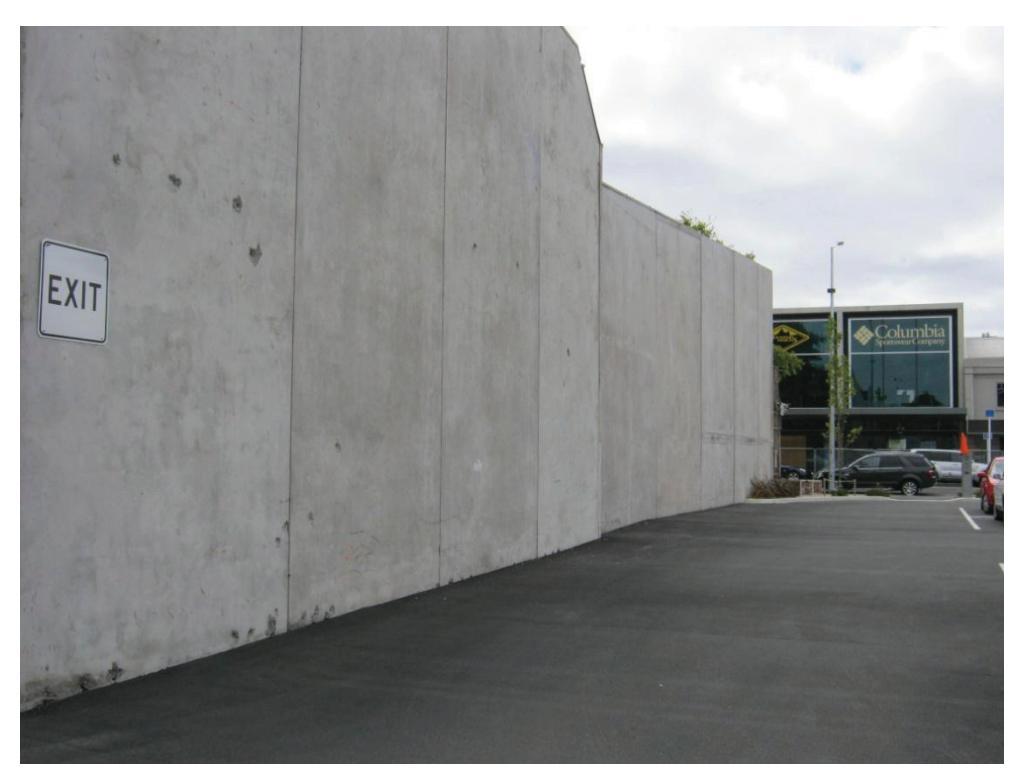
**Photograph 9** – General view looking east toward Colombo Street from the south corner of the Rohits building (24 January 2012).

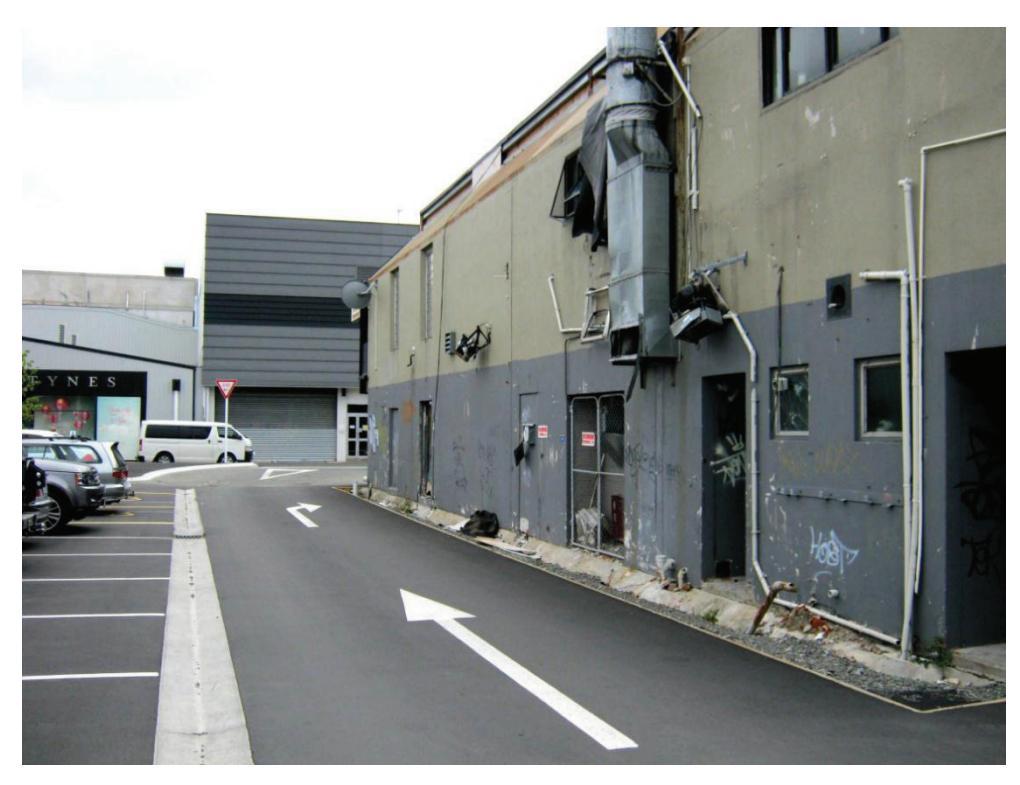
**Photograph 10** – General view looking north along the west side of the Rohits building toward Lichfield Street (24 January 2012).

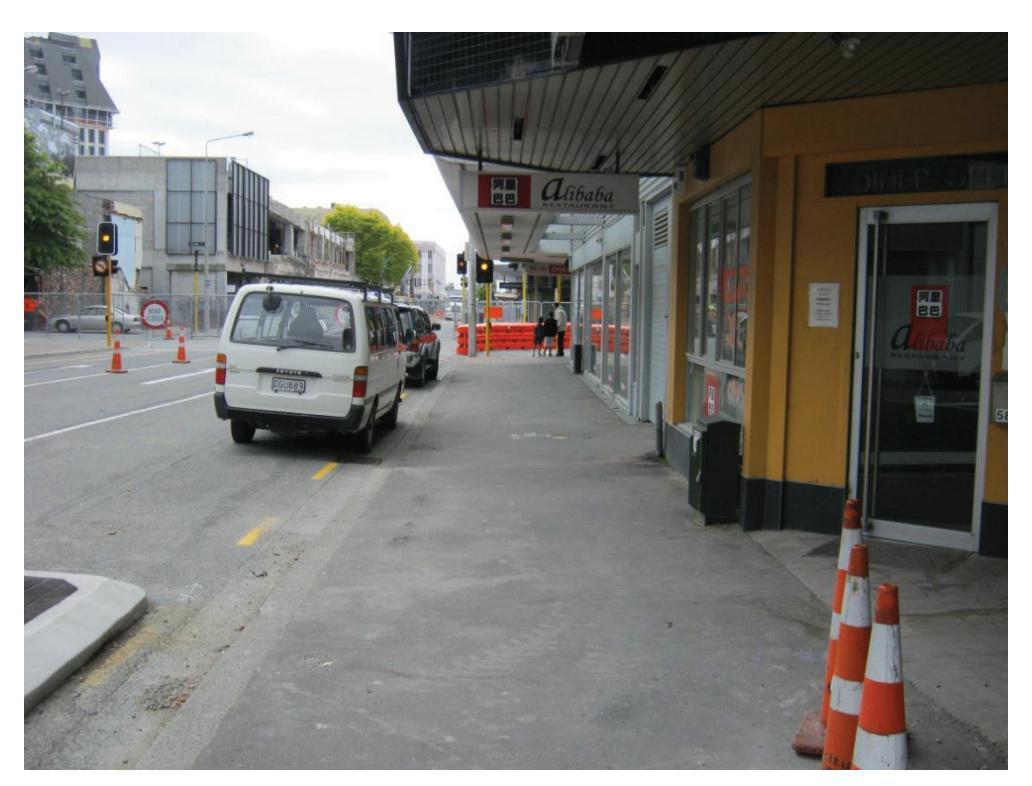
**Photograph 11** – General view looking east along Lichfield Street from the west corner of the Rohits building (24 January 2012).
