CHRISTCHURCH CITY COUNCIL
PRK_0895_BLDG_007 EQ2
Ruru Lawn Cemetery – Toilets
Raymond Road, Bromley

QUALITATIVE ASSESSMENT REPORT

FINAL

- Rev B
- 02 May 2013

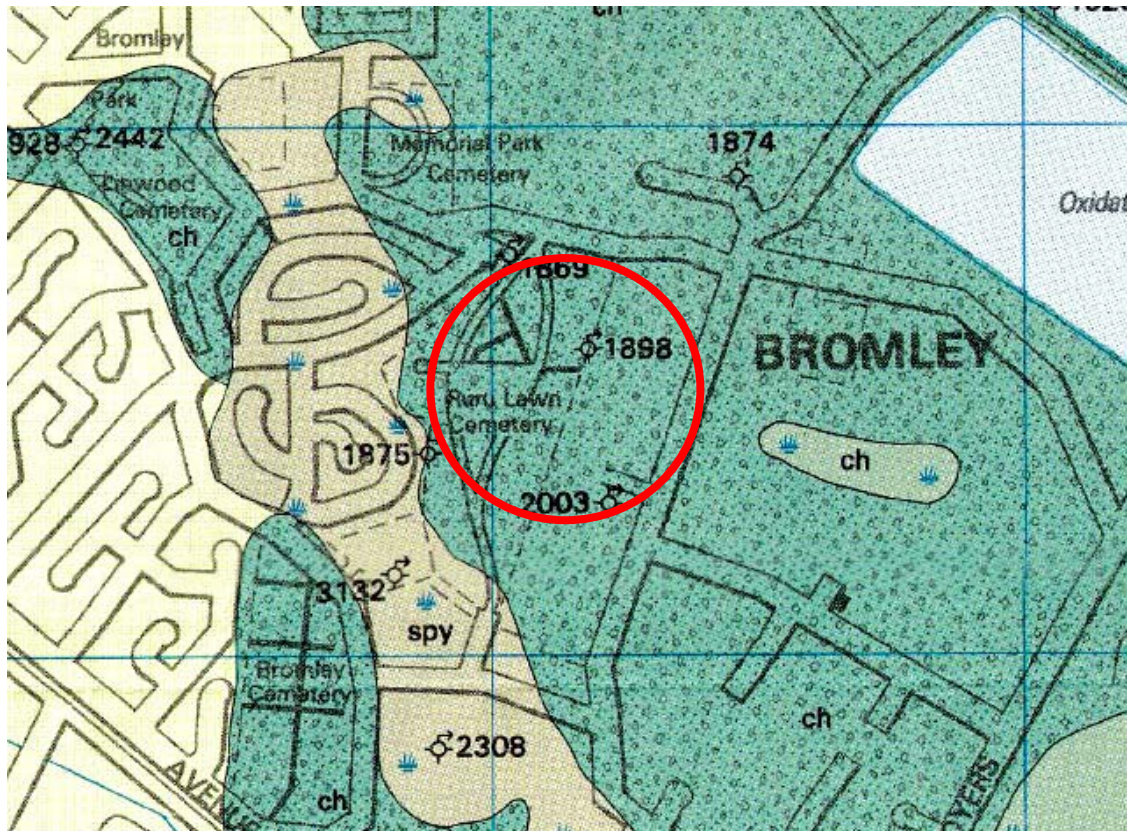
■ **Figure 3 – Local geological map (Brown et al, 1992). Site marked in red.**

The site is shown to be underlain by Holocene deposits comprising predominantly sands of fixed and semi-fixed dunes and beaches from the Christchurch Formation. The area immediately to the west of the site is underlain by peat swamps, now drained, from the Springston Formation.

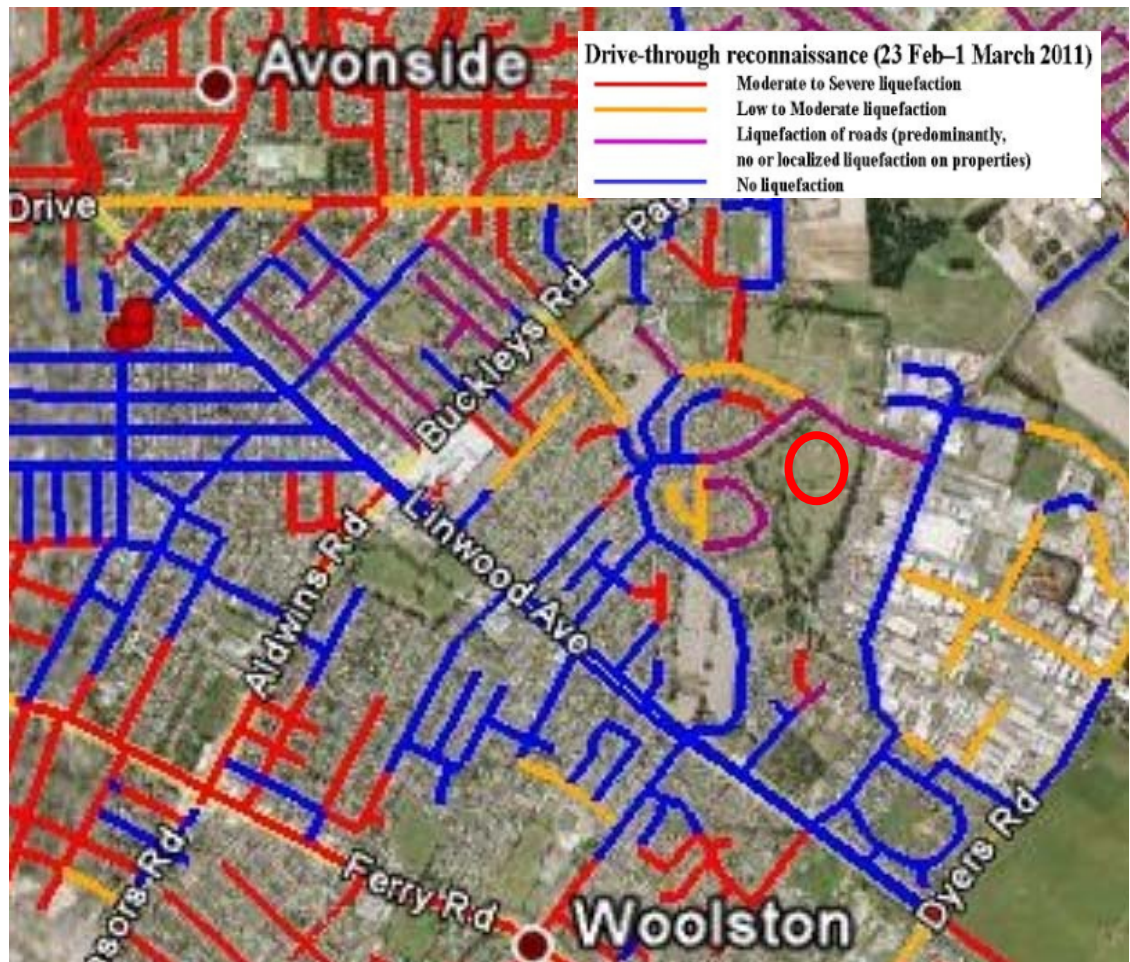
■ **Figure 4 – Liquefaction map (Cubrinovski & Taylor, 2011). Site marked in red.**

Following the 22 February 2011 event drive through reconnaissance was undertaken from 23 February until 1 March by M Cubrinovski and M Taylor of Canterbury University. Their findings show predominantly liquefaction of roads with no or localised liquefaction in the areas near the site. In parts of the area immediately west of the site low to moderate and moderate and severe liquefaction had been noted.

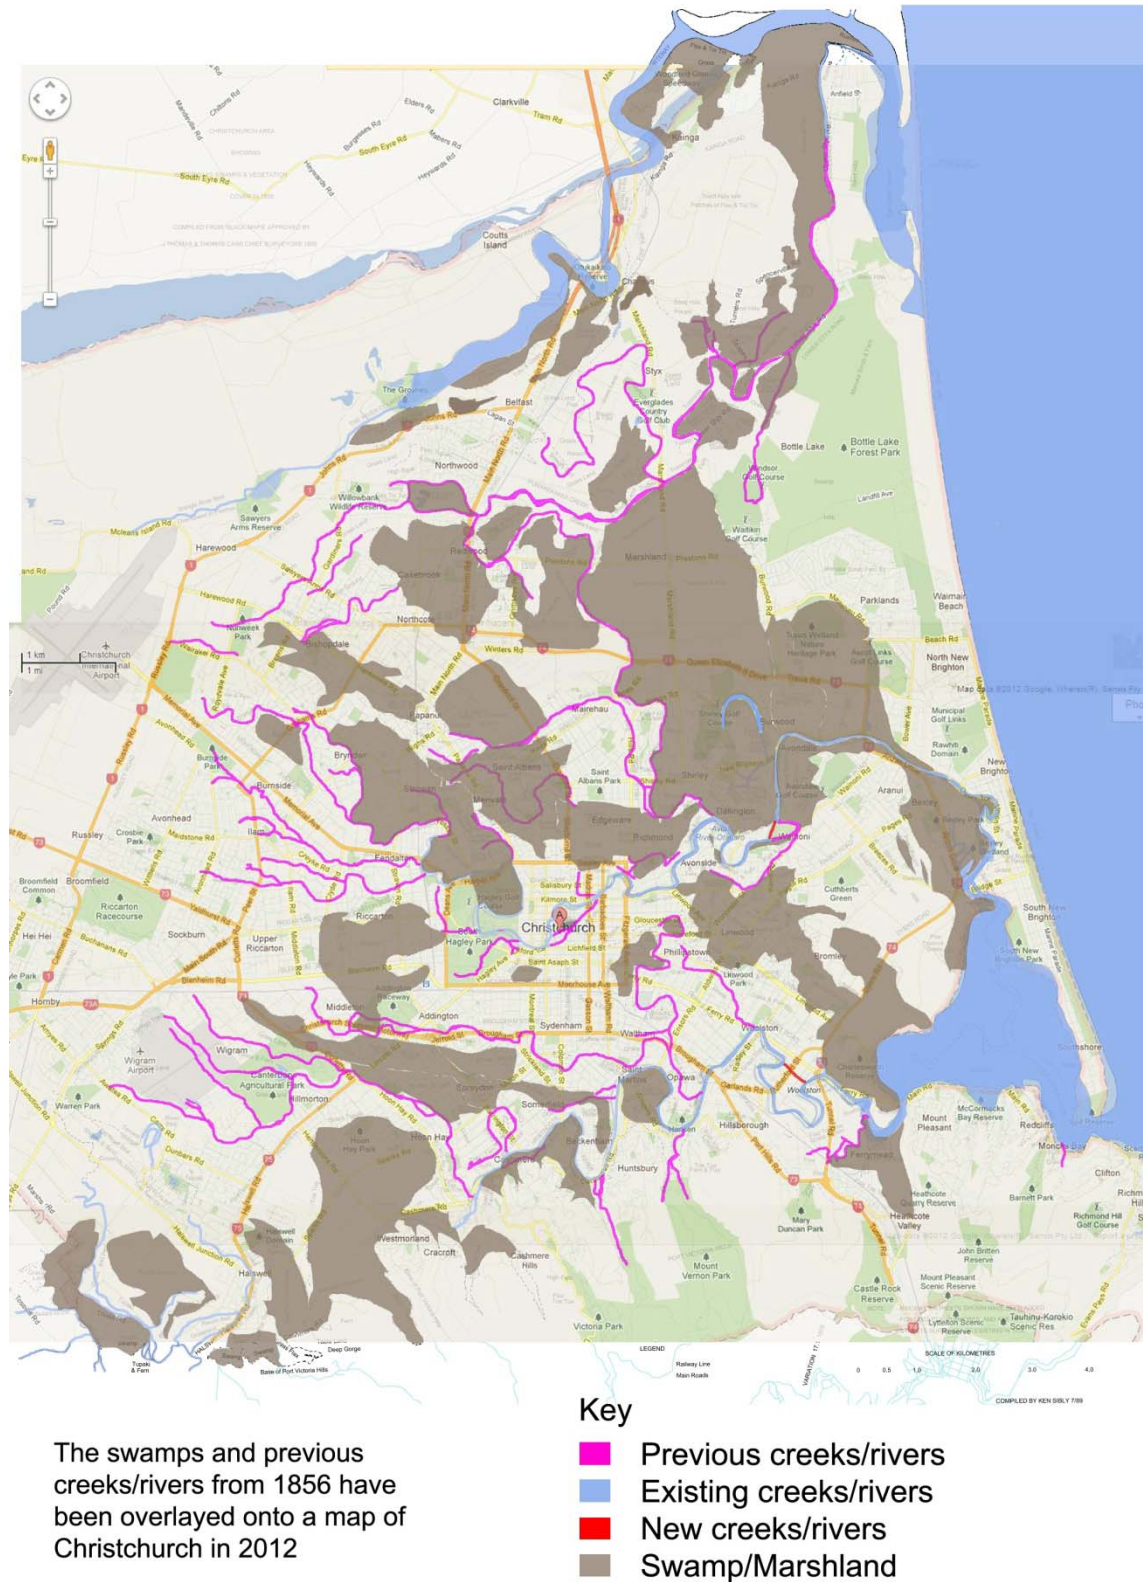
10. Appendix A – Christchurch 1856 land use

Reference to historical documents (eg Appendix A) shows that the site was recorded as marshland or swamp in 1856. Therefore, it is possible that soft or liquefiable soils would be present near the site.
