Toilets Upper Riccarton Domain
PRK 0236 BLDG 005 EQ2
Detailed Engineering Evaluation
Quantitative Report
Version FINAL

92 Yaldhurst Road, Upper Riccarton

Christchurch City Council

Date
15 March 2013

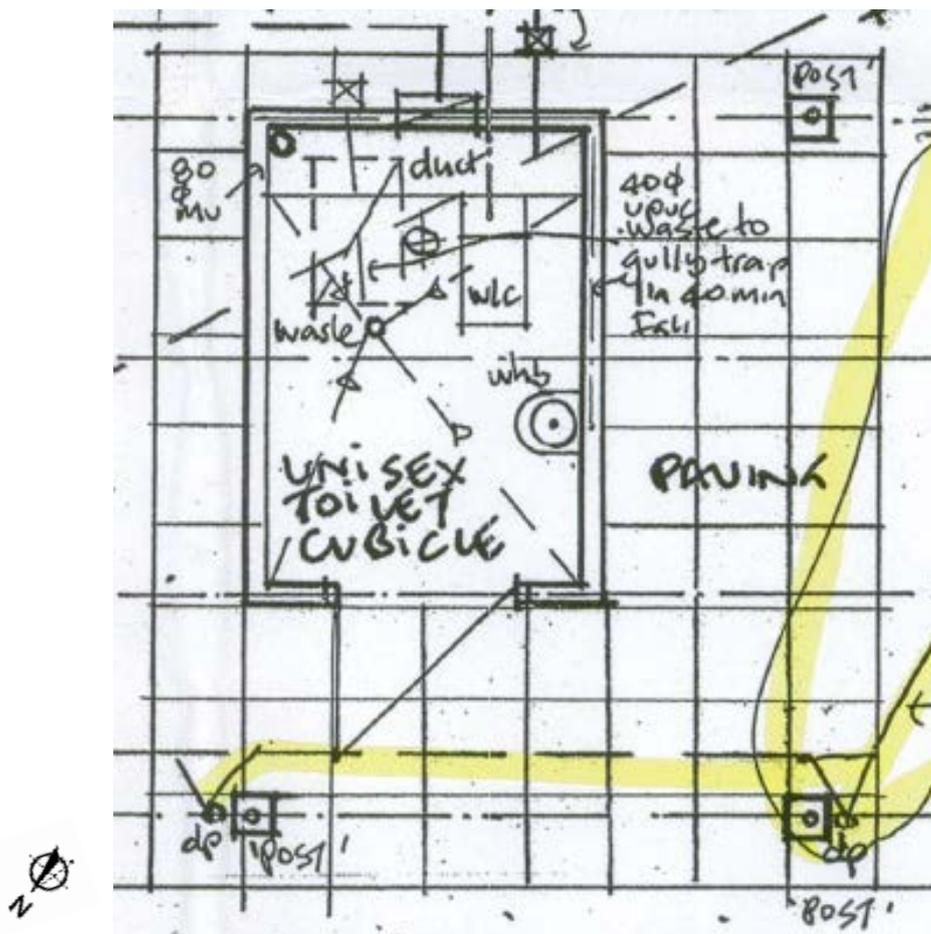
Figure 3 Plan of Original Structure

The curved metal clad roof is supported upon a $\varnothing 50\text{mm}$ steel tube frame with similar steel tube posts extending down to either isolated pad foundations at ground level or to the top of load bearing timber frame walls. The four load bearing lightweight timber frame walls, consisting of a plywood cladding over an internal Hardie's villaboard, form a ceiling-less enclosure beneath the roof. The timber frame walls are supported on a reinforced concrete strip footing with the floor consisting of a reinforced concrete ground slab on grade.

The building is approximately 4.0m in length by 3.2m in width and 2.8m in height. The overall footprint of the building is approximately 13m^2 . The nearest structure is sports rooms, situated 5m to the east. The flat site, located 600m south of Avon River, contains a large playing field, clubhouses, tennis and basketball courts, paved carpark and a small playground.
