# **Vincent Courts Housing Complex PRO 1012**

**Detailed Engineering Evaluation  
Quantitative Assessment Report**

**60 Vincent Place, Opawa,**

Date: March 2014  
Reference: 6-QC412.00  
Status: Final

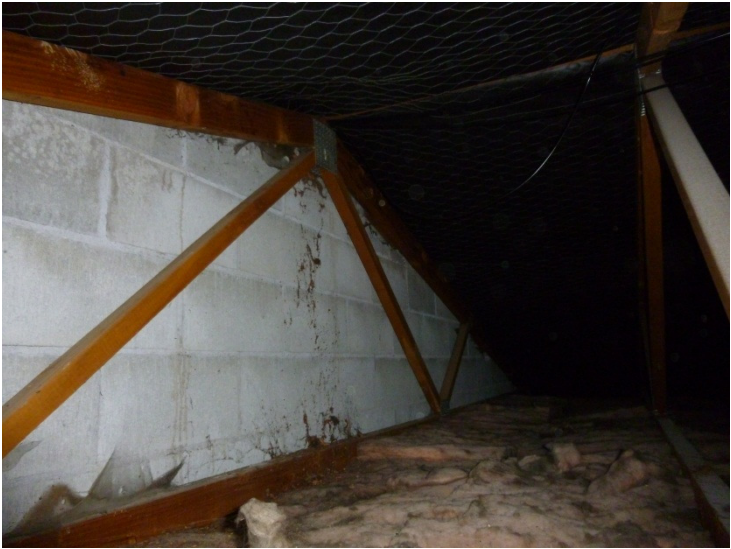
6.	Blocks A and B typical roof space showing fire wall (Unit 1)

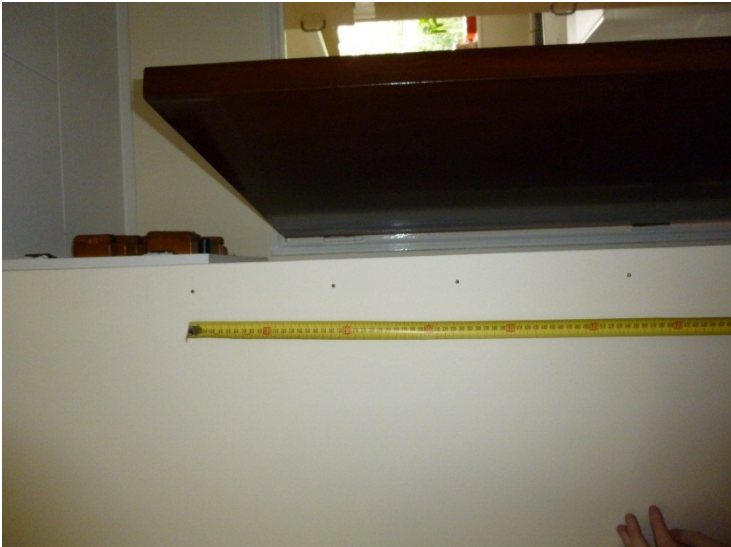
A photograph showing a view from a bedroom through an open doorway into a bathroom. The bedroom has a large closet with two doors. The bathroom has a sink, mirror, and a window.
15.	Typical kitchen view (Unit 14)	  A photograph of a kitchen area. It features a dark countertop with a stainless steel sink and a white electric stove. There are two windows with black frames, one of which is a bay window. The walls are a light beige color.
16.	Internal nail spacings (Unit 14)
