Waltham Park Pavilion
PRK 1044 BLDG 005 EQ2
Detailed Engineering Evaluation
Quantitative Report
Version FINAL

30 Waltham Road, Waltham

Christchurch City Council

Date
16th September 2013

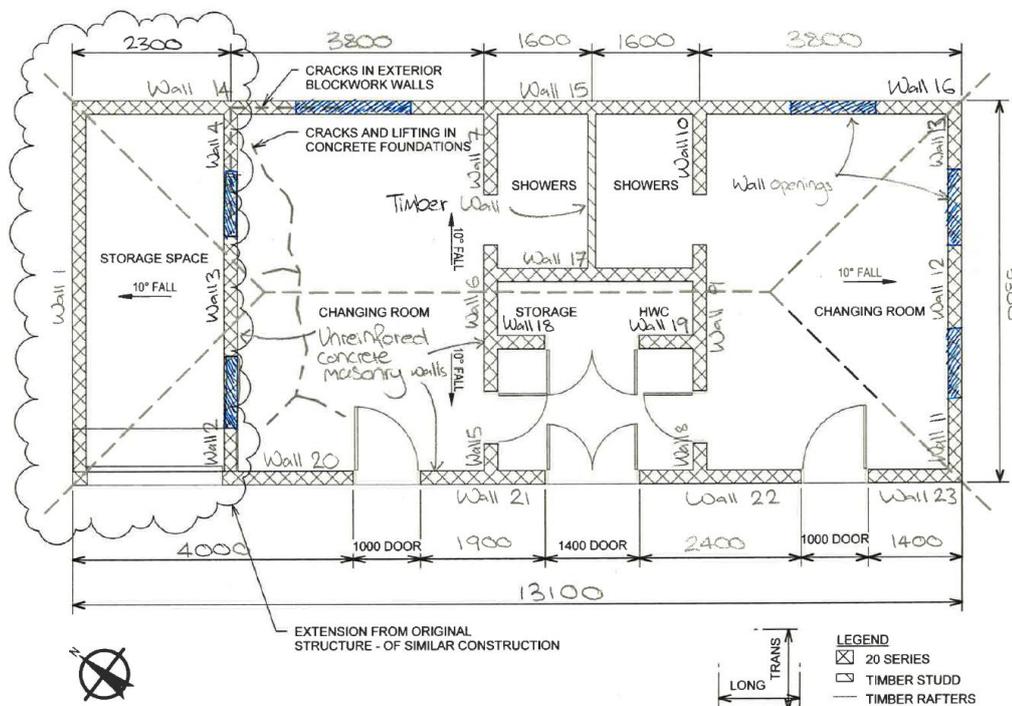
Figure 4.1 Floor plan of the building

An extension to the north-western end of the original building is likely to have been constructed after the completion of the original structure. The concrete masonry walls in this section (Walls 1 and 14 in Figure 4.1 and Appendix B) of the building are reinforced with 12mm vertical bars at 1200mm centres.

Cracking in the mortar between the concrete masonry units was observed in the north-western end of the original building. The observed damage is shown in Photographs 7 and 8. The location of the cracking observed in Walls 3 and 4 is shown in Figure 4.1 and Appendix B. The calculated load resisting capacity of Walls 3 and 4 has been reduced by 25% to account for the damage observed. These reduced wall capacities were not found to be the critical %NBS for the structure.

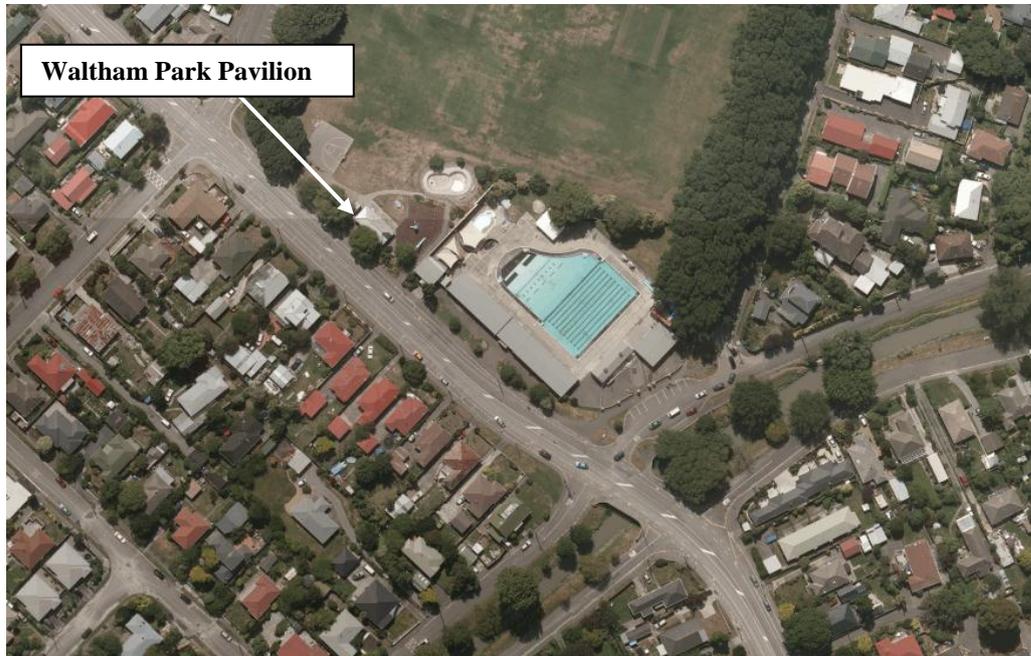
Figure 6.1 Post February 2011 Earthquake Aerial Photography ³

Aerial photography taken following the 22 February 2011 earthquake shows no signs of liquefaction outside the building footprint or adjacent to the site, as shown in Figure 6.1.
