**Willard Street
Housing Complex
PRO 1112**

**Detailed Engineering Evaluation
Quantitative Assessment Report**

Willard Street Housing Complex Quantitative Assessment Report

21-71 Willard Street, Spreydon,

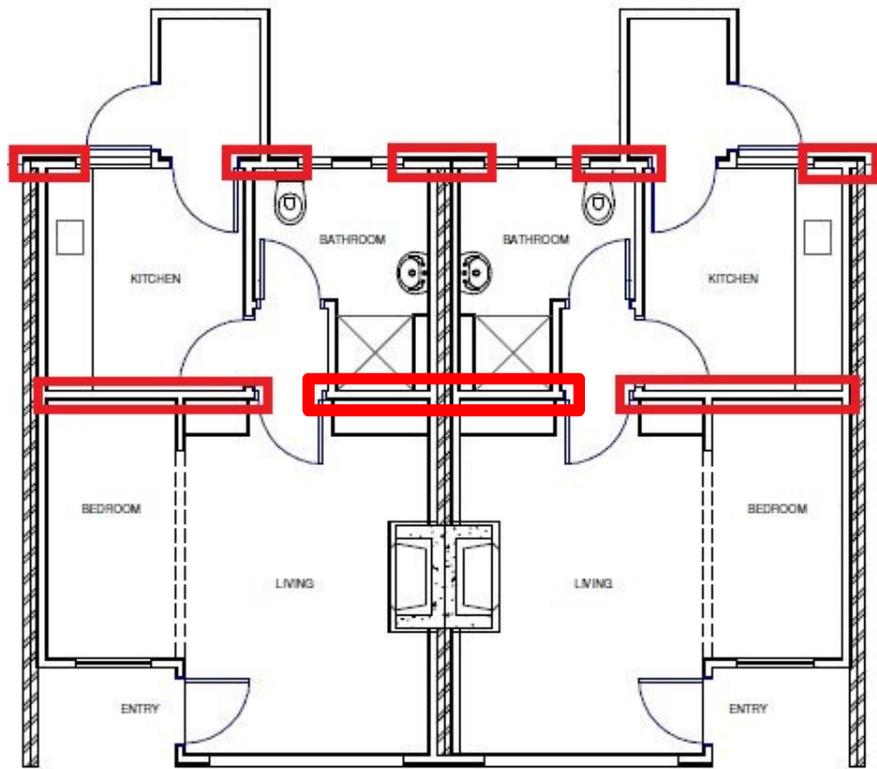
Figure 6: Walls used for bracing in the longitudinal direction.

Hand calculations were performed to determine seismic forces from the current building codes. These forces were applied globally to the structure and the capacities of the walls were calculated and used to estimate the %NBS. The walls, highlighted in Figure 6 and Figure 7, were used for bracing in their respective directions.

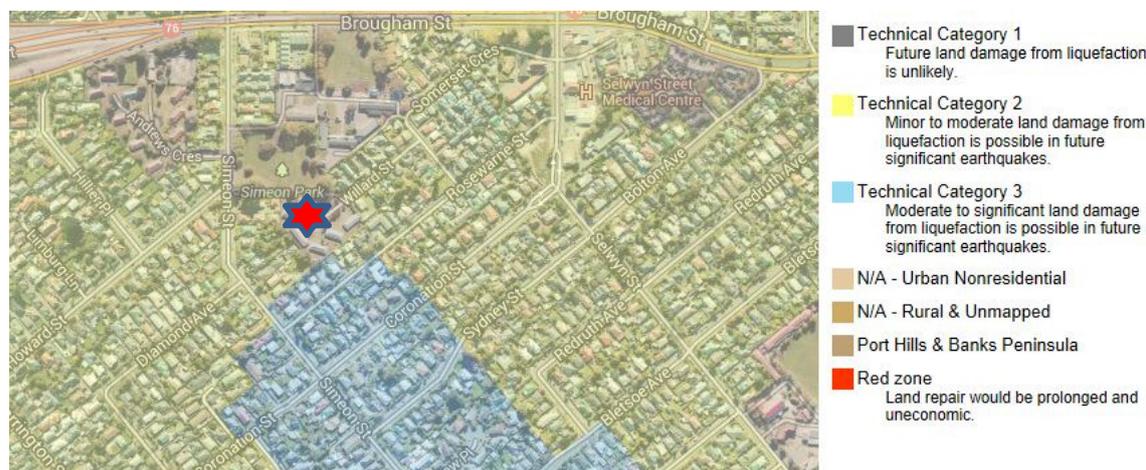
Figure 8: CERA Technical Categories map (loc. starred).

CERA indicates that Willard Street is located in a TC2 zone (as shown in Figure 8). This classification suggests future significant earthquakes will cause minor to moderate land damage due to liquefaction and settlement.
