**Project Number 28912.000.001**

**Geotechnical Assessment**

Lighthouse Road Landslide, Akaroa,

Submitted to:  
Christchurch City Council  
PO Box 73016  
Christchurch 8154

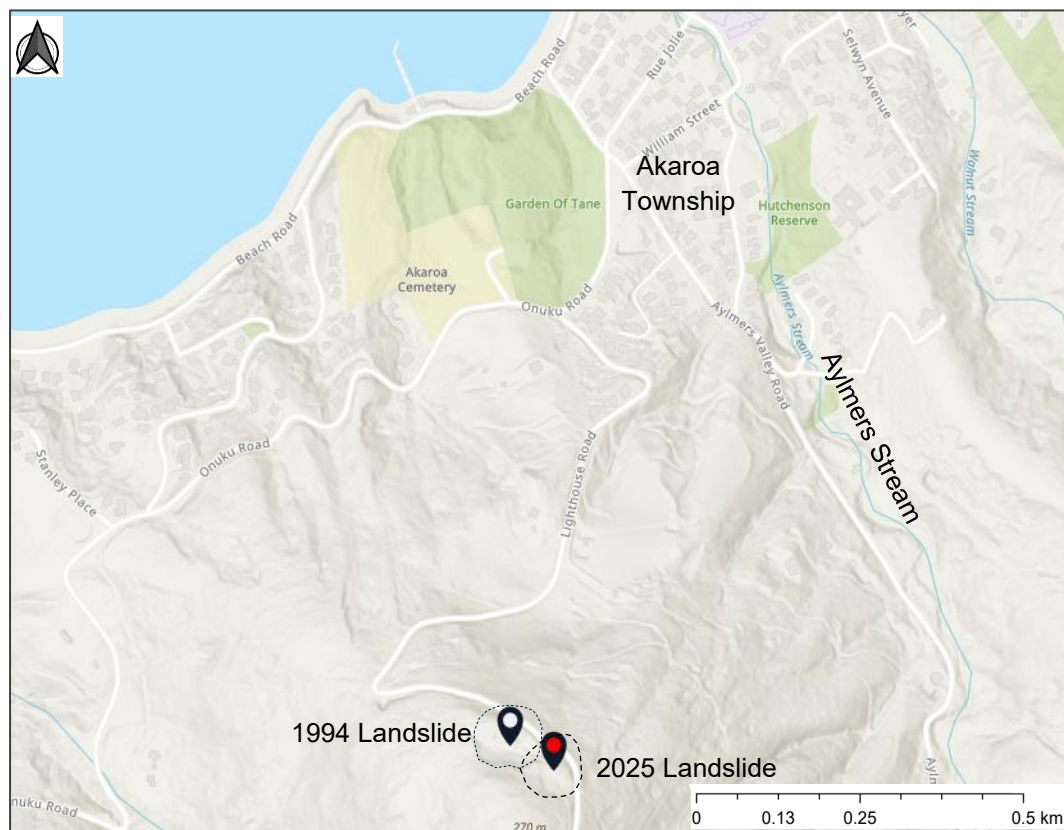
**Figure 1: Site Location**

Both the recent and 1994 landslides are situated at approximately 280 metres above mean sea level (m asl) on Lighthouse Road, overlooking the township of Akaroa (Figure 1). The overall site faces north-northeast and lies just downslope of a north-trending spur (Aylmers Hill), which descends from the Akaroa Crater Rim.

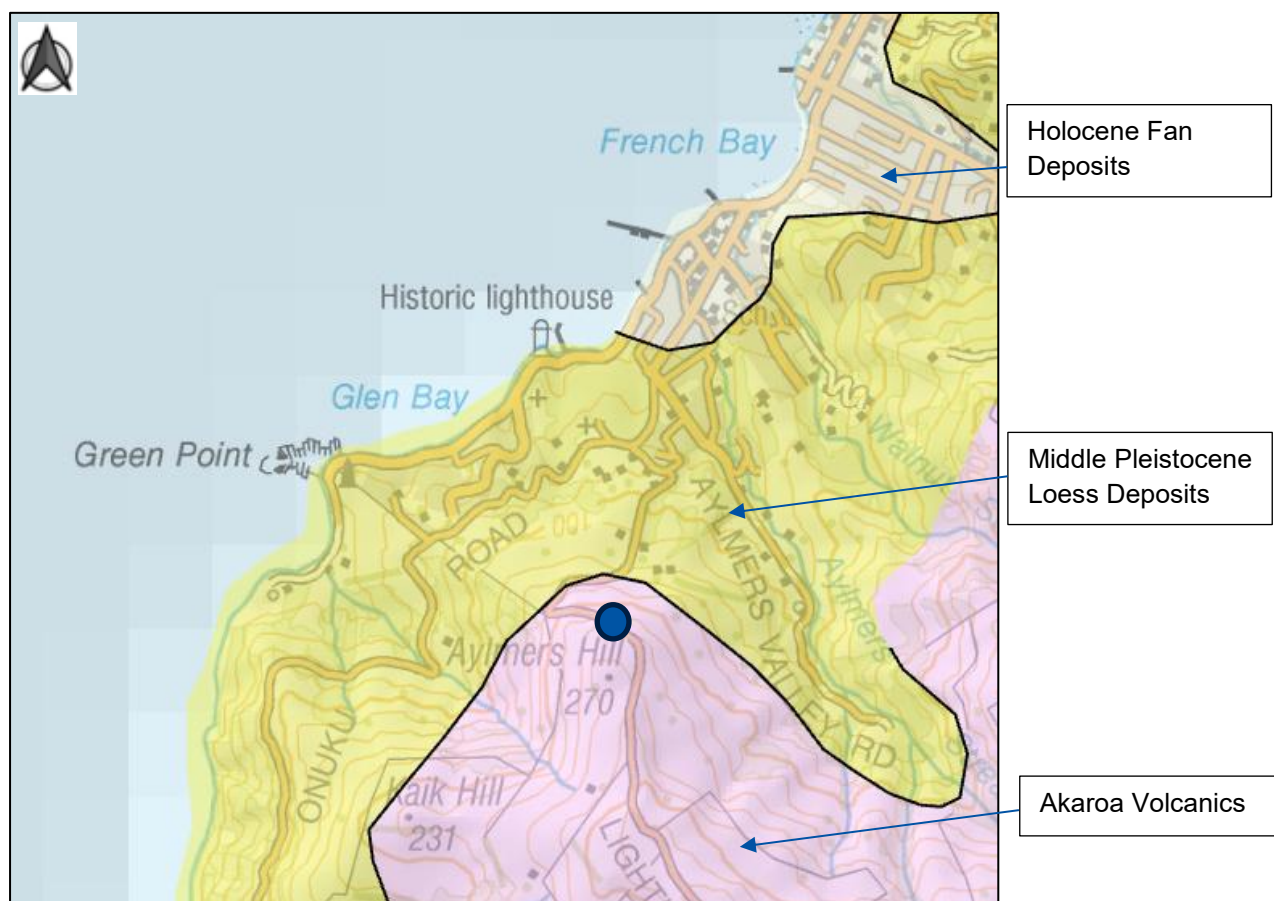
**Figure 2: Geological Setting (GNS online map).**

Both the 1994 and 2025 landslides are hosted in Akaroa Volcanics; described by GNS<sup>1</sup> as 'Basalt to trachytic lava flows intercalated with tuff pyroclastic breccia and agglomerate' (Figure 2).

Note: 2025 Landslide location shown in blue.

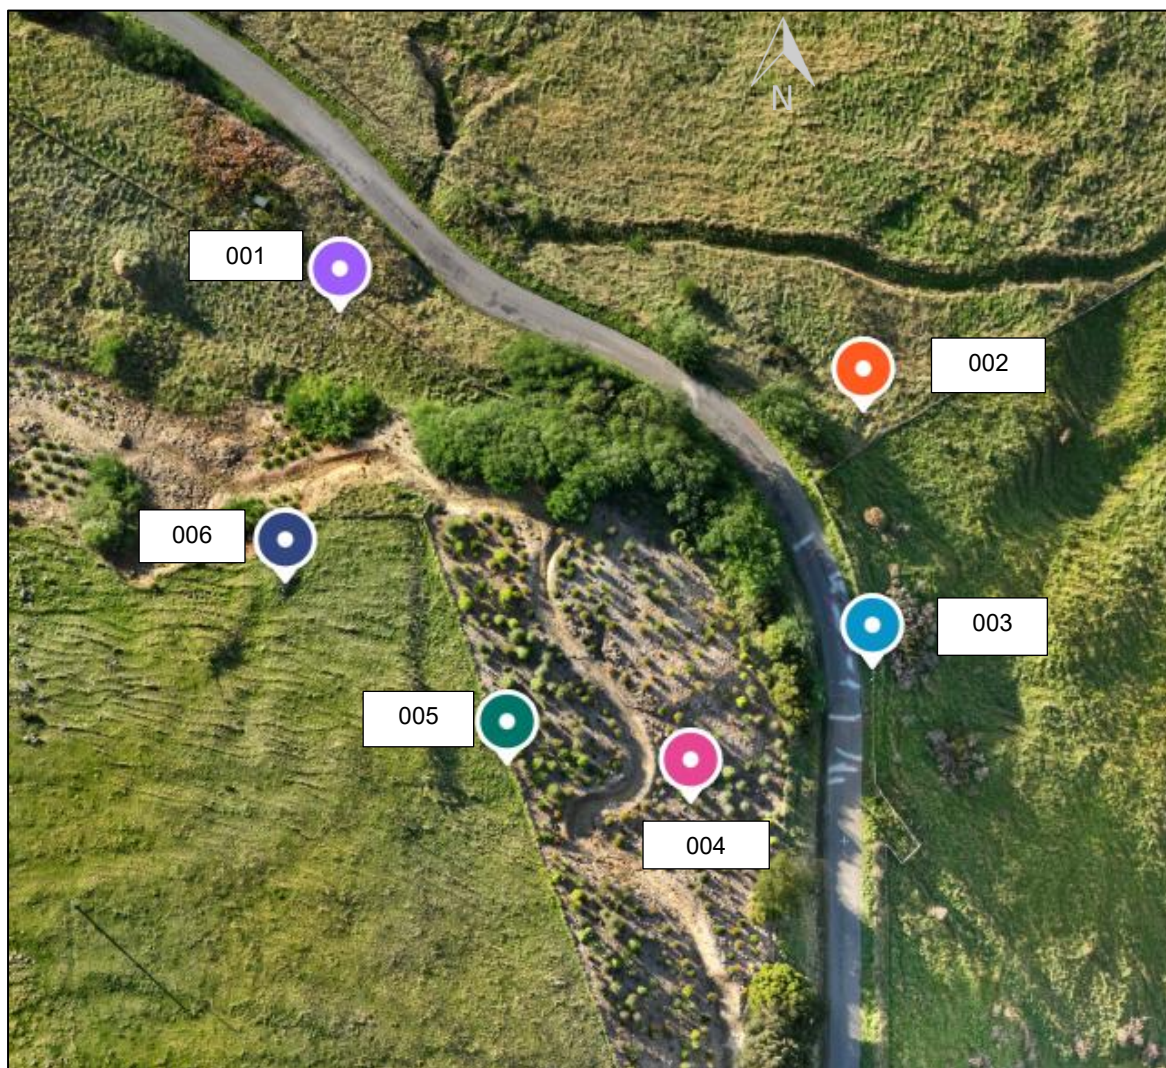
**Figure 4: Location of Surface Monitoring Sensors**

Kurloo GPS movement sensors were installed by CCC on 8 May 2025. These sensors comprise autonomous GNSS-based devices capable of measuring displacement and settlement to ~2 mm accuracy. Six sensors have been installed as shown on Figure 4.

At the time of writing, Sensor 003 has reliably picked up about 14 mm of net movement in the horizontal direction (towards the northeast) and approximately 10-15 mm in the vertical direction (downwards). Around half of this movement occurred during and immediately after the earthworks for the pads for the drill rig (i.e. the two boreholes).

None of the other sensors have recorded more than about 5-10 mm of net displacement.

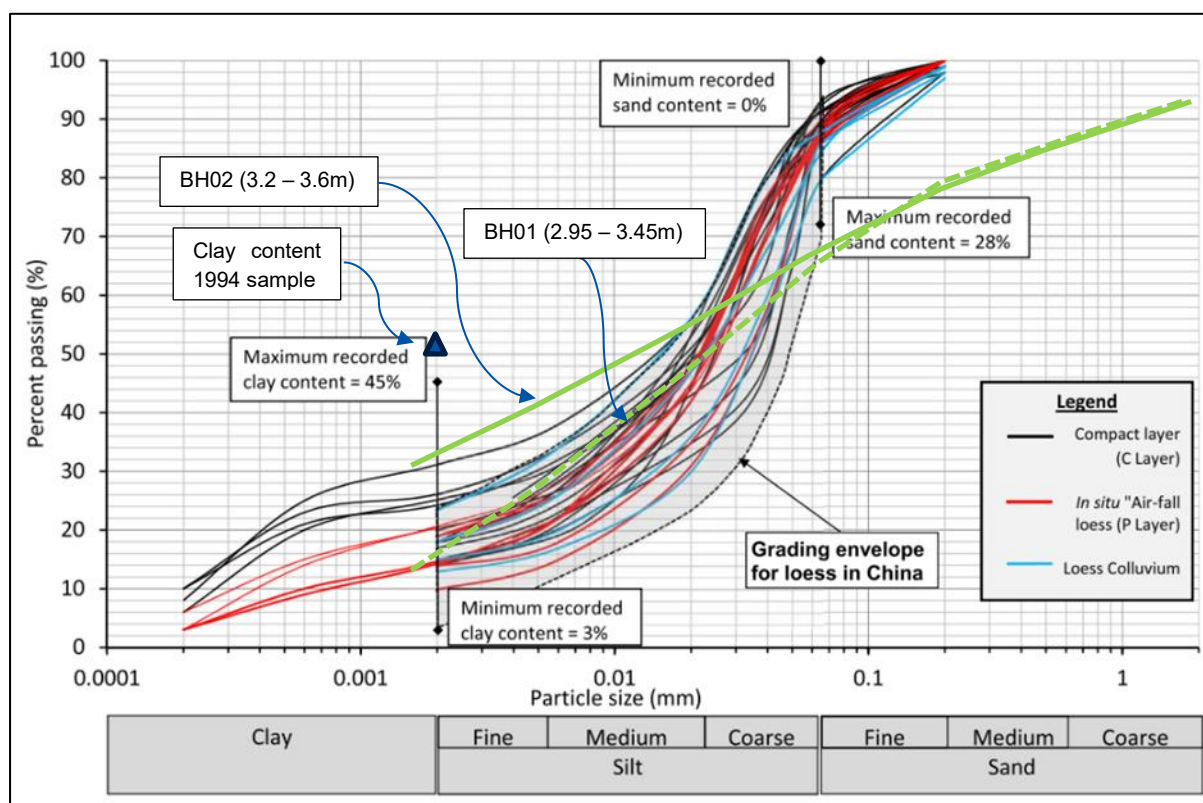
**Figure 7: Particle size distribution for Canterbury Loess deposits (Yates et al, 2018) compared to pyroclastic material.**

However, this type of behavior is not as apparent in finer grained (i.e. clay-dominated) materials which are not subject to liquefaction behavior on saturation. The particle size distributions of the recovered borehole samples (refer Section 5.4) are shown on Figure 7 in comparison to a range of measured distributions for loess (Yates et al, 2018). Also included in this figure is the value reported in Ekanayake & Phillips (1997) (refer Section 5.4).

In addition, the recent samples have higher liquid and plastic limits (LL and PL) and plasticity index (PI) than typical for Loess. Yates et al (2018) note values of LL between 24-30%, PL 15-20% and PI of 4-12, and, Moase (2011) suggests that the fines content of the flow must have a PI less than 5% to maintain the ‘debris flow’ classification; significantly lower than the values provided for the weathered pyroclastic material in Table 1. This suggests that the pyroclastic material is more likely to behave as a cohesive soil and is therefore not subject to the same degree of flow behavior compared to loess.

Note: Clay content in the 1994 sample is taken from Ekanayake and Philips (1997)

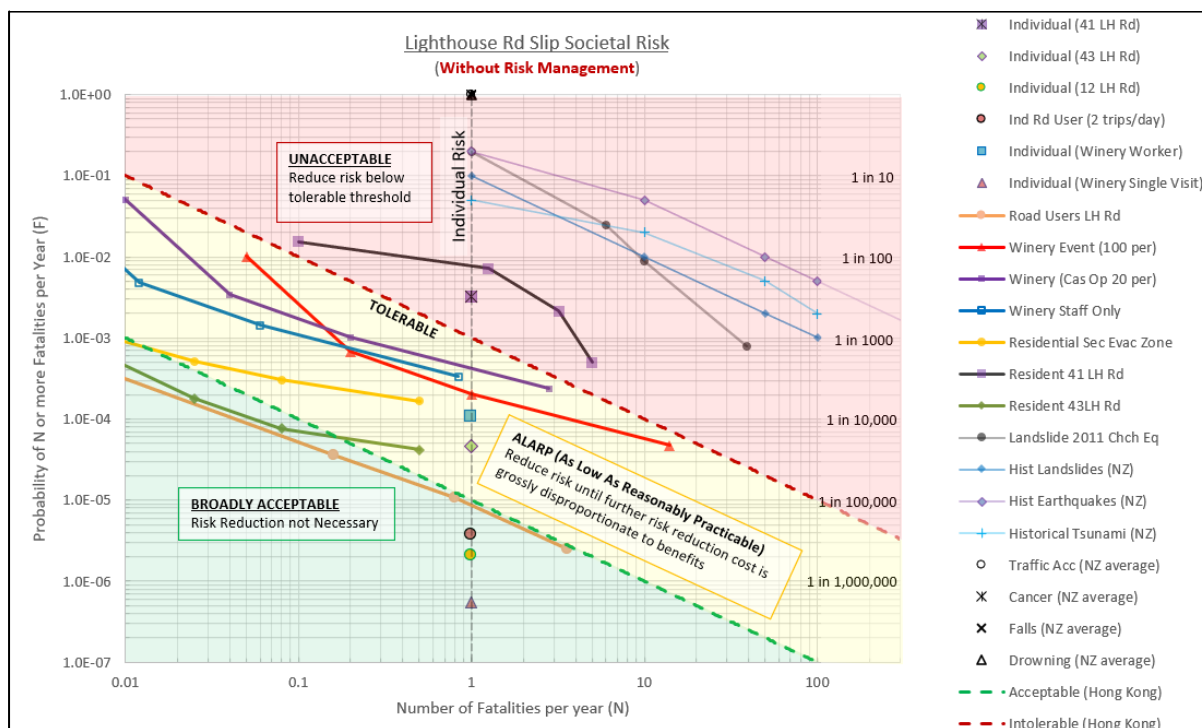
**Figure 9: Risk Assessment Results (Without Risk Management) with information known as of August 2025.**

Figure 9, below, shows an extract of the results of this risk assessment and the full assessment is included as Appendix 11.

Note that the societal risk curve for residents within the secondary evacuation zone indicates higher risk there compared to that for 43 Lighthouse Rd – this is due to the greater population exposed within the secondary evacuation zone. Hence, while the individual risk within the secondary evacuation zone (e.g. at 12 Lighthouse Rd) is acceptably low, the societal risk is within the ALARP (tolerable) region.

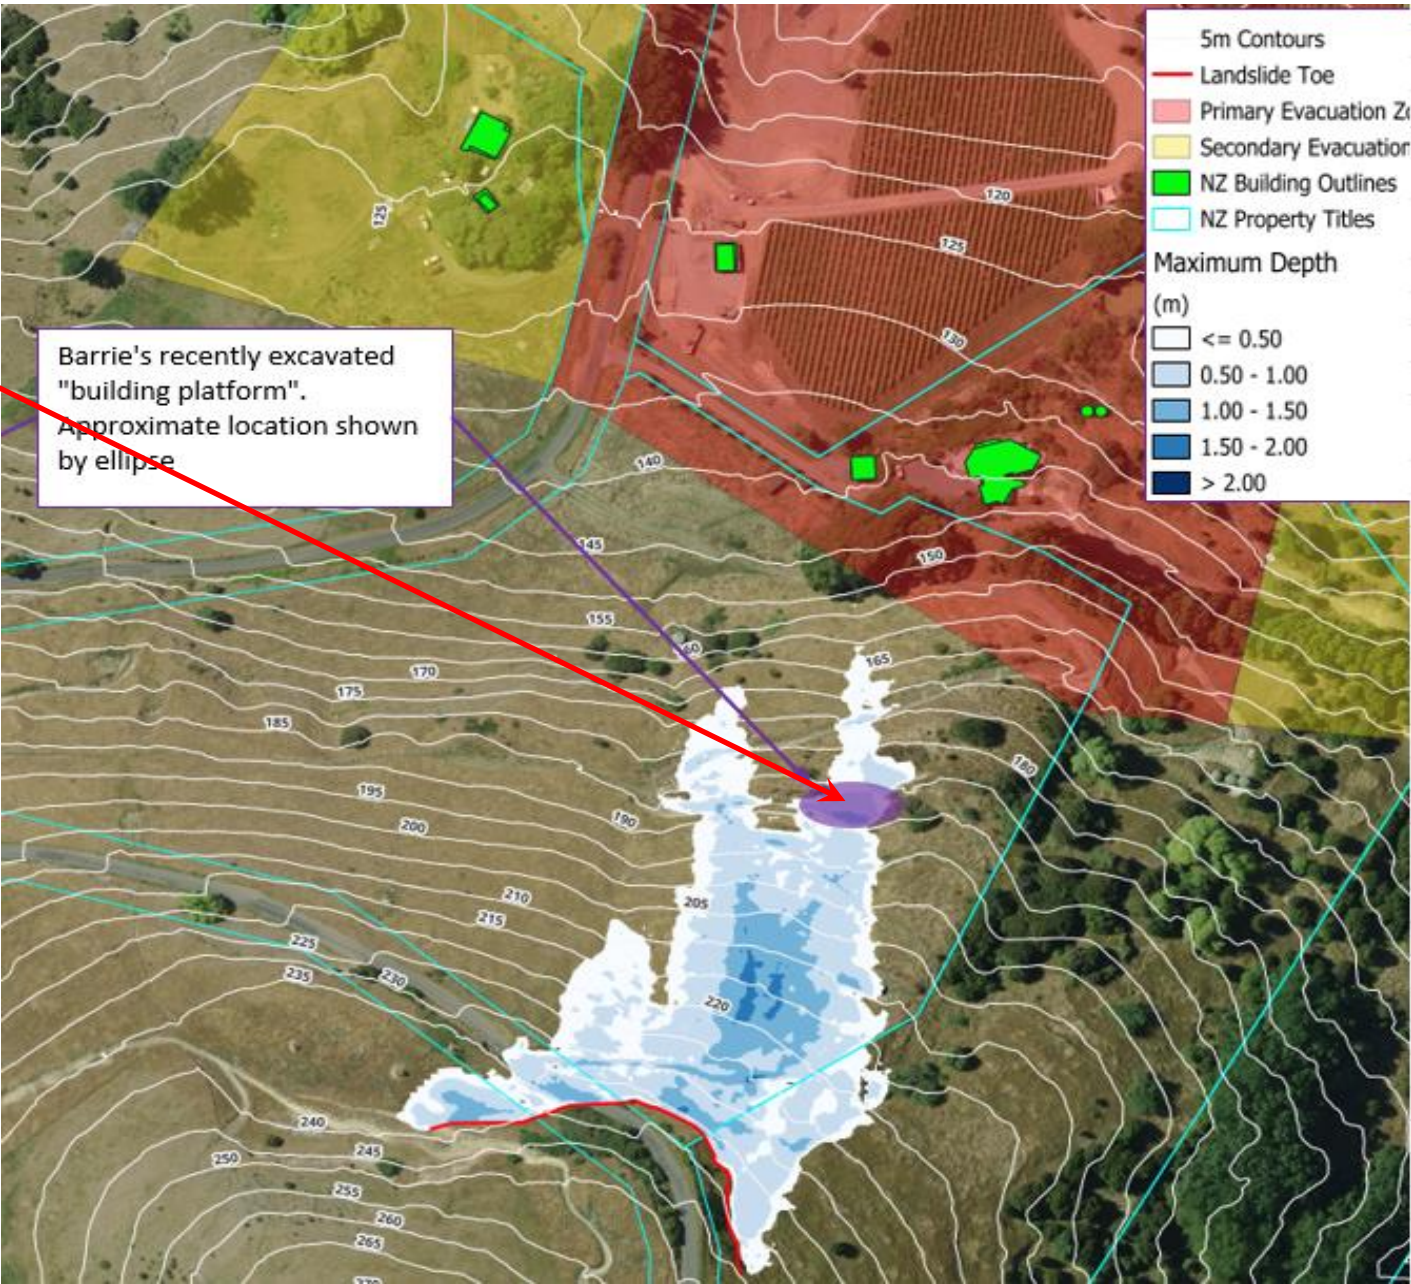
#12 Lighthouse Rd - Inputs

For the **Individual** most at risk  
Assumes a person on their propety who is subjected to debris flow or rockfall without any prior warning  
Hazard from the "active" landslide area is considered only  
Assumes person most at risk is fully exposed (not protected by barriers, etc)

Likely Debris Flow (~1,000 m3)		V <sub>(D:T)</sub>		vulnerability depends on depth and velocity of flow
probability of loss of life or serious injury given impact V <sub>(D:T)</sub>		0.50		even chance of survival
Maximum Credible Debris Flow (3,000 m3)				
probability of loss of life or serious injury given impact V <sub>(D:T)</sub>		0.80		low chance of survival
Very Large Debris Flow (5,000-10,000 m3)				
probability of loss of life or serious injury given impact V <sub>(D:T)</sub>		1.00		death is almost certain
Other (isolated Rockfall or small landslide)				
probability of loss of life or serious injury given impact V <sub>(D:T)</sub>		0.10		Rock is unlikely to have much energy even if it is able to reac

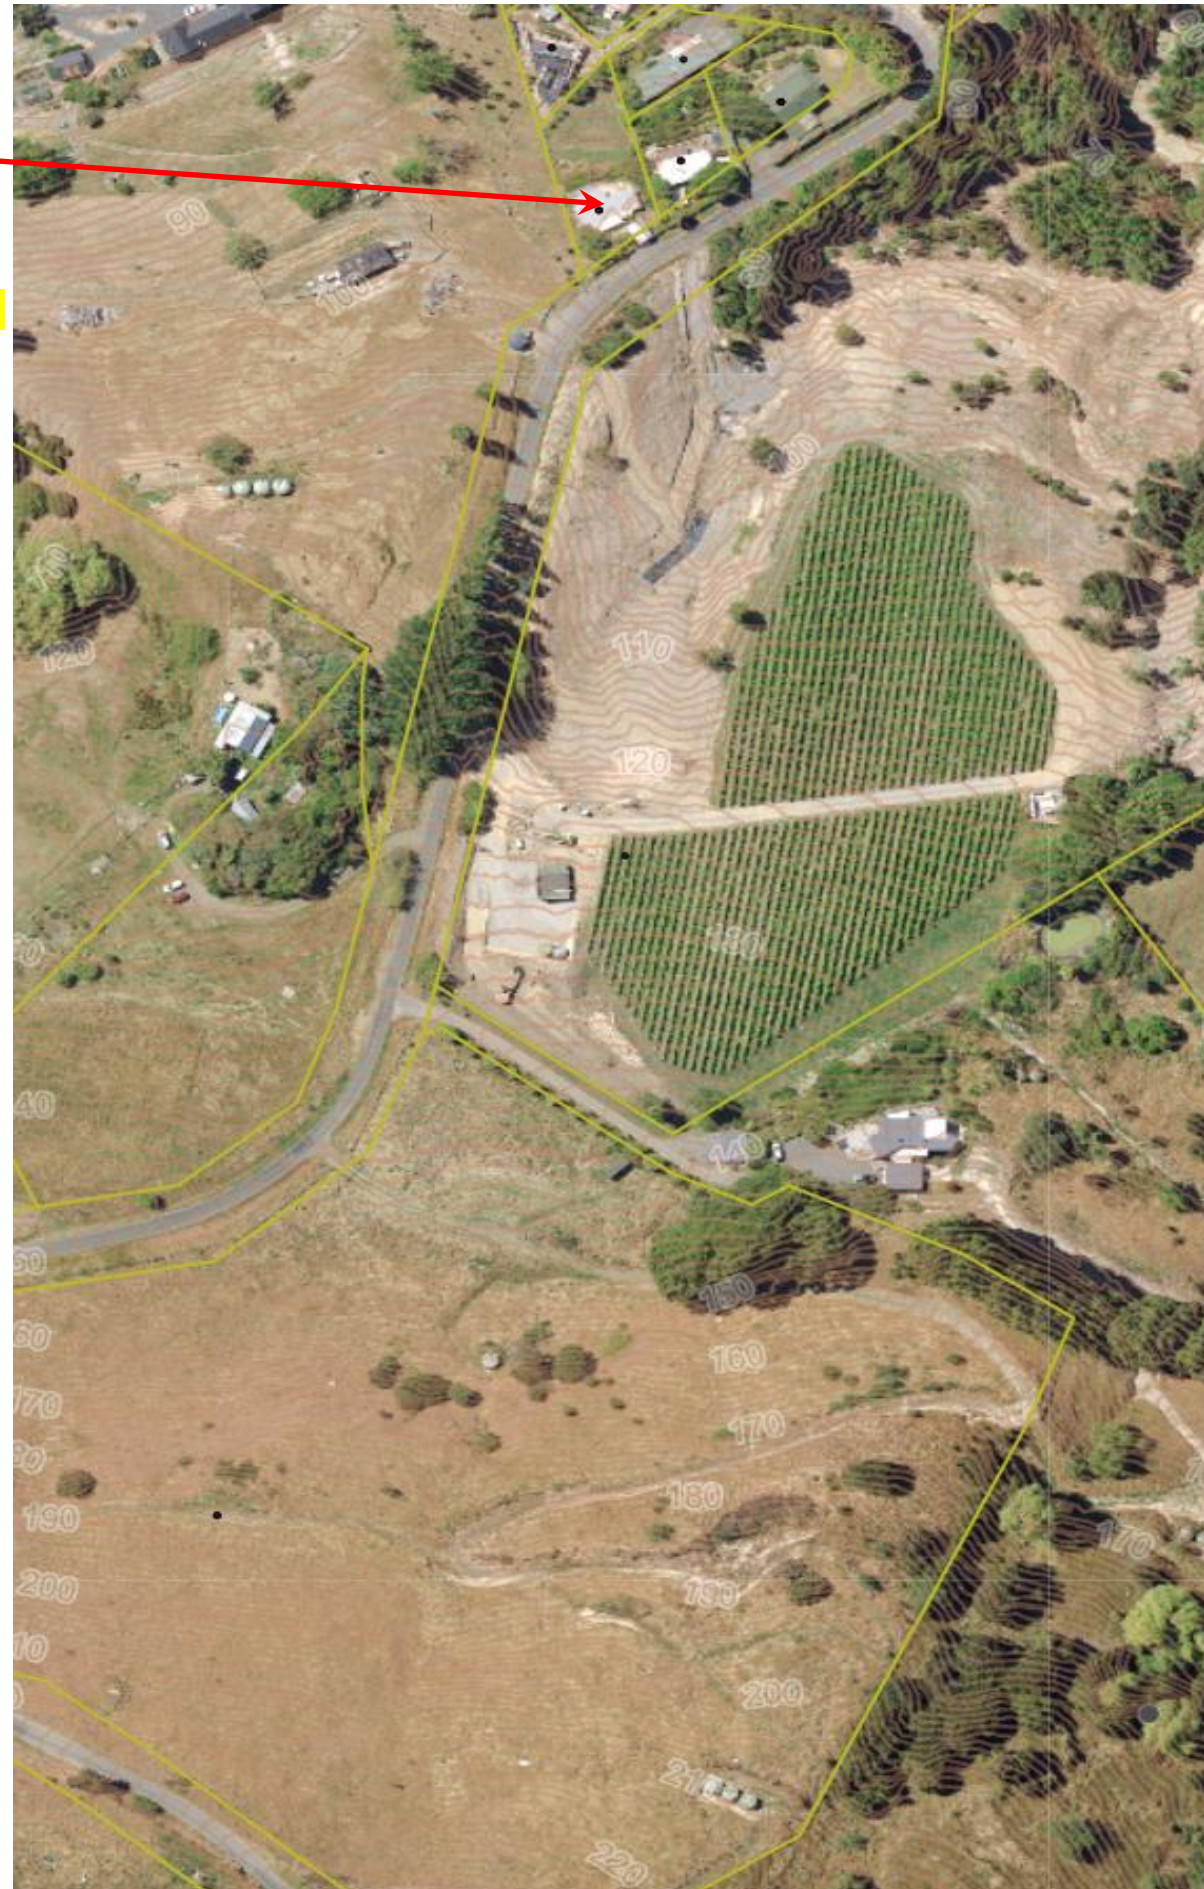
#12 Lighthouse Rd - Calculations

Risk Tables for Debris Flow & Rockfall Events

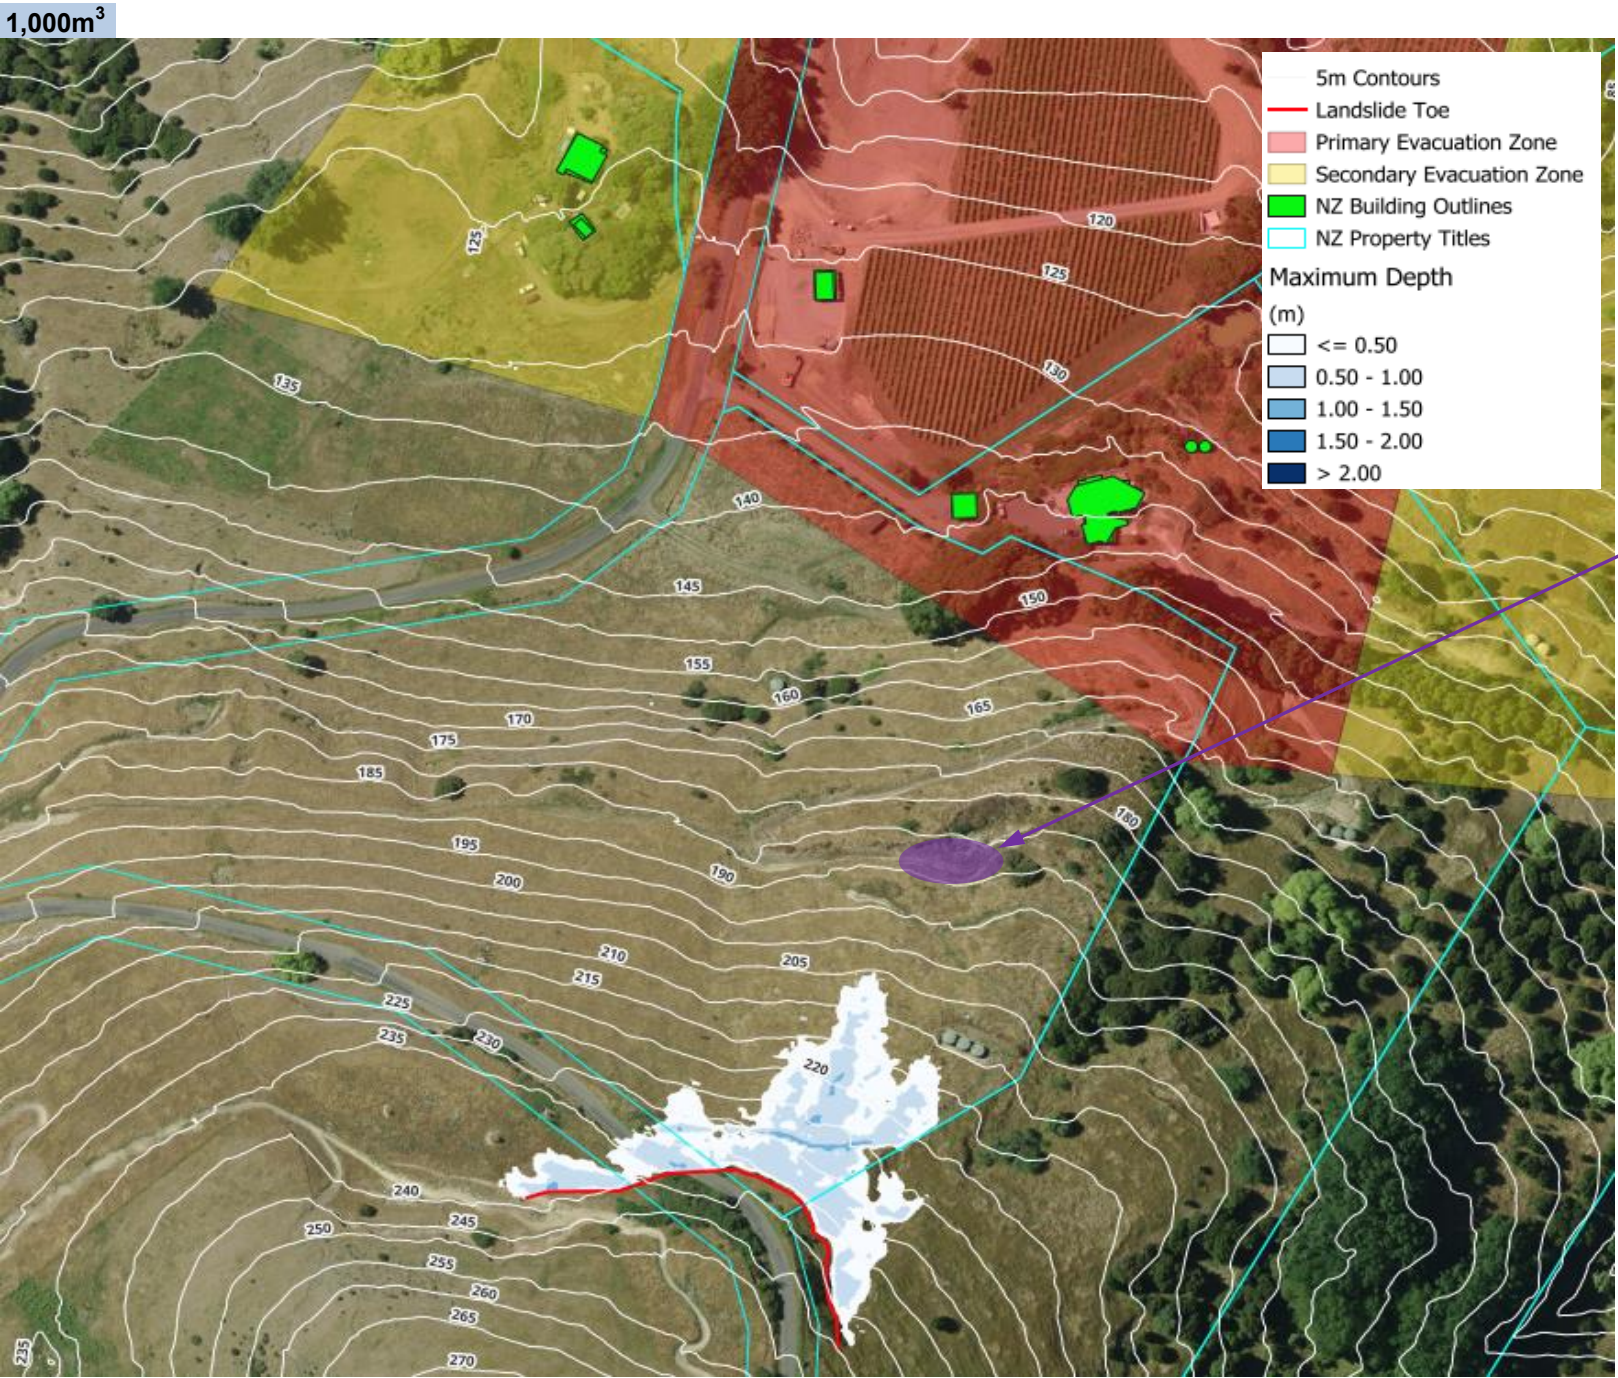
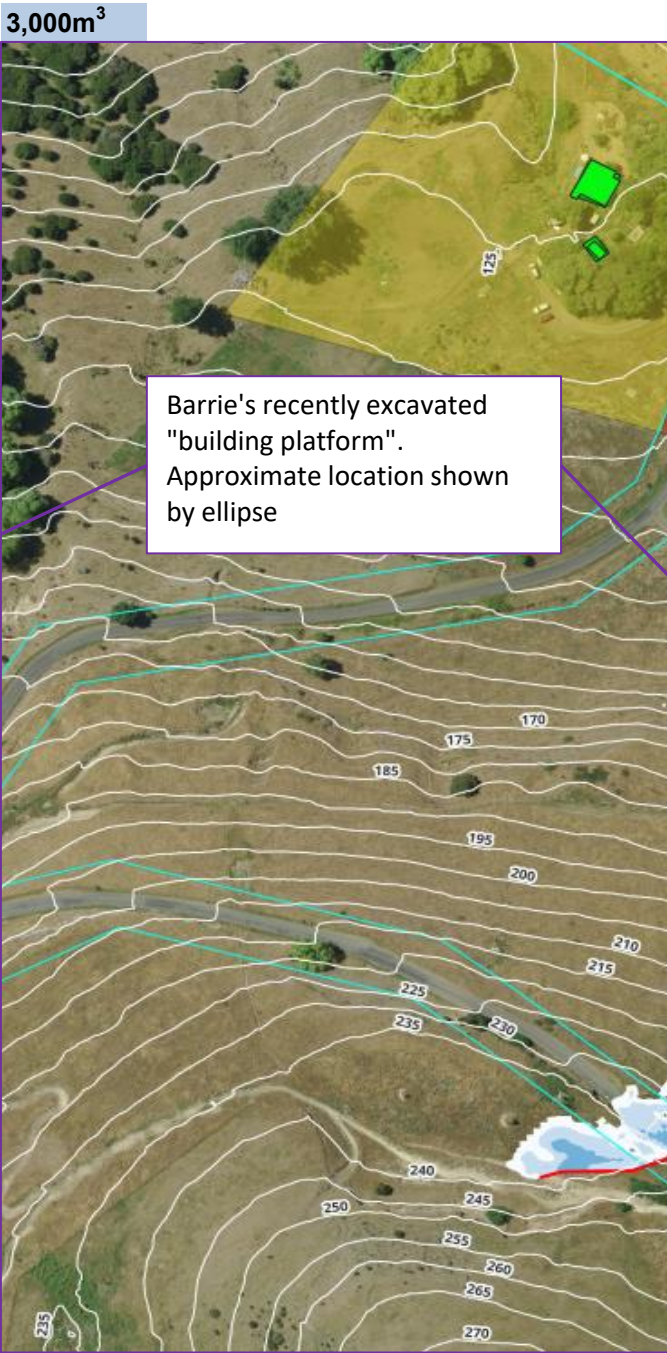
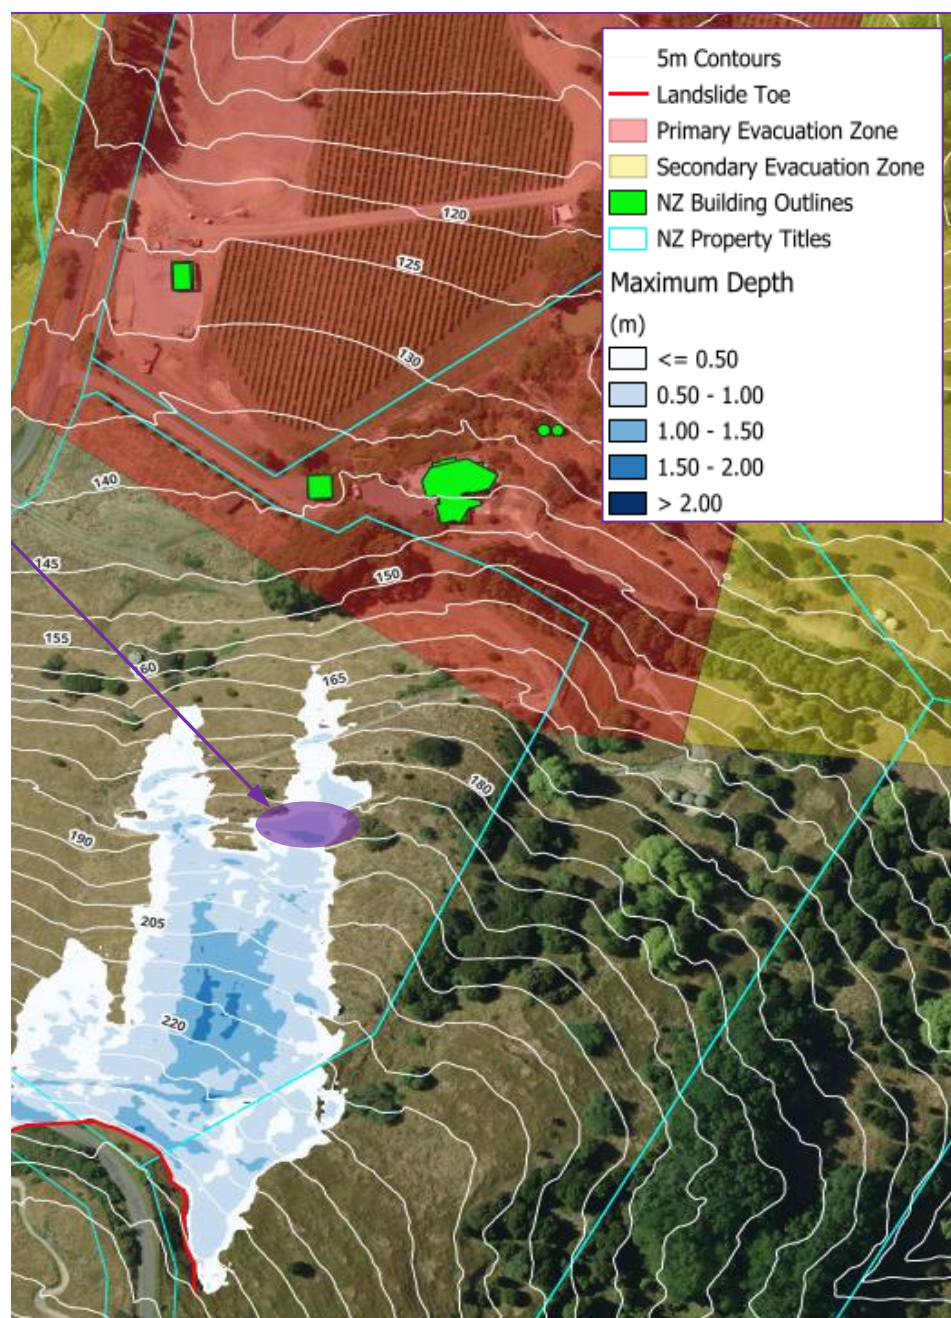
Largest credible event based on eng geological model.

No inundation of existing buildings/structures. Debris does reach excavated building platform on #41, but would have a maximum depth of around 1-1.5m at the back of the bench.
