Guidelines for As-Built CCTV Inspections of Lined/Rehabilitated Pipe

Prepared By:
ProjectMax Limited
8/11/2013

Supplementary Document to
the CCC Specification “CCTV
for Christchurch City Council
Earthquake Recovery”

This document provides a guideline for the assignment & interpretation of feature and defect codes, as part of the CCTV as-built inspections of Lined/Rehabilitated pipes for the Christchurch earthquake recovery.

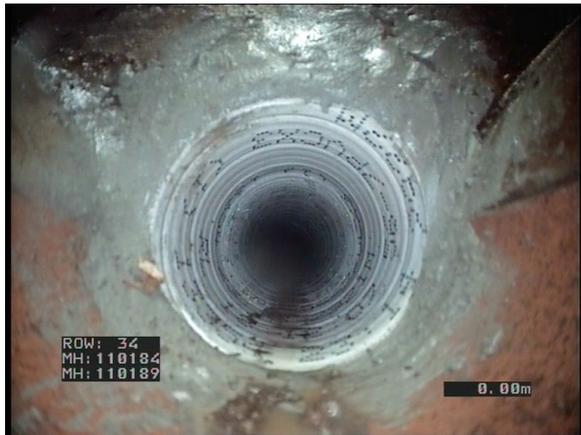
Good example of an end seal and transition in an Expanda (Spiral Wound) pipe.

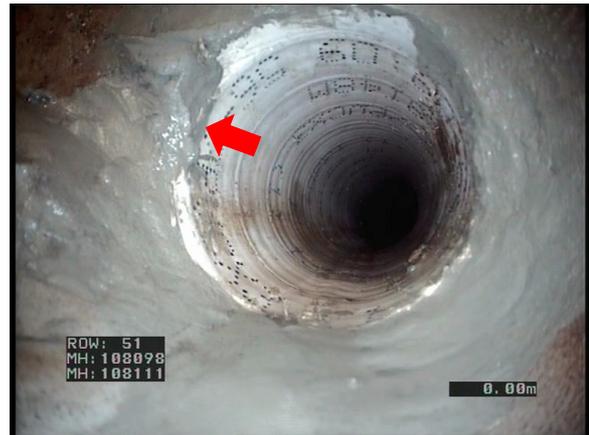
Excess mortar on the end seal causing rough entry and an obstruction – coded as OP, Small.

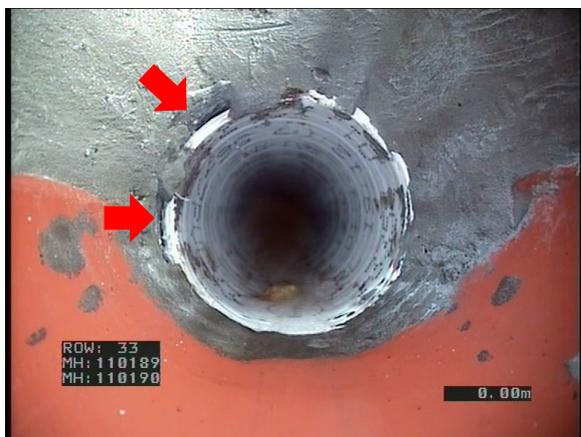
Good transition, but the end seal has gaps between the Expanda liner and the host pipe – Gap, but no evidence of pathway, coded as JF, Medium.

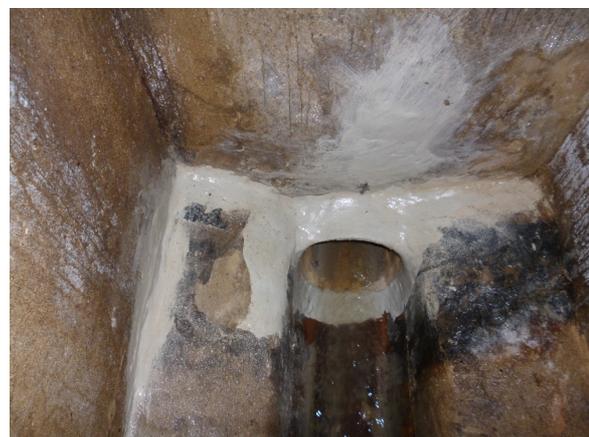
Good example of an end seal and transition for a CIPP liner.

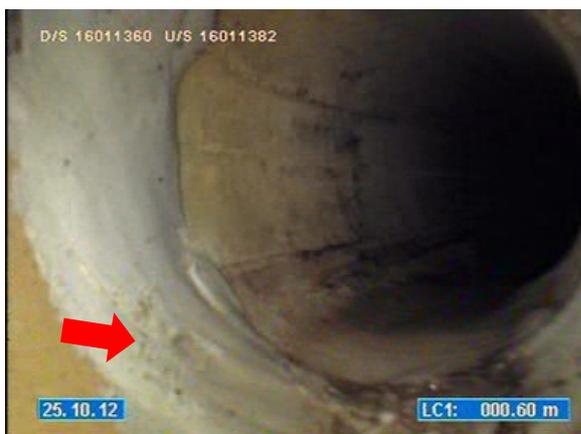
Excess mortar on end seal for a CIPP liner, affecting the transition between the channel and the liner (causing an obstruction) – coded as OP, Small.

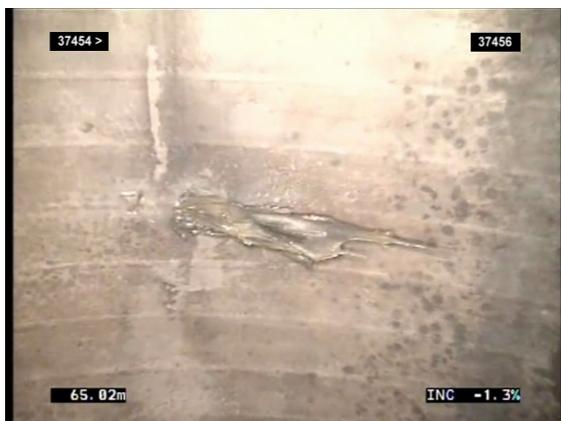
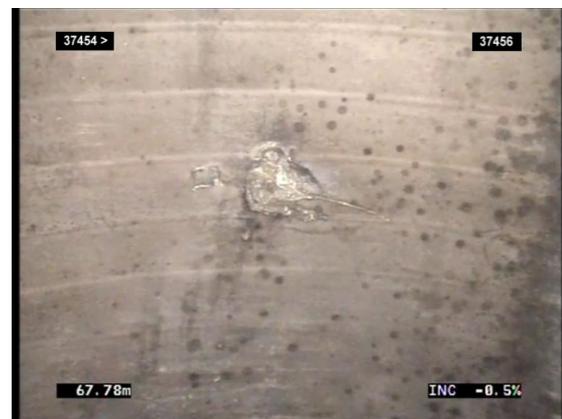
Vacuum/Impregnation patch – hot patch

Hot patches will appear a bit like a 'repaired hole' in the liner. Will often stain quickly, (and the pipe wall around it, as though there had been infiltration) as a result of the lubricant used to install the liner. An actual hole in the liner would look like a 'cut out' section in the liner and would not appear to be repaired.

- **Vacuum/impregnation patches:** During the liner wet out a vacuum is applied to ensure the resin fills all the voids in the liner without having excessive resin. A small incision is made through the liner coating into the felt of the liner. As the wet out process is worked through, the vacuum points are removed and the holes patched with a small glue on patch (PVC coated liners) or a small hot glue gun application patch (PE and PU coated liners). This may be a small patch repair or a hot glue gun repair.

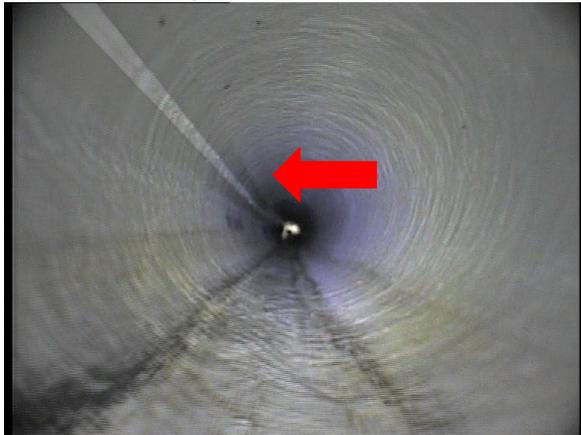
Seams/seam tape

The seam can be either heat sealed (pictured) or stitched. This seam is covered by a seam tape (note the tape band).

- **Seam tapes:** As part of the seam production, the seam is sealed with a tape that is applied by either heat or ultrasonic welding. The tape will seal up the holes made by the stitching process and is placed over the seam to ensure there is no resin leakage before installation and to isolate the resin from water or steam during the curing process. The seam tape is sacrificial and once the liner is cured it is no longer required. It does not provide any strength to the liner. The seam tape will, occasionally, come away (peeling off) from the liner after a period of time in service, usually after cleaning.

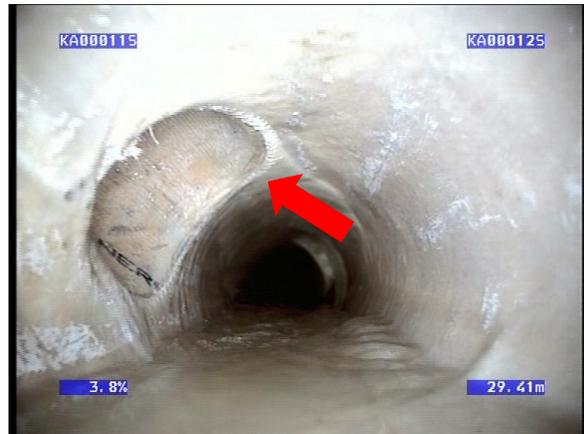
This picture shows an example of a 'stitched' seam used to join the lateral stub to this lateral junction repair (LJR or LCR). This stitching would not be recorded as a specific CF.

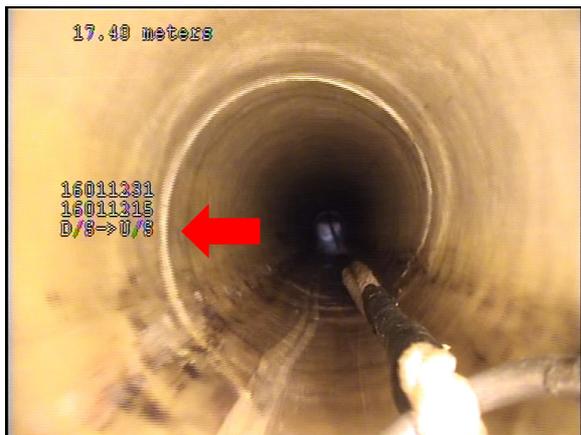
Joints (CIPP)

An example of a CIPP liner joint. These appear as 'spiral joint' in the liner. The spiral will start and end on the seam. The presence of the joint does not affect the performance of the liner

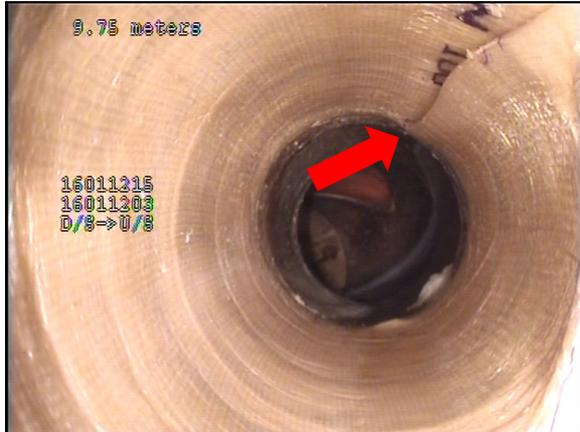
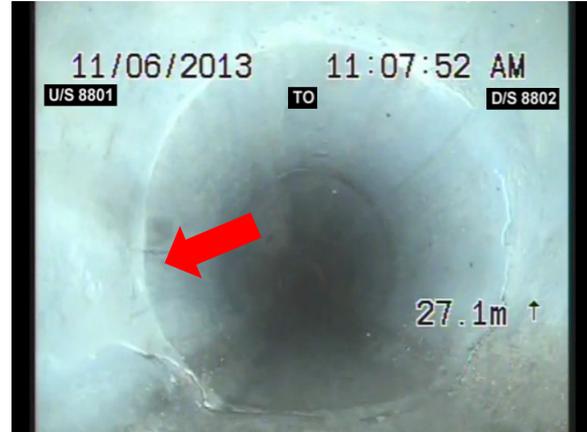
Laps

Lap in a CIPP Patch

A 'Pull and Inflate' liner (installed in sections). The lap for this type of liner should ideally cover the downstream section to minimise the hydraulic effect on the flow. The example in the picture has the lap over the upstream section, which is not ideal (this should be noted in the remarks). A slight lifting if the lap edge is acceptable.

- **Laps:** These are most commonly observed in "*Pull and Inflate*" (such as the Nuflow liner) type of liners where multiple installations may be required to line the full length of pipe. The lap should face downstream, e.g. the upstream liner should be installed over (after) the downstream liner. The lap will be seen as a slight constriction and a feathered edge on the downstream face of the lap.

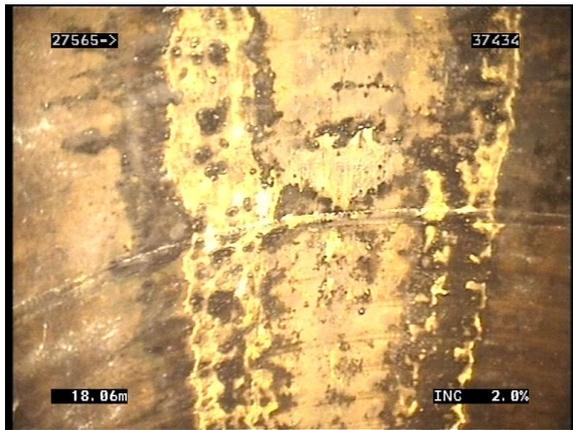
Staining of the liner material including measurements marked on liner

Photo, above, typical staining on the soffit (roof) of a liner, from the lubricants used during installation.

- **Staining of the liner material:** The liner material can be stained as a result of measurements marked on the liner during the 'wet out' or from lubricant (vegetable or mineral oils) used to assist installation, or over time from bacterial growth on the liner surface.

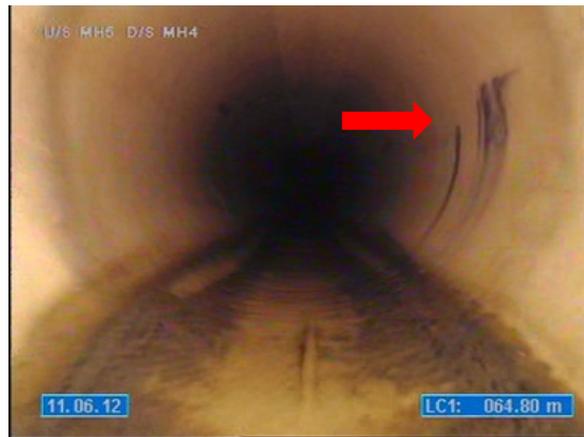
Photo, above, shows typical staining from notes written on the liner prior to installation. Staining such as this can also occur where:

- The installation lubricant has been concentrated, if water was used during the curing process; or,
- It could indicate a pinhole in the liner. If in doubt, a pressure test should be carried out to confirm the integrity of the liner.

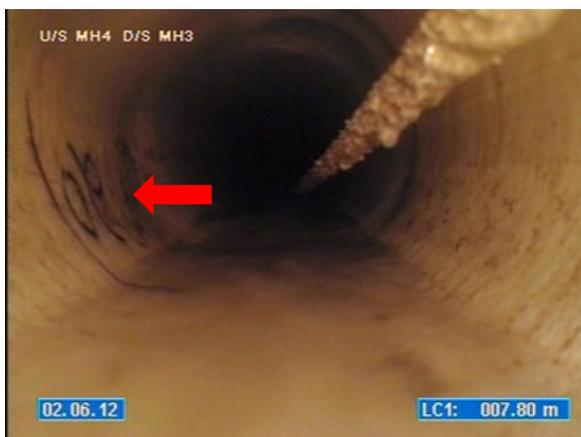
Photo, left, shows notes marked on the liner during wet out.

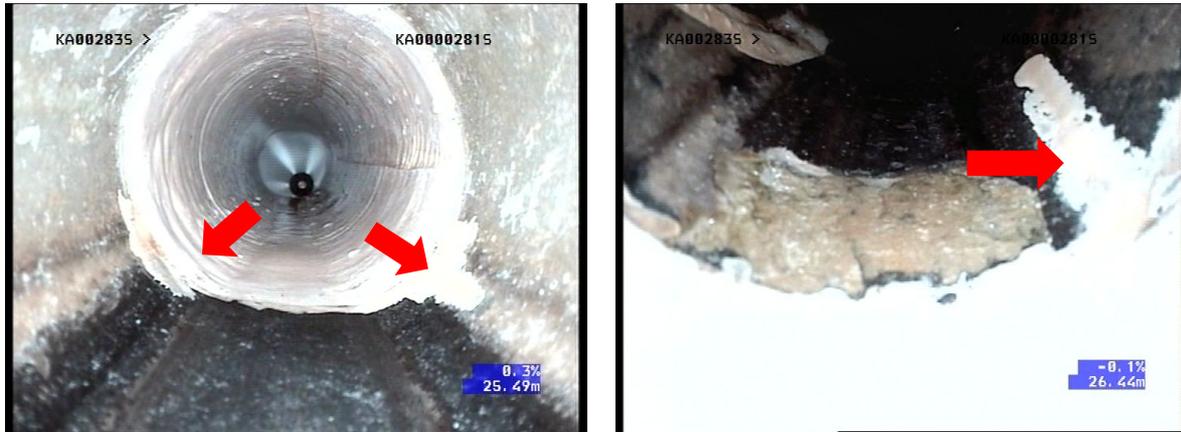
Extruded excess resin (feathering at the edges of patch liners or LJR's)

The photo on the left shows feathering of resin on the upstream edge of a CIPP patch. The photo on the right, shows feathering of extruded resin (appearing as white) on the downstream edge of the patch. This epoxy extrusion assists with a smooth transition between the pipe and the patch (i.e. no 'step' between the two).

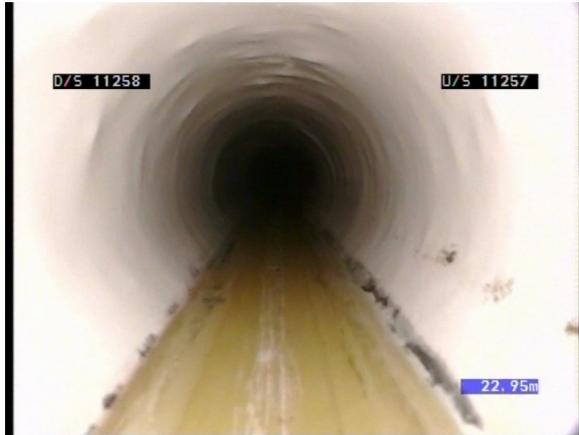
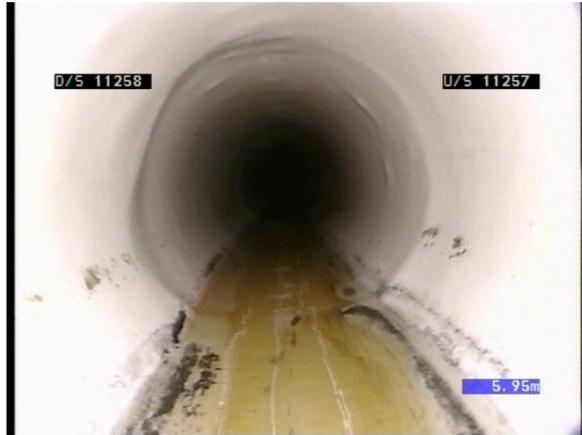
Reflective shape of the host pipe

Flexible liner showing reflective shape of the pipe beneath the liner.

- **Reflective shape of the host pipe** (where liner is over accepted pre-lining deformations, displacements or holes in the host pipe): Flexible liners, such as CIPP or Fold and Form, will take the shape of the pipe that is being lined. Any defects or deformations in the host pipe will be reflected in the liner. Remaining defects in the pipe to be lined are called 'Latent Defects'. Types of latent defects which will commonly be reflected in flexible liners include: dips, deformed pipe, pipe holes, displaced joints, minor protrusions. These will appear as bulges and deformations in the liner. Latent defects are not liner defects. Reflective latent defects, identified with a GC should be compared against the pre lining CCTV inspection to confirm the nature of the pipe prior to lining. A comment should be added to remarks to describe the latent defect reflected in the liner. Where the defective pipe diameter is reduced by latent defect, the estimated percentage reduction in the diameter should also be included in the remarks.

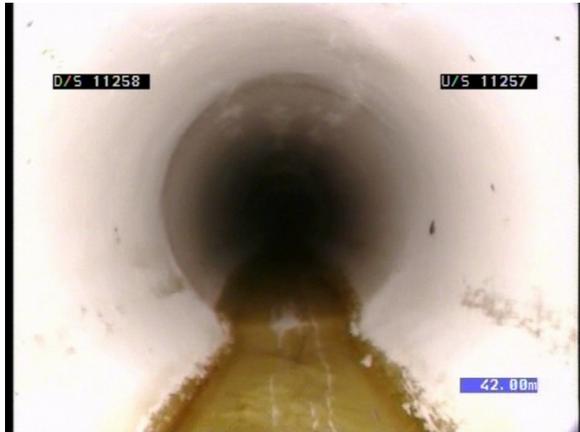
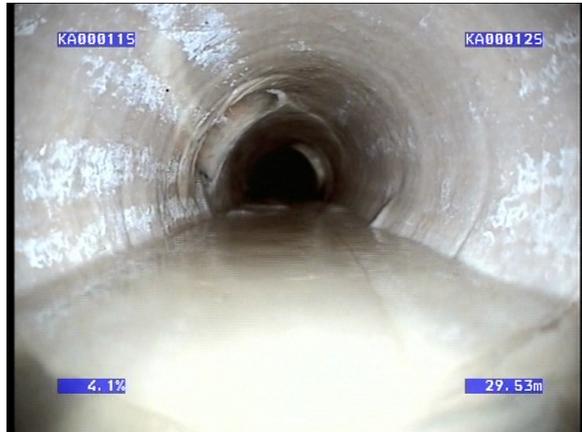
Flexible liner over a minor displaced & open joint in the host pipe

Another example, above, of a flexible liner over a displaced joint in the host pipe

Flexible liner, above, installed in a deformed lateral junction – liner takes on the deformed pipe shape.

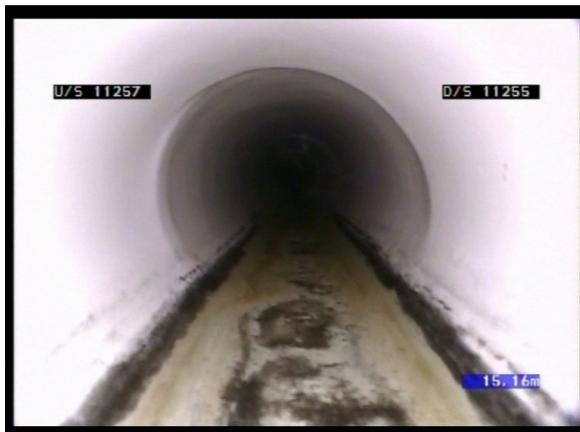
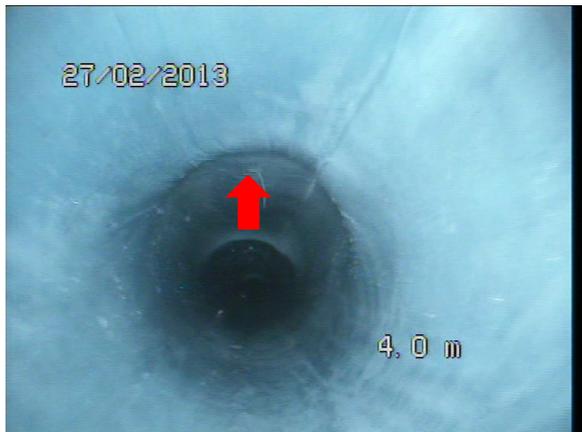
Flexible liner installed in a deformed pipe – liner takes the shape of the host pipe.

Flexible liner covering an inspection point in an EW pipe (100mm). The liner reflects the shape of the host pipe feature (expanding out to fill the

shape

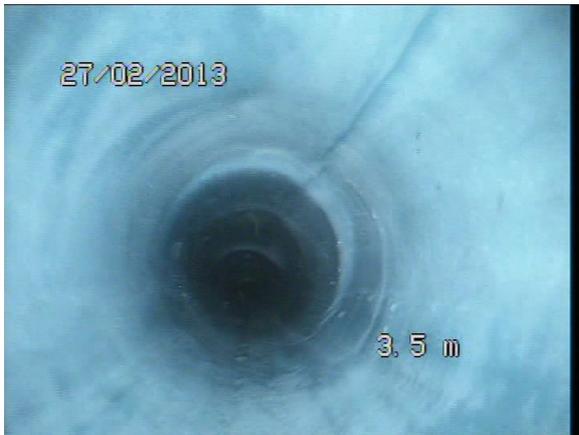
Flexible liner over what appears to be either a slight displacement or an uneven (irregular) wall thickness at the joint that you commonly see in EW pipes.

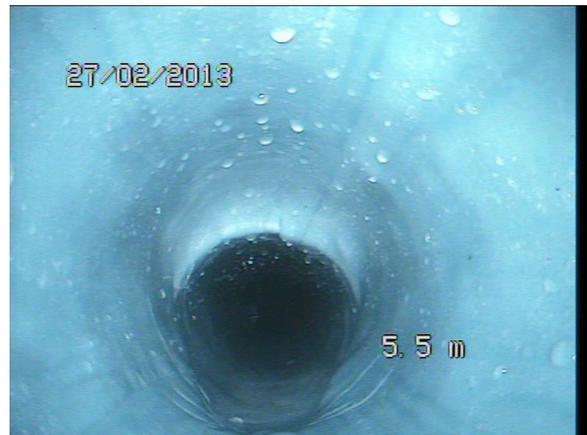
Flexible liner over a displaced joint in 100mm diameter pipe

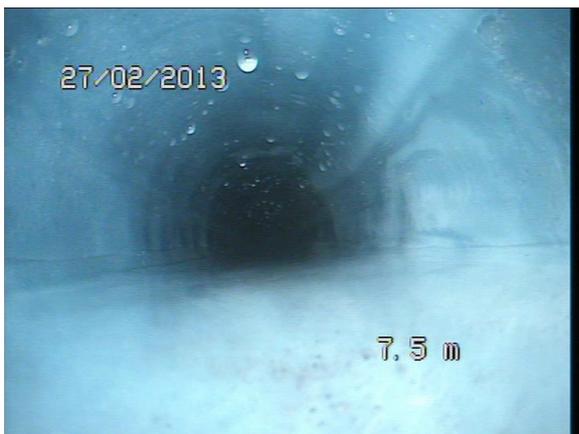
Dips in the host pipe are reflected in the lined pipe.

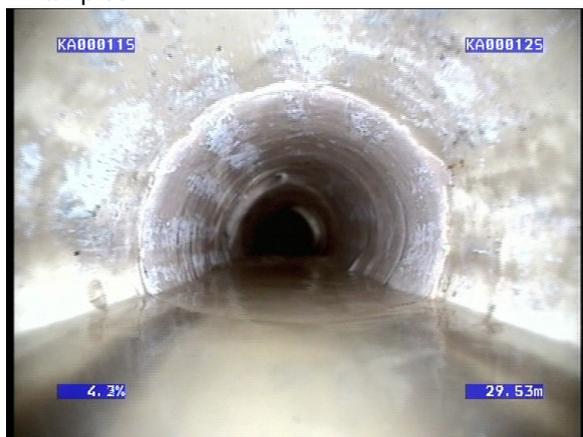
LJR installed in a lined pipe. The lap of the LJR at the start of the patch is visible as a 'lip'.

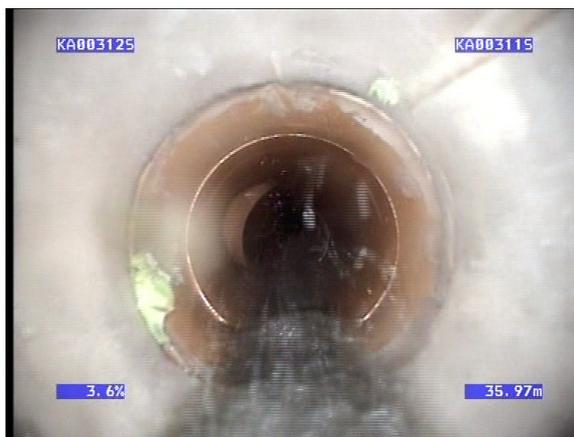
Picture above, shows the transition from a CIPP patch to the original pipe that has been repaired. The green material at 8 o'clock is masking tape used to bind the patch to the packer for installation. The tape is protruding from the end of the patch, caught between the pipe and liner. This is not a defect in the patch liner. The tape will eventually break off – this can be recorded as a temporary obstruction (OT).

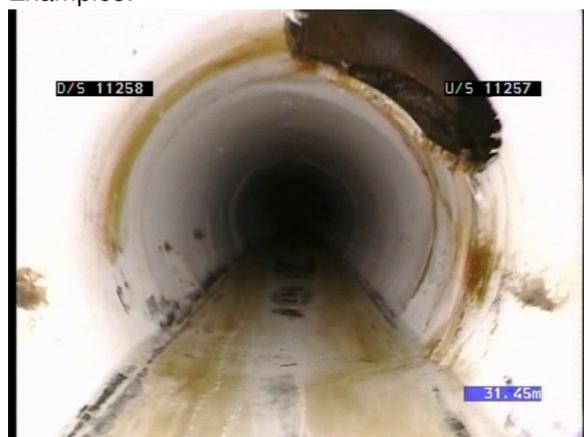
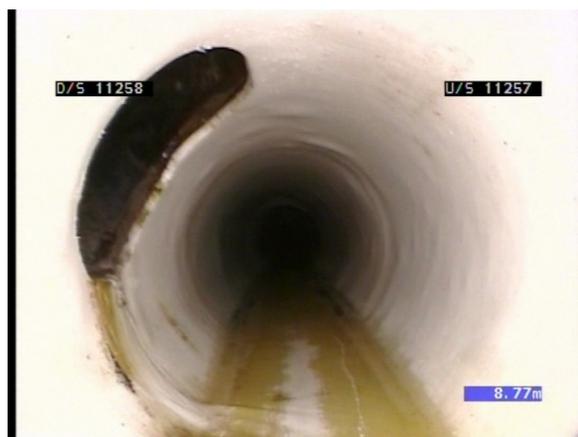
Photos above show examples of where the liner has been re-opened (cut out) to reinstate a lateral connection, but an LJR/LCR has not been installed. There is evidence of leakage (LF, Large)

The “LF” code is used to record defects at lateral connection associated with the ‘sealing’ between the installed liner and the host pipe/lateral. This code is generally used where a lateral has been re-opened, or cut out, but a LJR or LCR has not been installed.

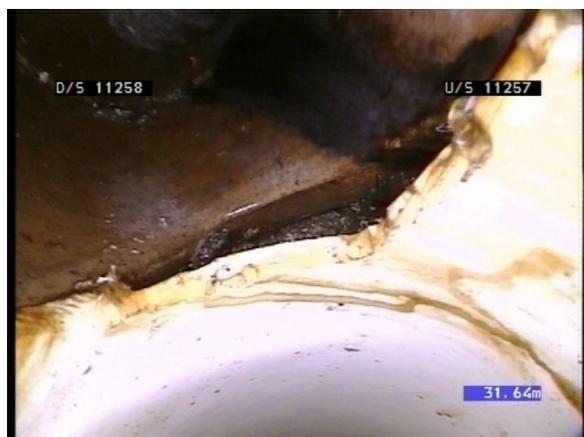
Panned view, left, of the cut out liner at a lateral connection with no LJR/LCR – showing gap between the liner and the host pipe/lateral.

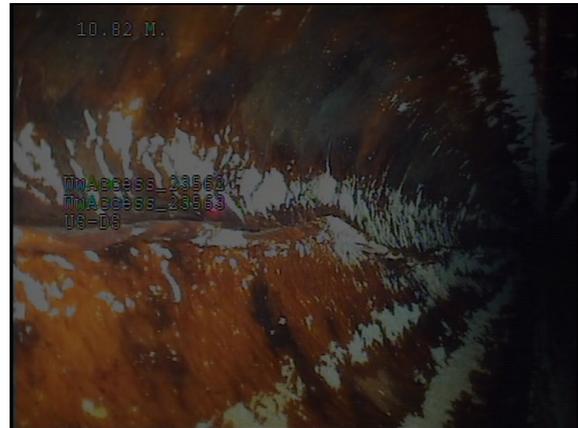
Small, longitudinal wrinkle on the side wall

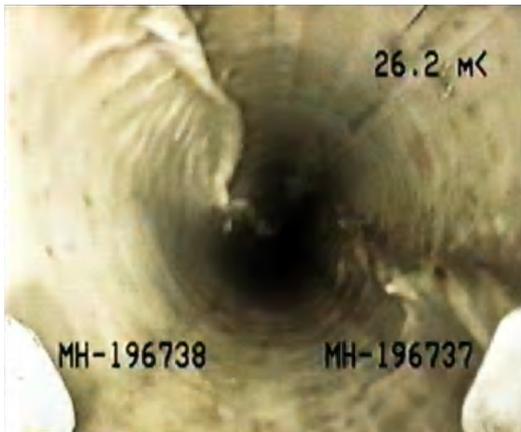
Large, longitudinal wrinkles

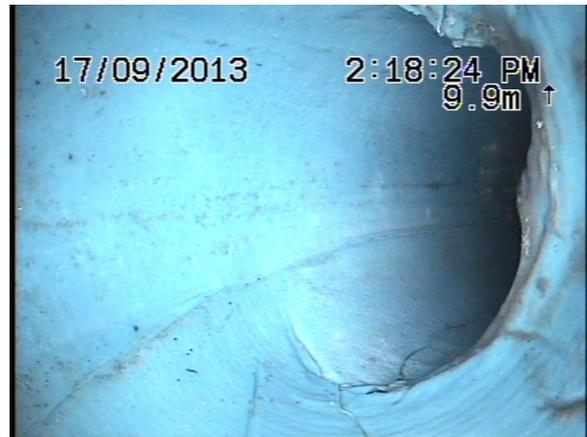
Large, Circumferential wrinkle on the inside of a bend.

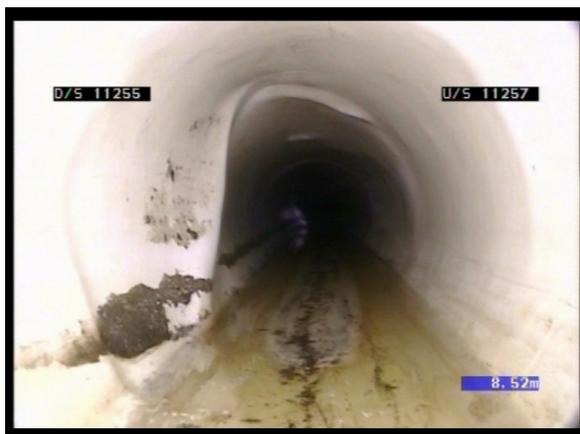
Medium, longitudinal wrinkle mid-line.

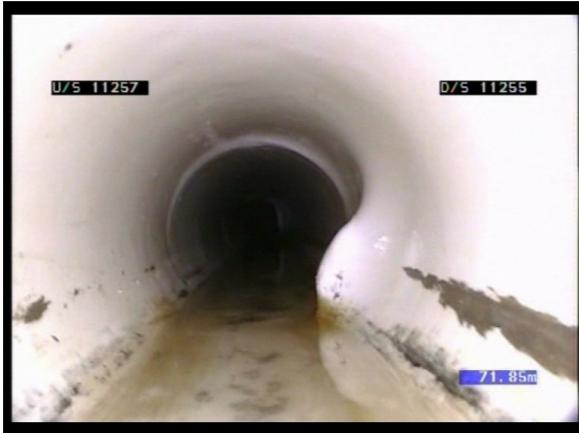
Large, bulge in the liner

- **Bulges:** These can result from lining over debris/object in the pipe, or protrusions in the host pipe. They can also be caused by poor quality control of pressure or temperature during the curing process, causing local 'sagging'.

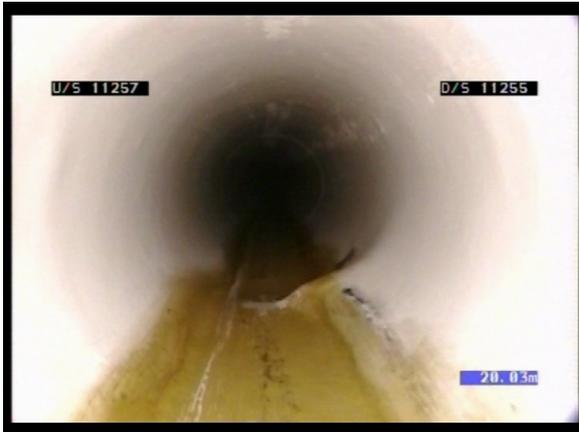
Medium, bulge in the liner.

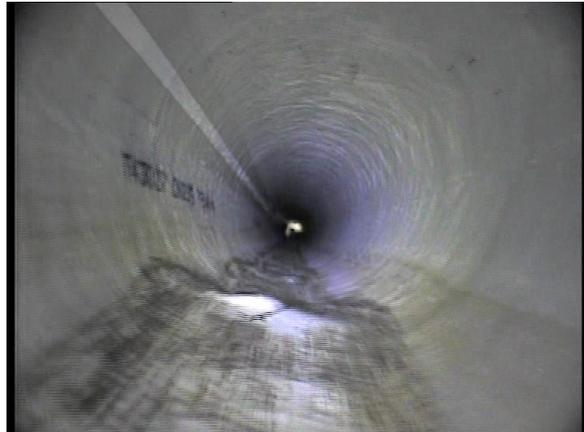
Small, bulge where the liner has gone over an object.

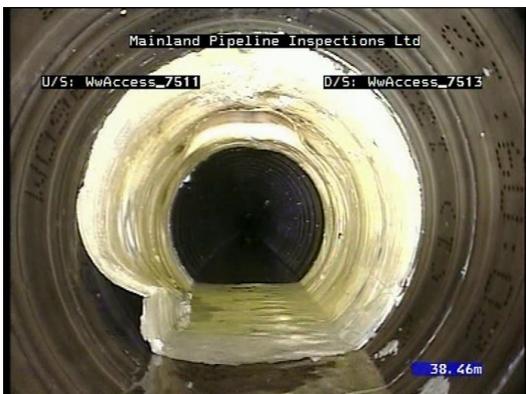
Medium PL, LJR/LCR lifted/separated from the spiral wound liner.

- **Separation from the host pipe wall:** This will typically occur on the outside of bends.
- **Lifting/separation of a patch liner/LJR from the pipe liner:** This is most commonly caused by post patch installation cleaning or maintenance using mechanical methods such as rodding. It can also be caused by poor quality control of the patch wet out and patch preparation or poor quality control of pressure during installation.

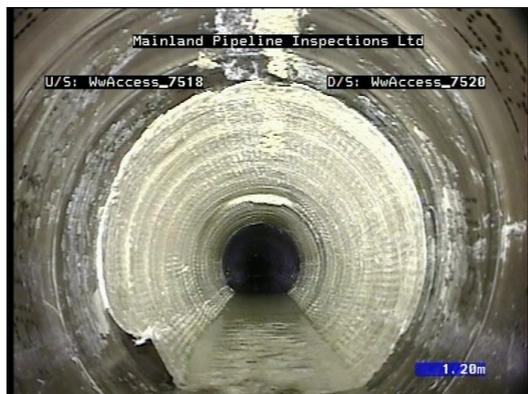
Small PL, CIPP patch lifted/separated from the spiral wound liner.

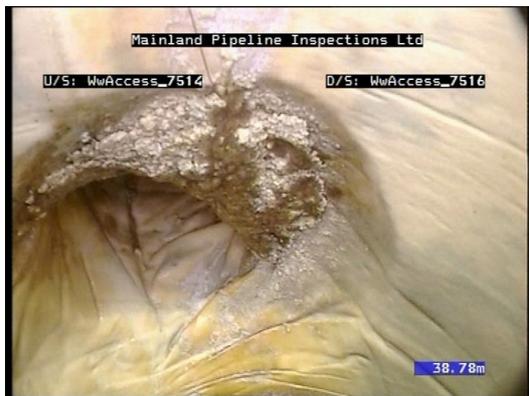
Large, PL – appears that an incorrect size LJR/LCR used, with excess resin.

- **'Bunching' or restriction at lateral connections:** This is where the lateral connection opening is restricted by the installed LJR/LCR. This can be caused by:

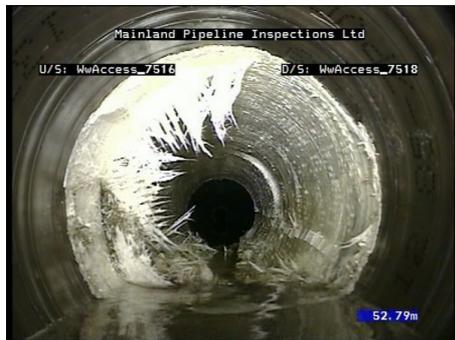
mechanical damage to patch possibly due to water blasting of the pipe

- **Abrasion:** Damage to the liners as result of water blasting or drain cleaning rods etc.
- **Popped Locks:** This can occur in spiral wound liners. It is seen as a joint in the liner sitting above the liner.
