GEOTECHNICAL REPORT FOR PROPOSED PLAN CHANGE
340 Cranford St and 60 Croziers Rd, St Aibans, Christchurch
For GM & M Case and RJ & LT Crozier

30 June 2015

**GEOTECHNICAL REPORT FOR PROPOSED PLAN CHANGE
 340 Cranford St and 60 Croziers Rd, St Albans, Christchurch**

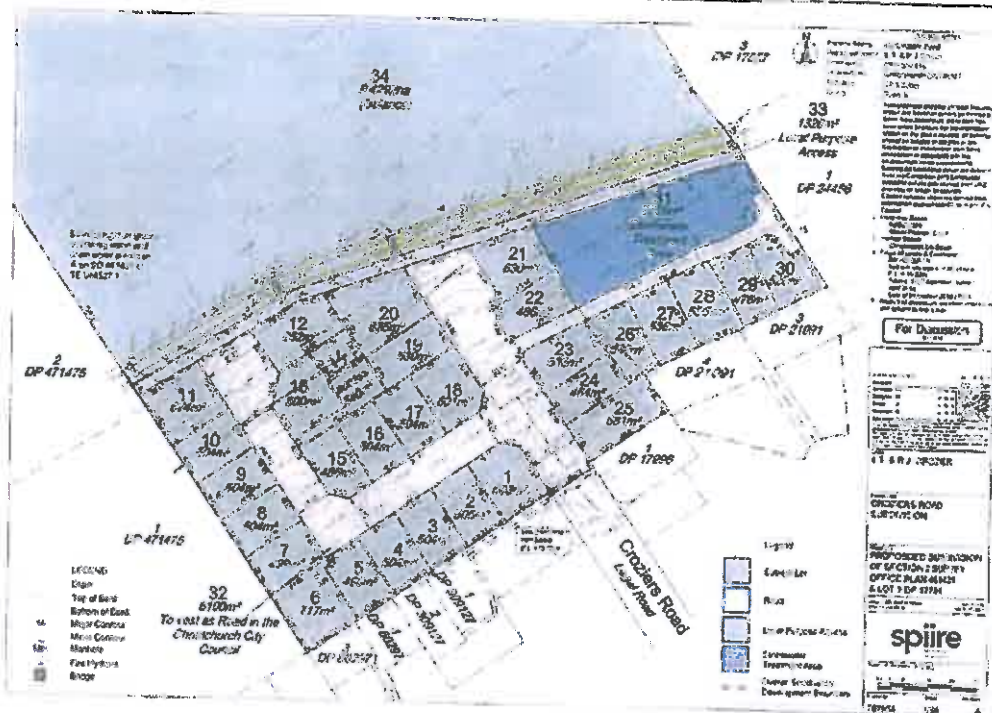
Figure 2: Possible subdivision layout for 60 Croziers Road, Christchurch.

A Possible subdivision layout for 60 Croziers Road is shown in Figure 2.

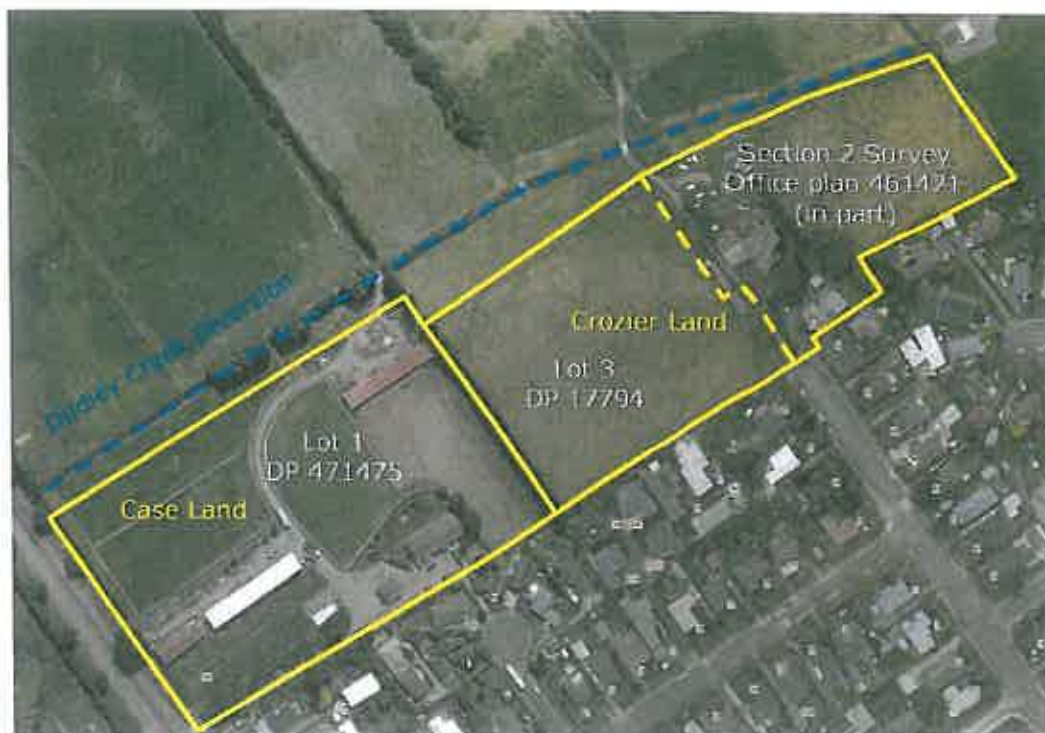
Figure 3: Site boundaries (yellow outline). Photo from 24 February 2011 (source: CGD, June 2015.)

Refer to Figure 3.

The proposed lot boundaries in the Crozier land extend to the upper Dudley Creek Diversion amenity strip. Refer to Figure 3.

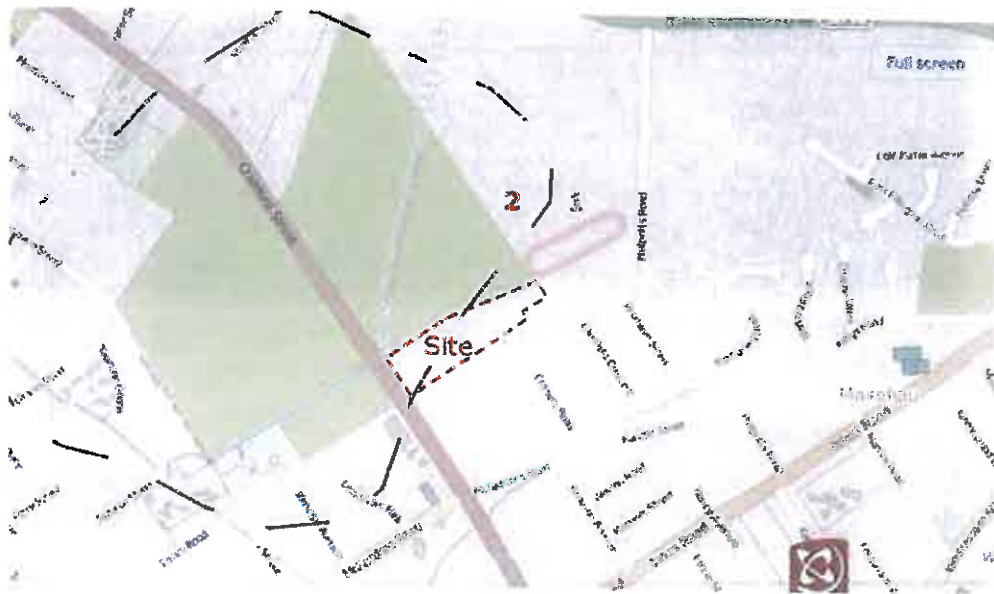
Figure 4: Geological map of Christchurch²

1	Modern river floodplain/low-level degradation tce. Unweathered, variably sorted gravel/sand/silt/clay. Surfaces <2 degree slope
2	Peat, silt and sand; in swales between dunes and abandoned river channels

The geological map of Christchurch indicates the majority of the site is underlain by 'modern river floodplain/low-level degradation tce. Unweathered, variably sorted gravel/sand/silt/clay' with an area to the southwest underlain by 'peat, silt and sand; in swales between dunes and abandoned river channels'. Refer to Figure 4.
