AKAROA WHARF RENEWAL: PRELIMINARY REBUILD OPTIONS

PREPARED FOR CHRISTCHURCH CITY COUNCIL

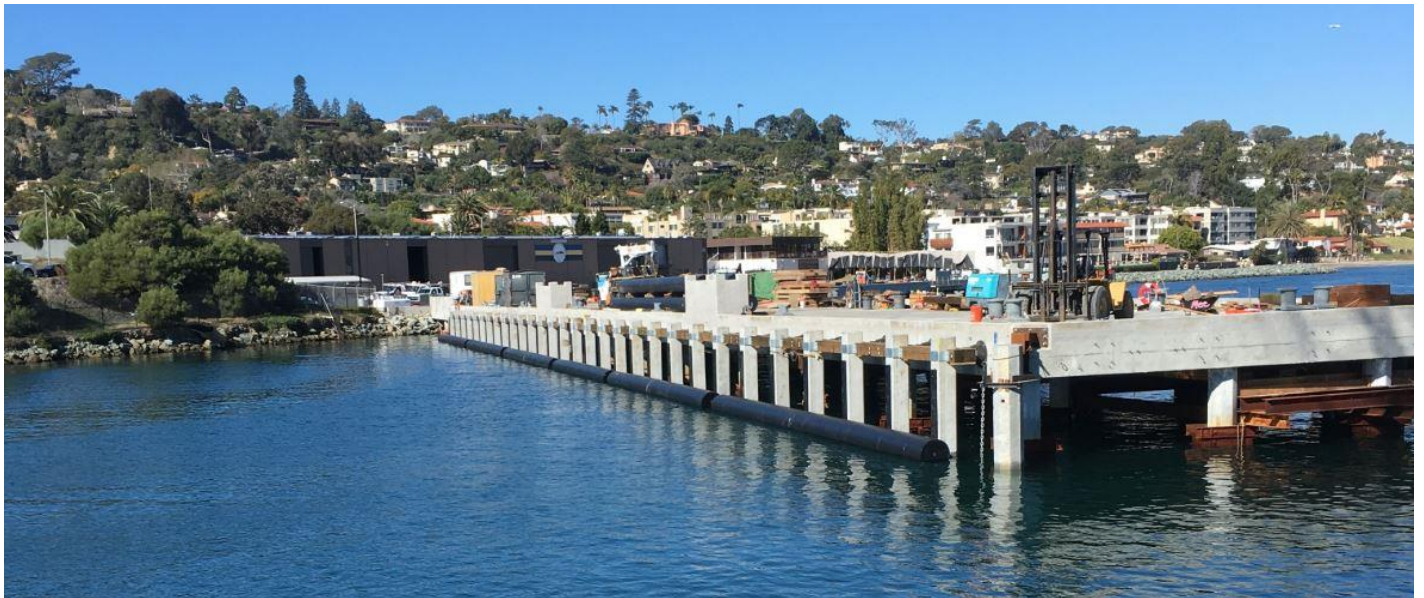
Figure 4.4 UCSD Nimitz Wharf. Example of reinforced concrete wharf

A new modern reinforced concrete structure, built with a higher deck than the current wharf. A modern structure can easily be designed to accommodate berthing loads from larger fishing vessels that are known to berth at the wharf, taking shelter during storms.

Using modern materials for the piles would mitigate the risk of damage from marine borers. Fewer piles would need to be driven and standard pre-cast bridge beams could be used to form the deck.
