# Groundwater Quality and Quantity Annual Report 2021

Prepared to meet the Requirements of CRC214226

**Christchurch City Council**

June 2022

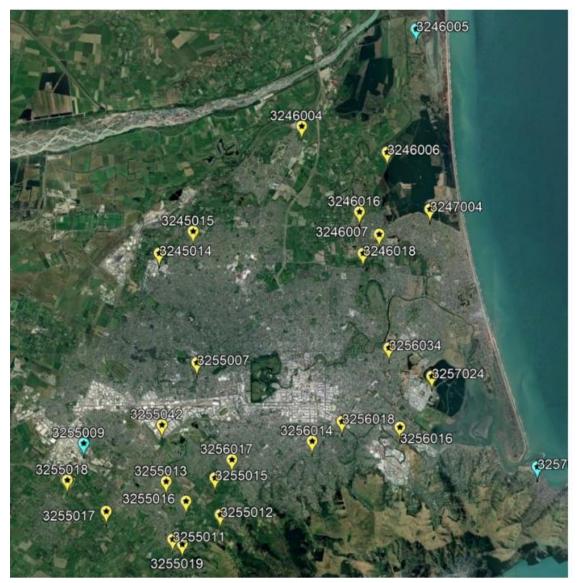
Figure 1. Location of CCC groundwater level sites during 2021. Telemetered sites are labelled with blue pins and manual sites with yellow pins.

Figure 1. Location of CCC groundwater level sites during 2021. Telemetered sites are labelled with blue pins and manual sites with yellow pins.

The CCC groundwater network consists of 35 sites (24 permanent sites and 11 project sites). At the end of 2021, the Council groundwater network consists of 35 permanent sites. Three of the sites, Kruses Drain (66649), Richmond Hill Waterway (66676) and Creamery Stream (67809) were decommissioned in late January as requested by the Council's Stormwater and Waterways Operations Team. The Prestons Subdivision water-level and flow site (66446) showed no discharge record for the entire period, the sensor is functioning normally however sedimentation of the sensor continues to be an issue at this site. No significant change in water level was recorded for the 2021 calendar year (NIWA, 2021). The minimum, mean and maximum stage levels for January to December 2021 are presented in Appendix A.
