**CHRISTCHURCH CITY COUNCIL**  
PRK\_1133\_BLDG\_001 EQ2  
Bradford Park Pavilion  
196 Milton Street, Sydenham

QUANTITATIVE ASSESSMENT REPORT

FINAL

- Rev B
- 13 December 2012

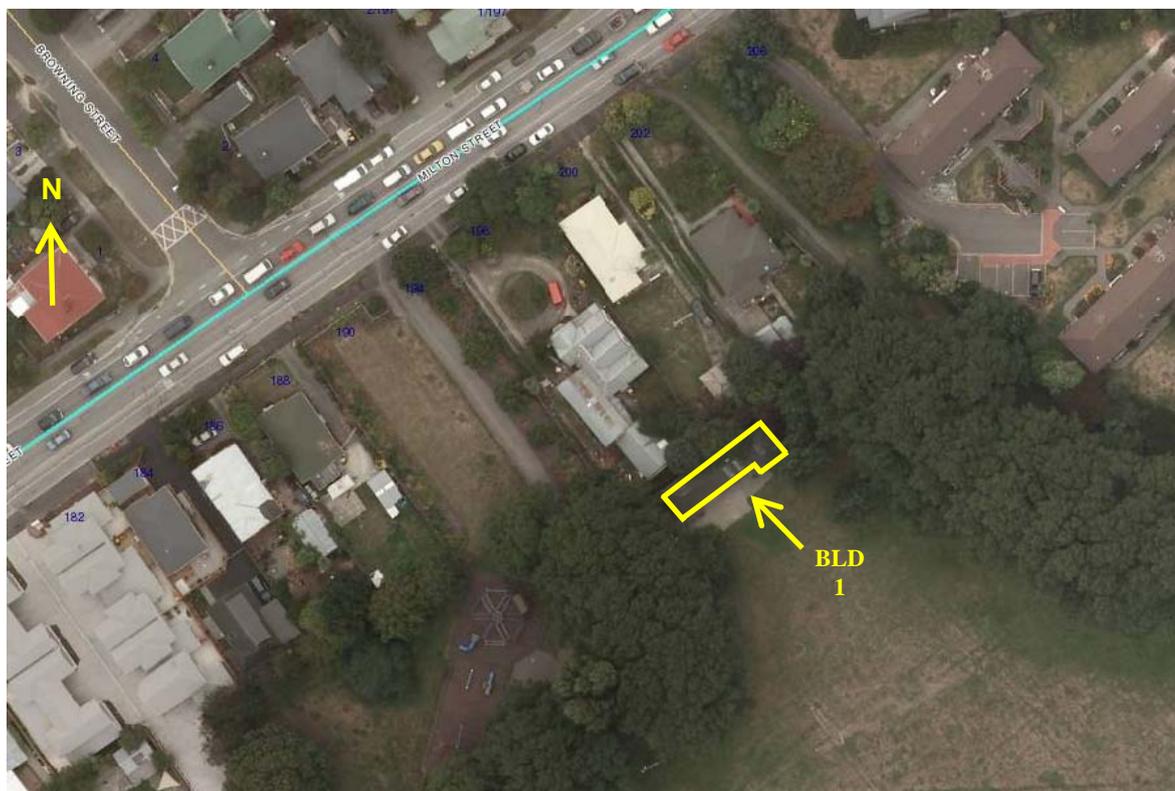
### ■ Figure 1: Aerial Photograph of the Bradford Park pavilion at 196 Milton Street

A quantitative assessment was carried out on building PRK\_1133\_BLDG\_001 EQ2 located in Bradford Park at 196 Milton Street, Sydenham. This building is a single storey pavilion that is currently utilised as changing rooms. It was built in two sections. The original structure appears to be constructed from partially reinforced masonry walls while the more recent extension has reinforced masonry walls. Both sections have a timber-framed roof. An aerial photograph illustrating the building's location is shown below in Figure 1. Detailed descriptions outlining the buildings age and construction type are given in Section 5 of this report.
