Bottle Lake Forest - Flammable Shed Qualitative Engineering Evaluation Reference: 228588 Prepared for: Christchurch City Council Revision: 2 Date: 10 October 2013

PRK_0158_BLDG_016

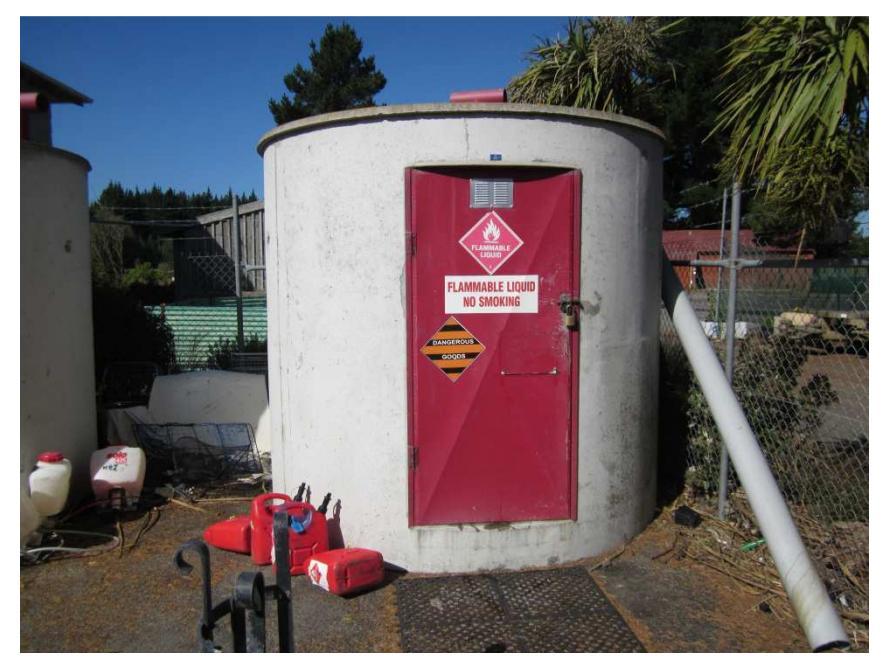
The Bottle Lake Forest - Flammable Shed is a small modified precast concrete water tank with a door opening built circa 1990. The roof consists of a concrete lid with a gentle slope.

Front Elevation of the Flammable Shed

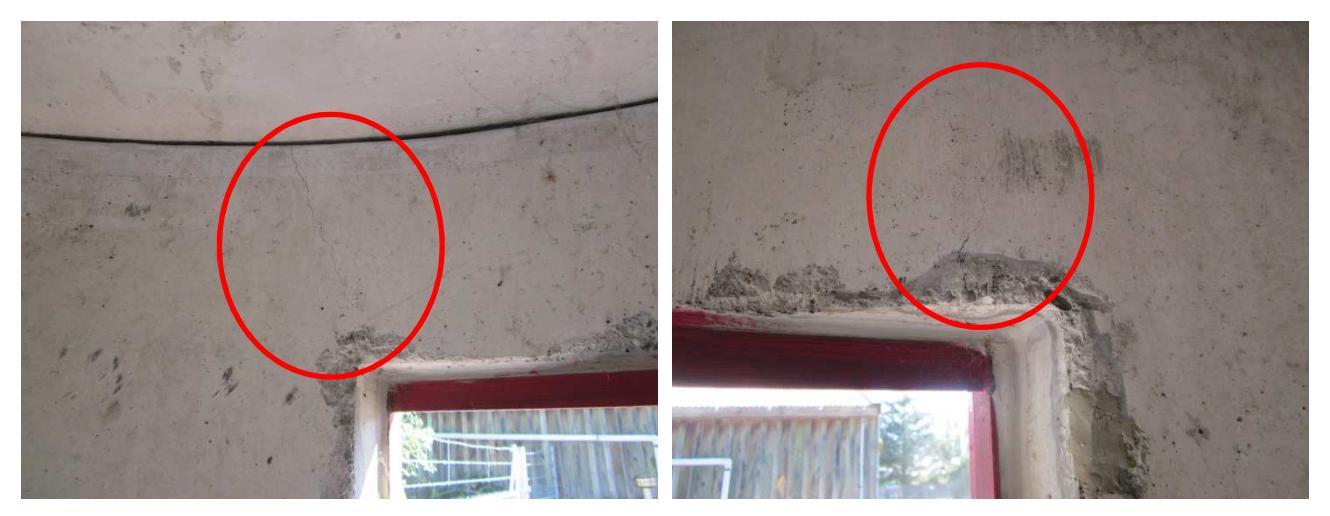
Small diagonal cracks were observed around the door opening. These cracks are a result of stresses concentrations around the door opening. They appear to be fresh and may be a result of seismic actions.

The smooth edges around the door opening suggests that the door opening was not cut post construction and therefore it is assumed that trimming bars are present to control these cracks.

Fresh cracks found around the door opening

Visual inspection and conversations with the park rangers have indicated that there is little noticeable damage to the building from to the recent seismic events. Analysis has confirmed that the shed has sufficient stability to resist overturning from code level seismic events accordingly it is considered acceptable to continue to use the structure without further assessment or strengthening.
