Heathcote update

Work to improve Heathcote's stormwater network

Heathcote update October 2015

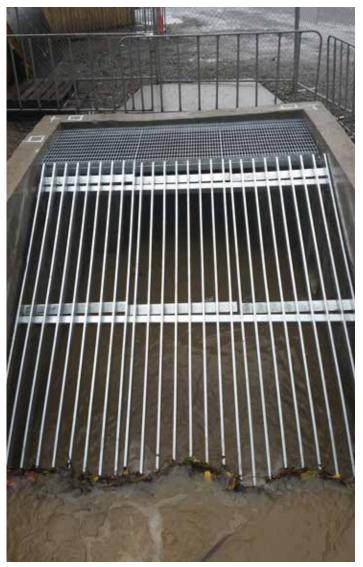
Work to improve the inlet to the Bridle Path Stream culvert beneath Port Hills Road by the domain is now complete. The existing structure was prone to debris blockage when the stream was in flood. The work involved constructing a larger, purpose-built inlet structure with a new and larger screen that enables flood debris to be more easily and safely removed when in flood.

Bridle Path Stream intake under Port Hills Road

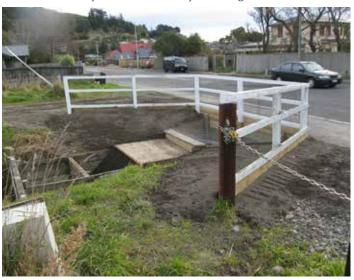
Work to upgrade the culvert is now complete and provides a muchimproved linkage between Bridle Path Stream and Truscotts Road Drain. Work included the installation of a large concrete box culvert, a construction project made more complicated as a section needed to be laid beneath the Lyttelton Port Railway overbridge.

Completed Martindales Road culvert

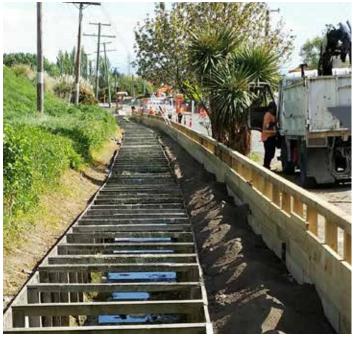
Work is now underway to install new culverts beneath Truscotts Road to enable water-flow in the Truscotts Road Drain to more easily reach the Matuku Waterway and ponds. The timbering of the drain sides will increase the capacity of the drain and help prevent water spilling across Truscotts Road and into adjoining properties.

Work on culverts across Truscotts Road

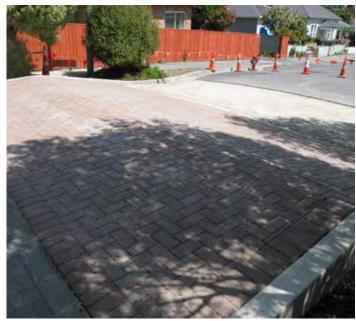
Work is also underway to construct a bund – which looks much like a speed hump – across Marsden Street close to the Bridle Path Road intersection. While work on the bund is finished, the footpath area is still being worked on. This is an engineering challenge as the design must prevent/limit overland water-flow along Bridle Path Road running down Marsden Street and flooding residential properties.

Marsden Street bund
