Rydges Latimer Christchurch

Introduction to the Project

This construction waste reduction case study demonstrates that with careful planning and management of contractors at least 71.9% of construction waste can be recovered for reuse and recycling.

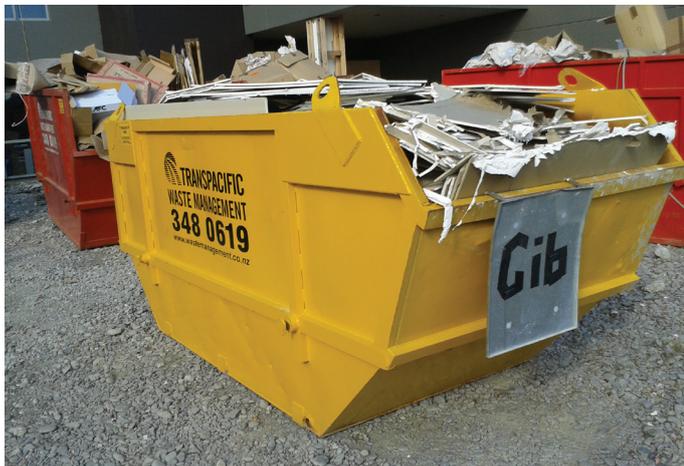
Plasterboard recycling skip © Copyright

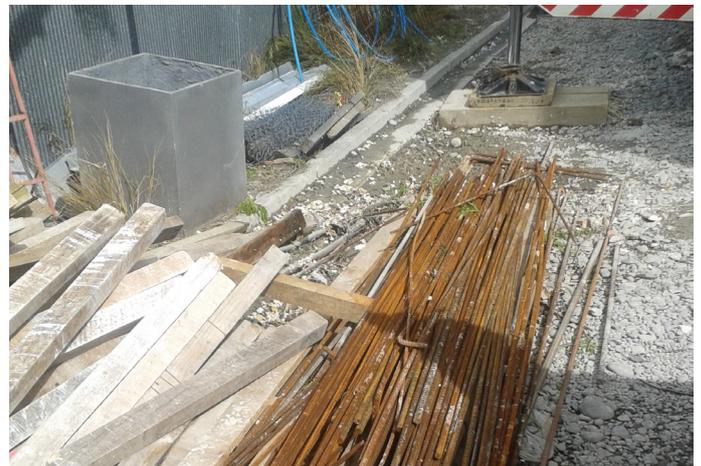
Reinforcing steel set aside to return to the yard for reuse © Copyright

0.9		This was off-cuts of reinforcing steel and excess reinforcing steel which on many sites would end up in the metal recycling skip but in this case was sent back to the Lanyon and Le Compte Construction yard to be reused.
Cardboard	21.7		This was packaging waste, mostly from the fit-out of the hotel and was sent for recycling.
Plastic wrap	0.5		This was packaging waste, mostly from the fit-out of the hotel and was sent for recycling.
Polystyrene	9.9		This was packaging waste from the fit-out of the hotel and was sent for recycling.
General		71.3	This was general non-recyclable waste such as treated timber and contaminated materials. This was sent to landfill.
TOTAL TONNES	182.6	71.3	
Percentage	71.9%	28.1%

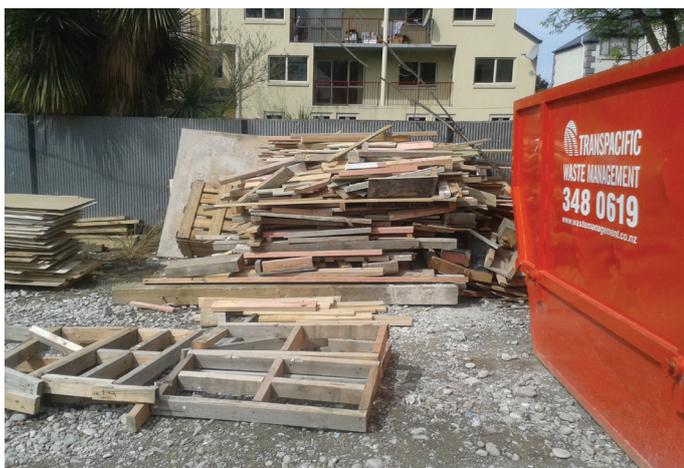
Reusable lengths of timber set aside to be reused © Copyright

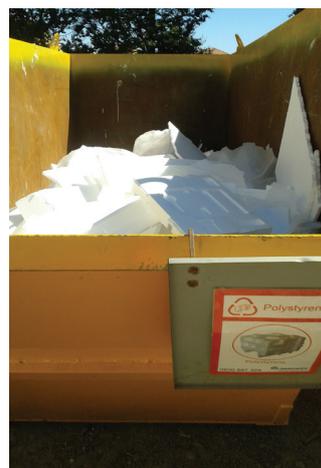
Polystyrene recycling skip © Copyright

- Worked with Waste Management to implement a solution to recycle significant quantities of polystyrene.
- Located a co-mingled recycling receptacle outside the staff lunch room for staff and contractors to use.

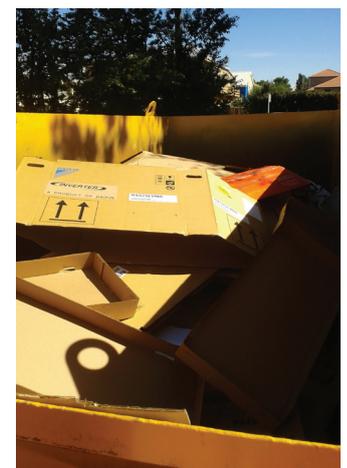
Cardboard recycling skip © Copyright

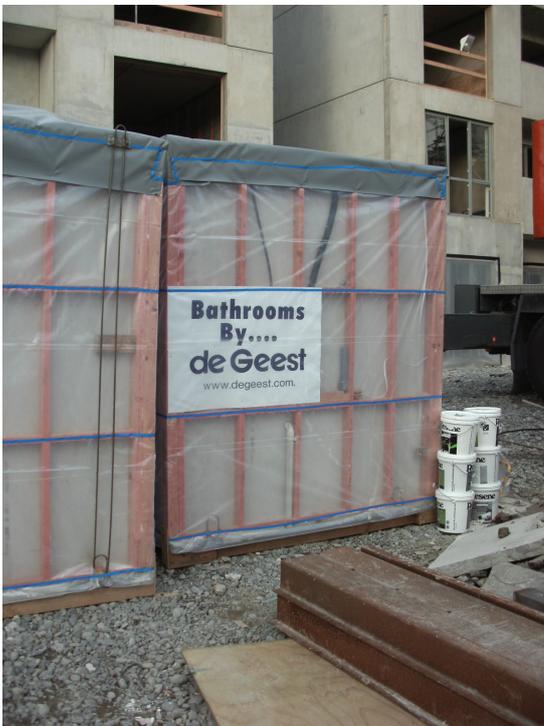
Pre-fabricated bathrooms ready for installation
© Copyright

- Manufactured bathroom units off-site as pre-fabricated modules enabling significant waste to be eliminated from the site and significantly shortening the construction time schedule.

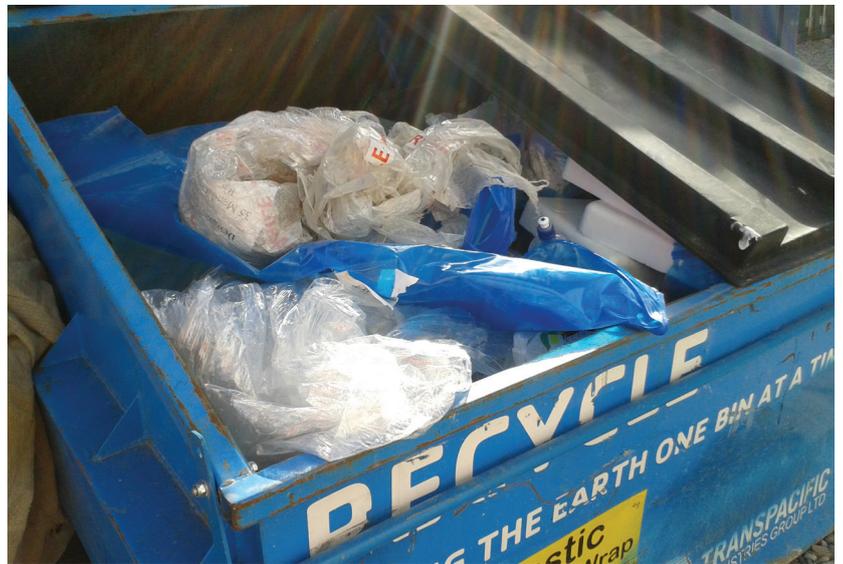
Soft plastic recycling skip © Copyright
