PRIORITY AREAS FOR WORK

- Tree, buildings and pathway positions have been taken from an aerial photo. Exact position will need to be verified on site.
- Refer to Sheet 4 for details of the central park.

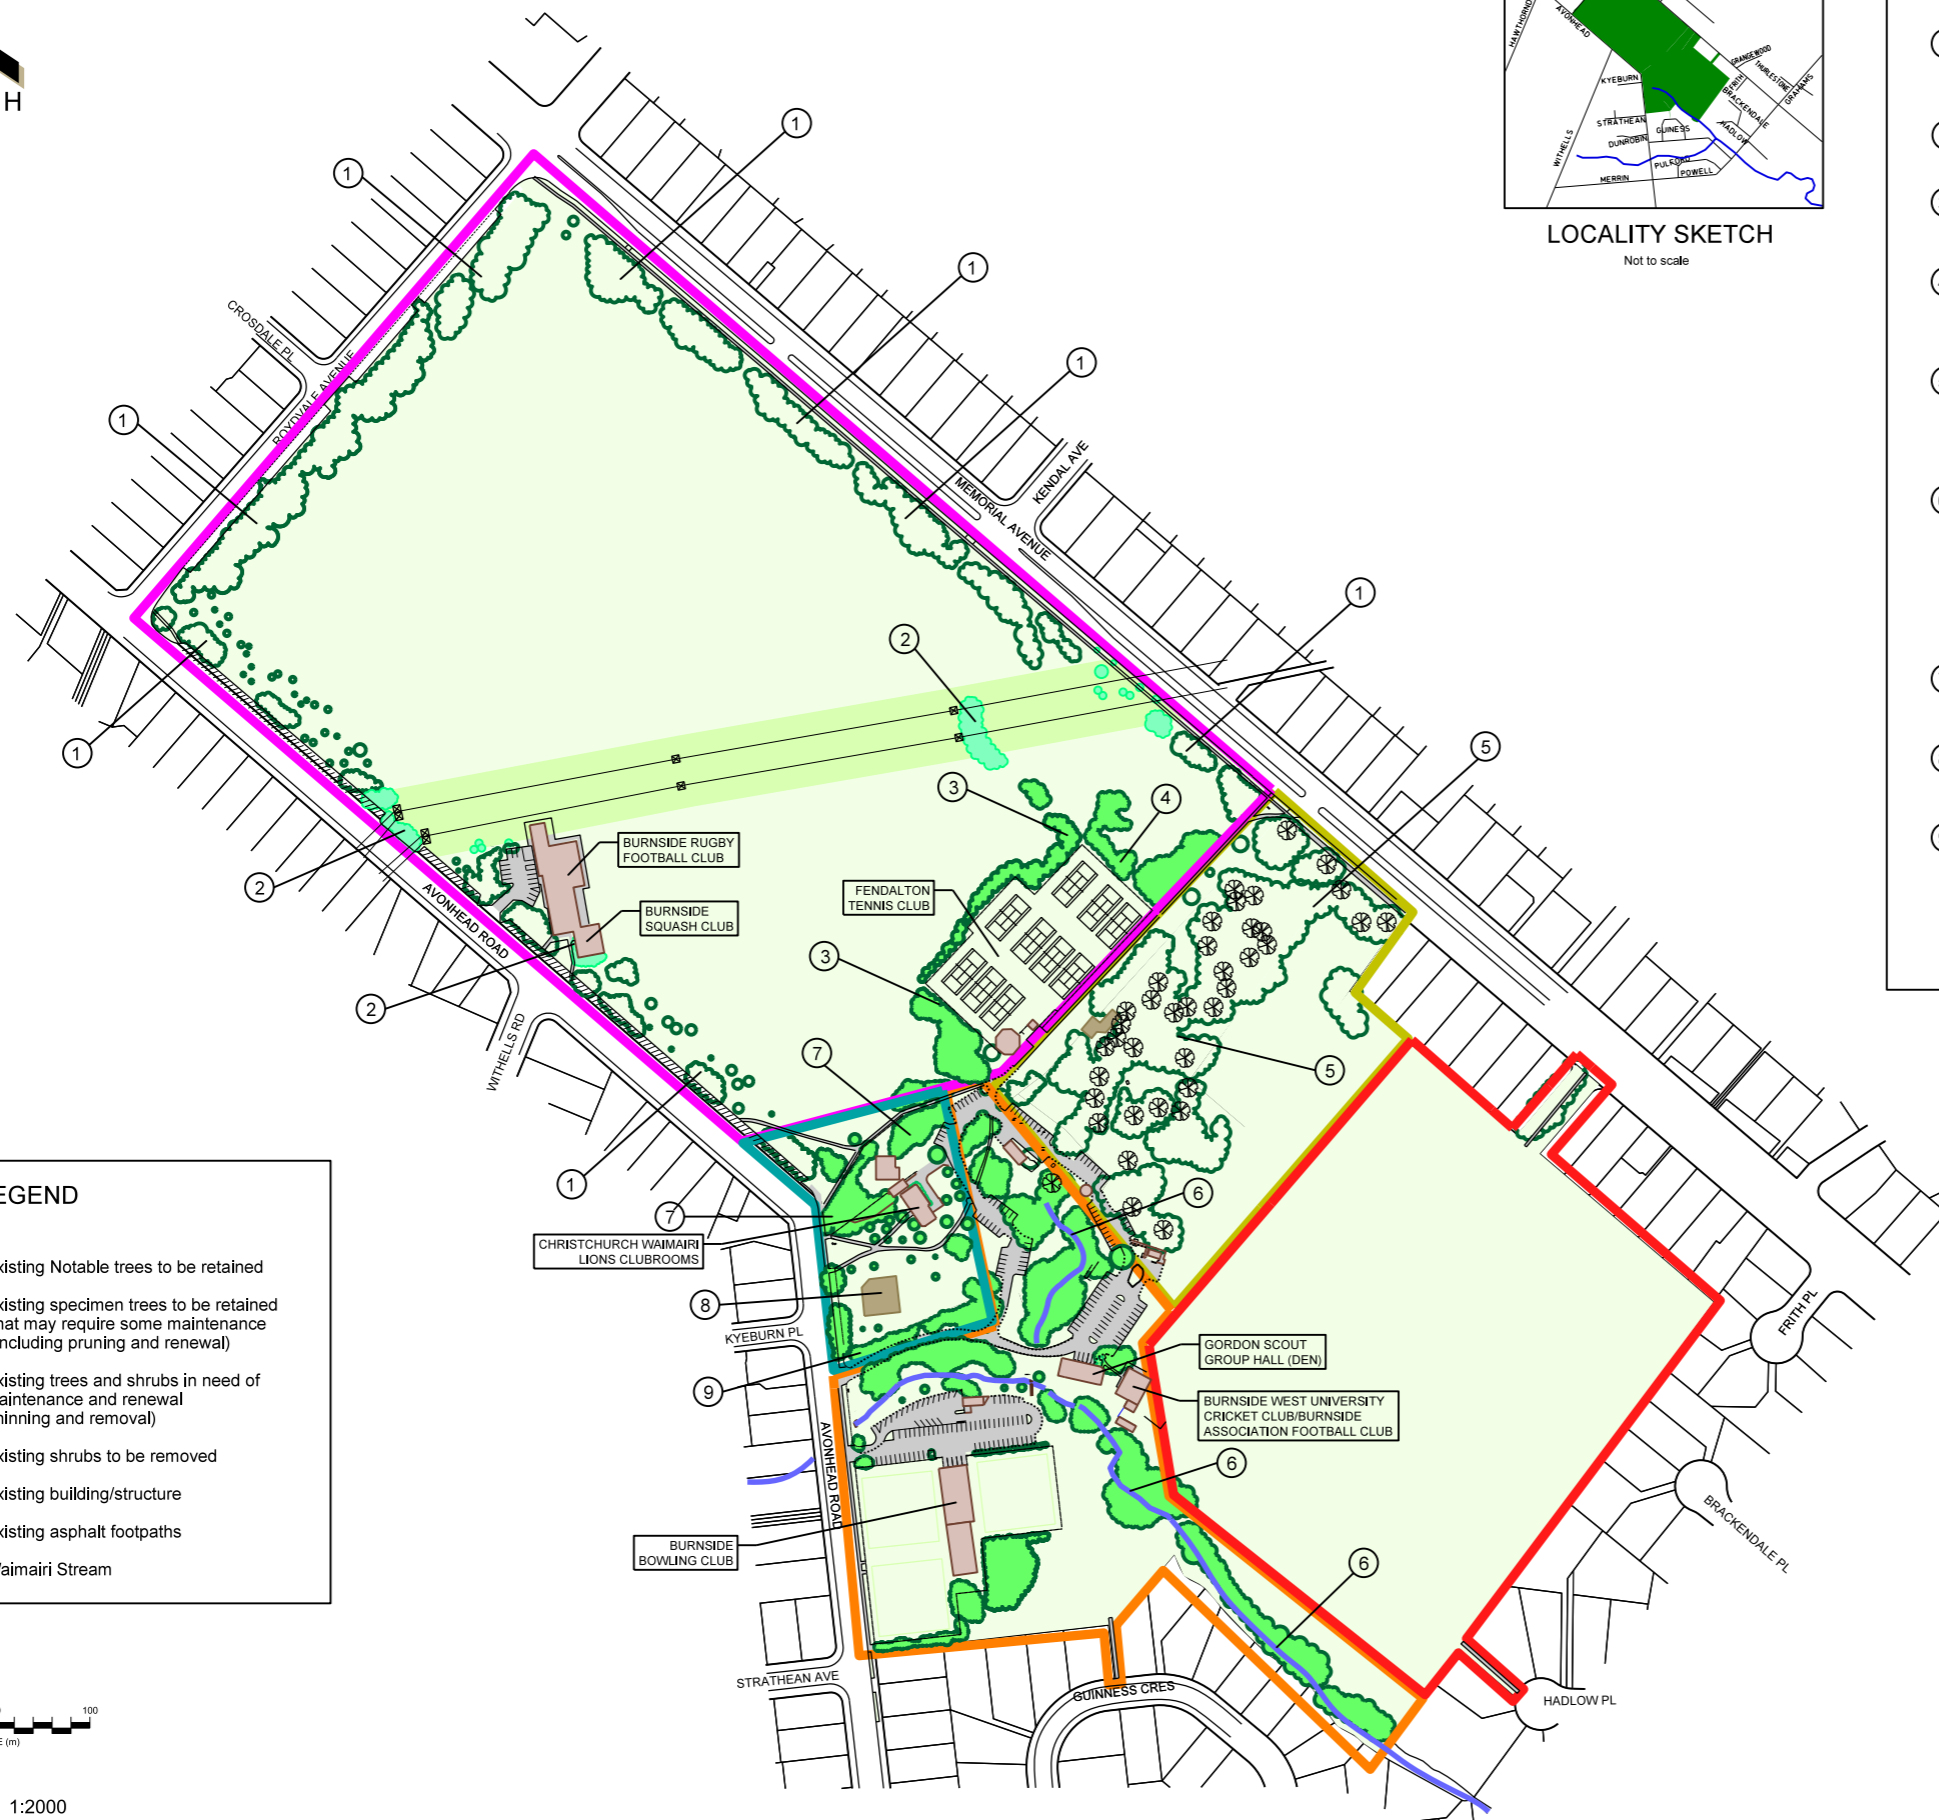
- ① Prune trees to approximately 1m up above ground level to retain views in and out of the park (this may also include the removal of species not doing well). Thin large groups of trees as required.

- ② Remove the entire shrub bed and reinstate grass.
- ③ Trees around the perimeter of the Tennis Club are to be retained. If any removal is required at any stage consult with the Tennis Club.

- ④ Trees in front of the tennis courts require thinning and pruning to approximately 1m up above ground level to retain views in and out of the park. Consult with the Tennis Club on all work in this area.

- ⑤ The existing wooded area contains a mix of trees which includes 38 notable trees. Species include Ash, Cedar, Cypress, Douglas Fir, Elm, European Beech, Lime, Oak, Redwood, Sycamore and Yew. All the trees are to be retained and maintenance undertaken as required.

- ⑥ All trees and planting adjacent to and along Waimairi Stream will need maintenance, this is to include:
 - Thinning;
 - The removal of small shrubby trees;

- The removal of undergrowth and
 - The removal of any trees not doing well - large specimen trees are to be retained. This will improve sightlines through the central area of the park.

- ⑦ The area around the old council nursery house will need extensive maintenance (including removal).
- ⑧ All trees and planting around the existing playground area and Lions Club will need maintenance.

- ⑨ When the existing macrocarpa hedge is due for renewal, replace with a lower growing hedge, possibly alternating with pool fence sections to improve sightlines to / from playground while retaining some shelter.

PRIORITY 1 - Areas adjacent to Waimairi Stream
-

PRIORITY 2 - Area adjacent to carpark and childrens playground
-

PRIORITY 3 - Wooded area
-

PRIORITY 4 - Sports fields - West
-

PRIORITY 5 - Sports field - East
