Please find below an update on the road work underway in several Banks Peninsula bays, following the December rain storm event.

Background information

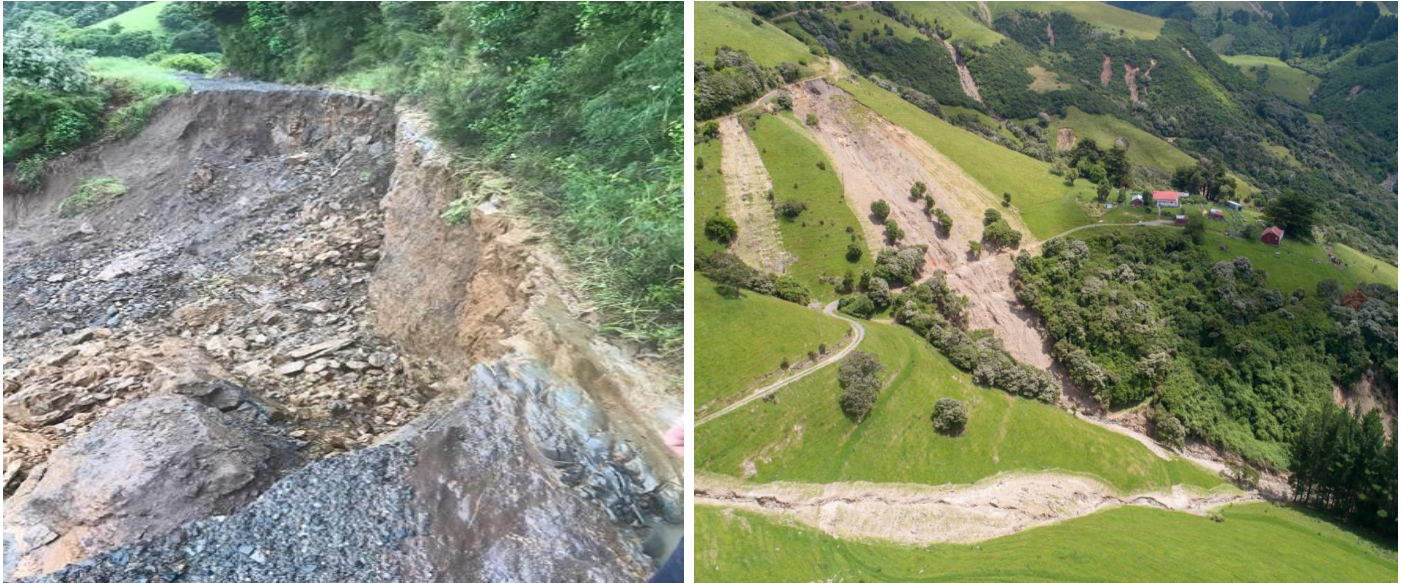
Above: Goughs Road, where approximately 30 metres of the road dropped away to 12 metres below its original position.

Various full length slips, dropouts on the bottom half of the road, with a full road dropout approx. half way down.

A path has been cleared through all slips to the main slip. Quad bike access has been created to all residents below the slip.

Work is underway on creating access for residents to get out of the bay. Slip clearing below the main slip to the bottom. Repairs to culverts and dropouts below the main slip. Design and construction of a solution for the main dropout.

We will have a clearer plan as to what we can do to fix the dropout over the next two weeks.

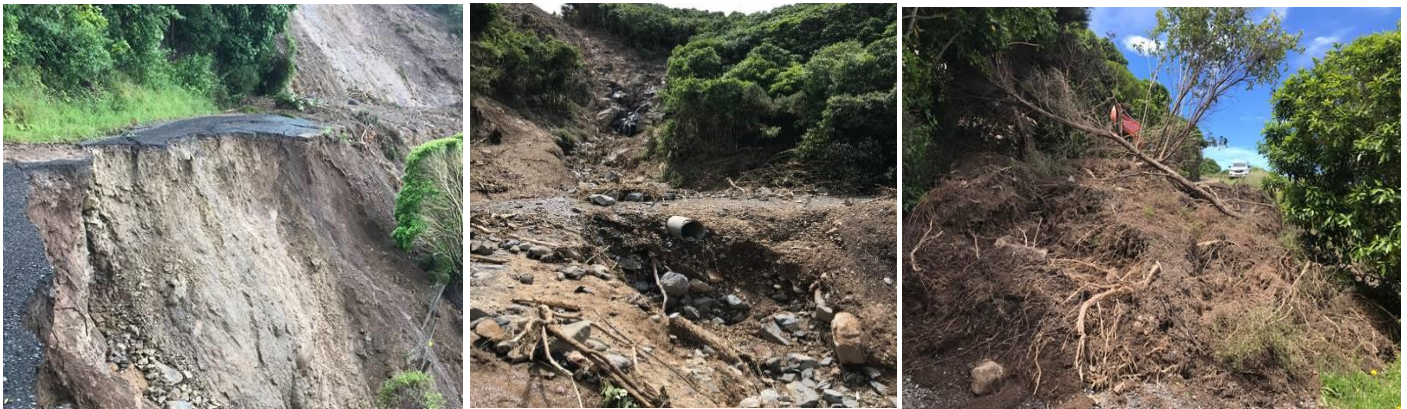
Above: Damage on Long Bay Road

Various small and large slips full length from Fishermans Bay Road, large dropout above Paua Bay Road and various slips.

A path has been cleared through all slips.

Clear remaining slip material, approx. 50 per cent of this is completed. Design and repair of main slip.

We will have a clearer plan as to what we can do to fix the main slip within the next few weeks.

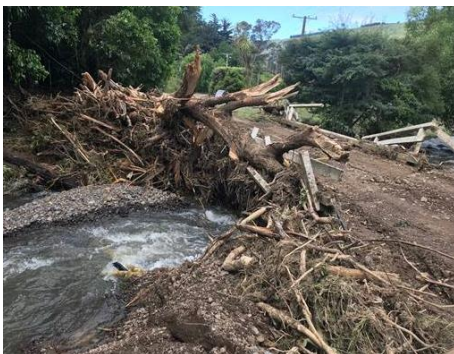
Le Bons Valley Road bridge

Various flooding debris, one large debris flow and one blocked culvert that caused damage to the seal.

Slips/ debris have all been removed (except one which we are waiting on Orion to install a pole next to it). A temporary pavement repair has been made to the sealed part of the road. Once all work is completed we will be making permanent repairs to this sealed section.

Prepare and seal damaged sealed area.

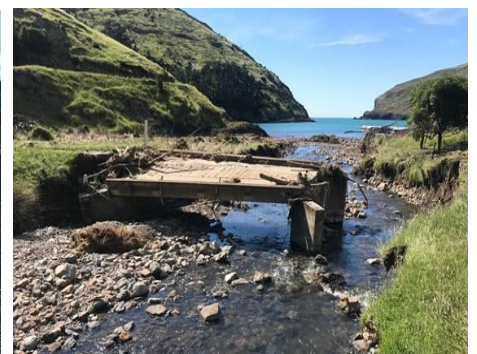
Flea Bay Road bridge

Various small slips. Bridge washed out at the end of the road.

Slips have been removed, a temporary ford plus twin 600mm culverts have been installed.

Design and replacement of the bridge.

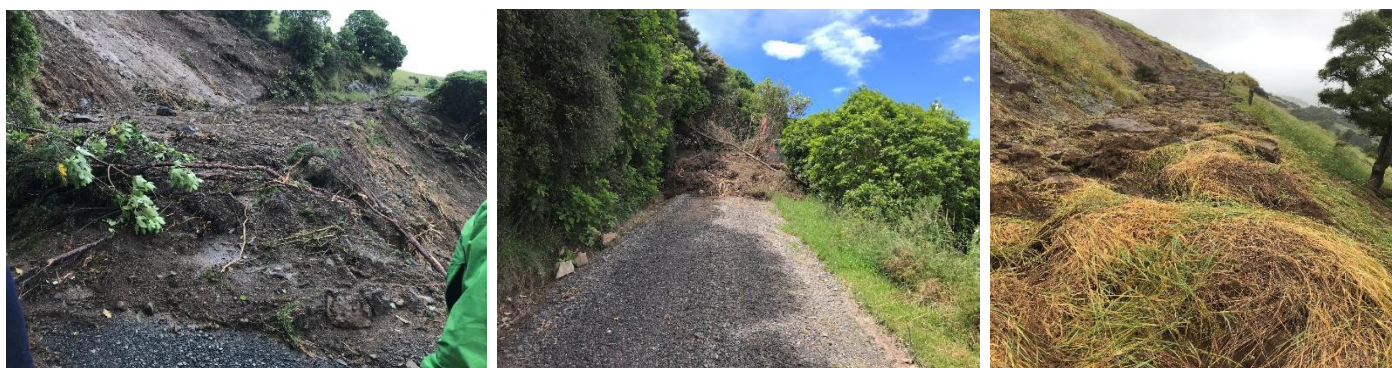
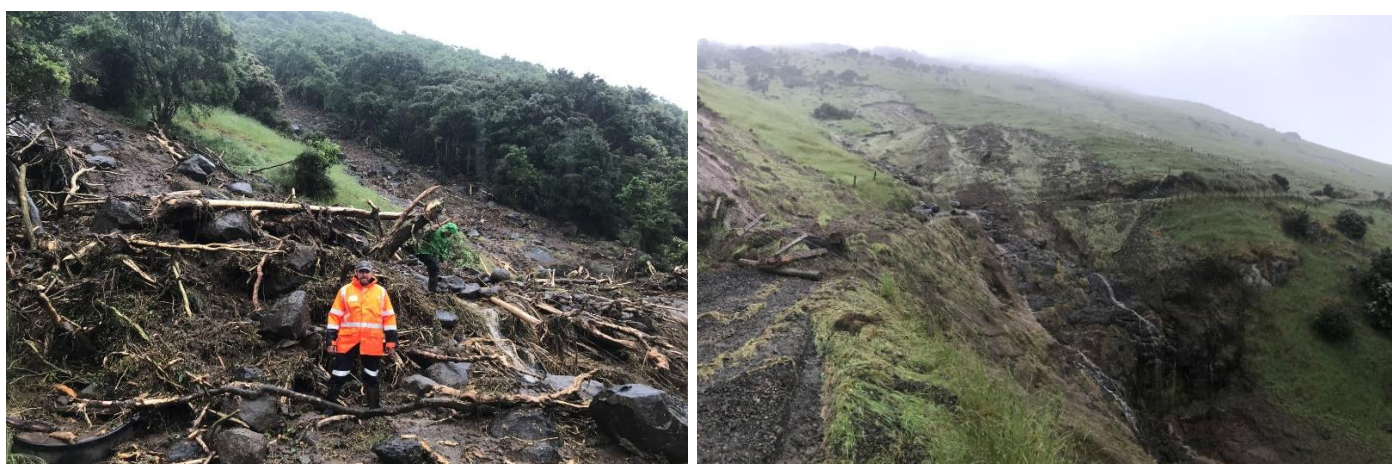
Above: Material has slipped down the hillsides and covered the road.

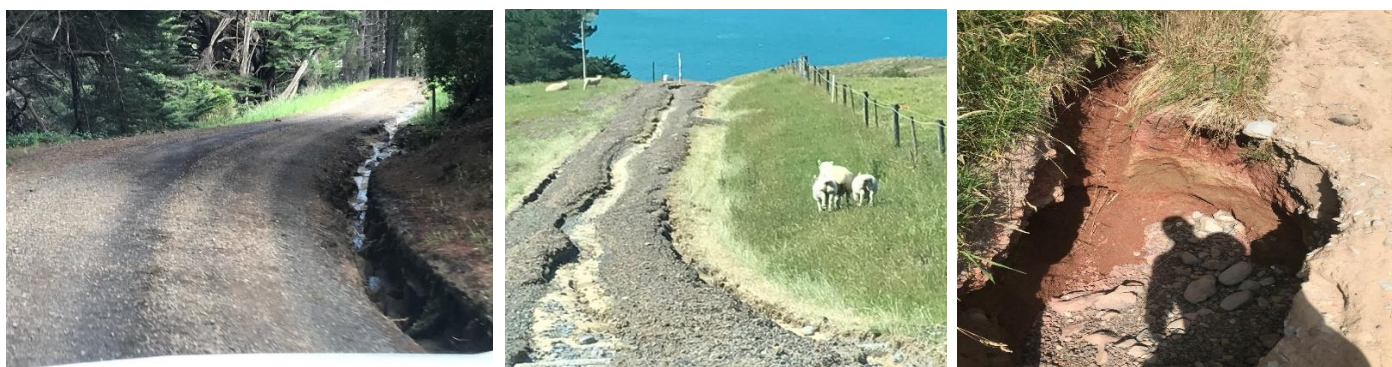
Above: Water has scoured out the road.

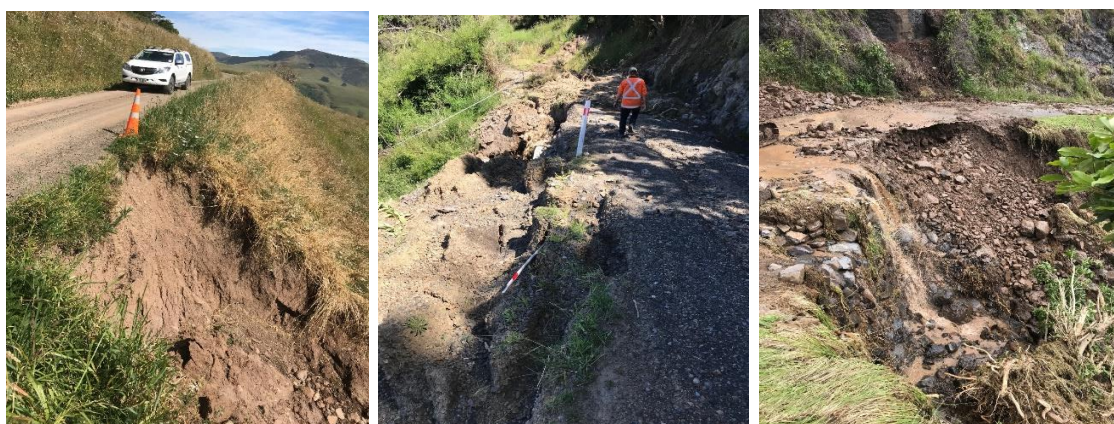
Above: The sides of the road have dropped away.

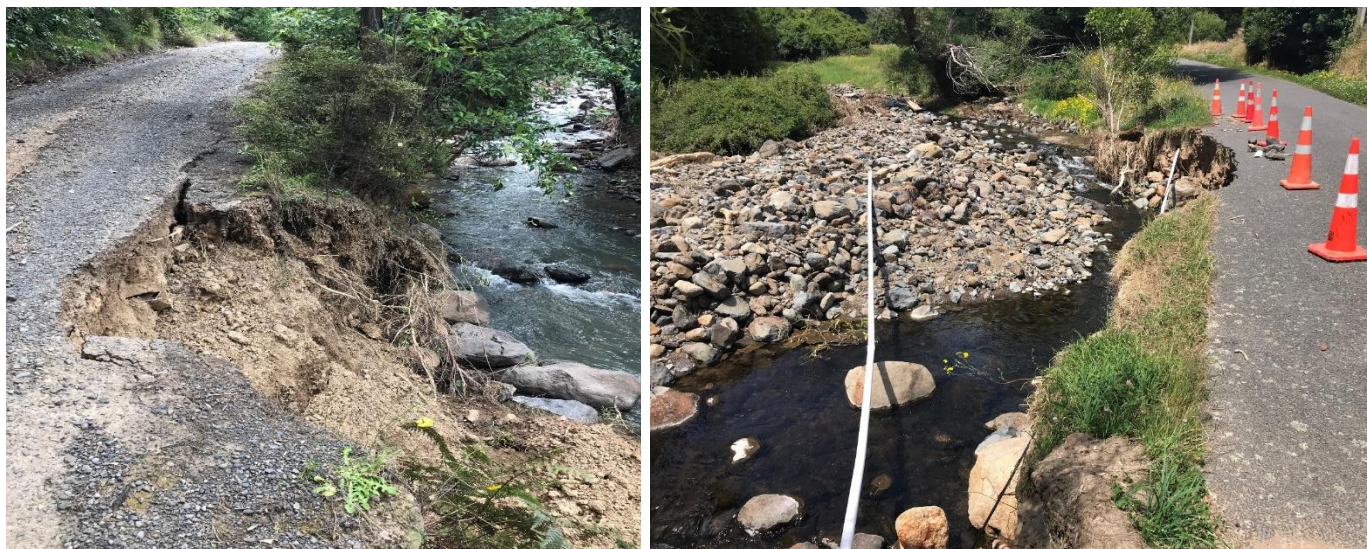
Above: The original path of water has changed and scoured out the road.
