Hagley Park North – Band Rotunda
Quantitative Engineering Evaluation

Reference: 228660
Prepared for:
Christchurch City Council

Functional Location ID: PRK_1190_BLDG_033
Address: 6 Riccarton Avenue

Revision: 2
Date: 11 October 2013

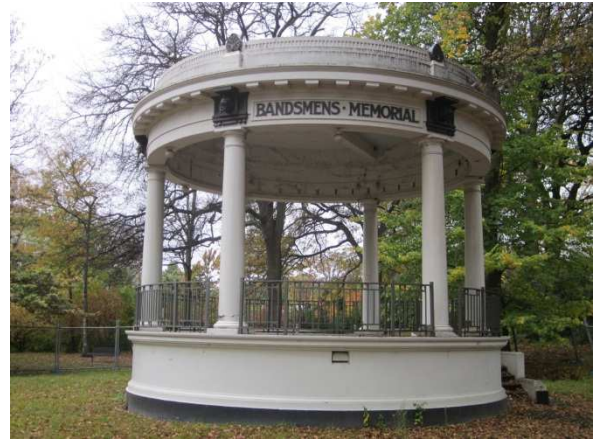
Image 2.

General view 1 of the roof.

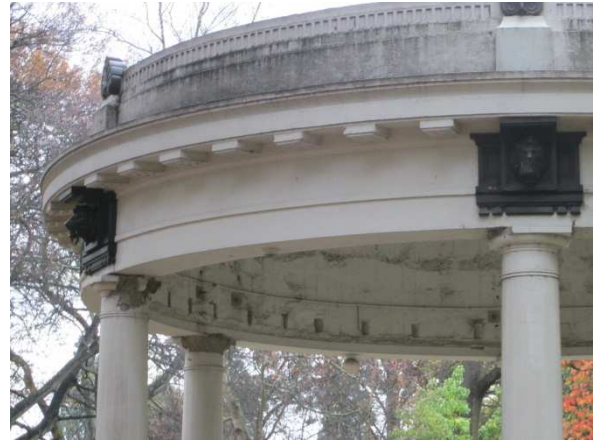
Image 3.

General view 2 of the roof.

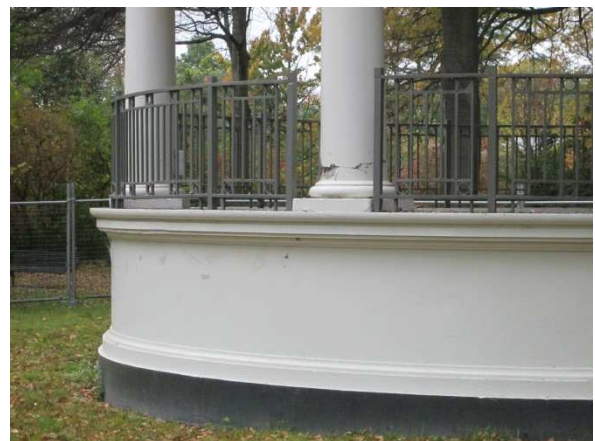
Image 5.

General view 2 of the base.

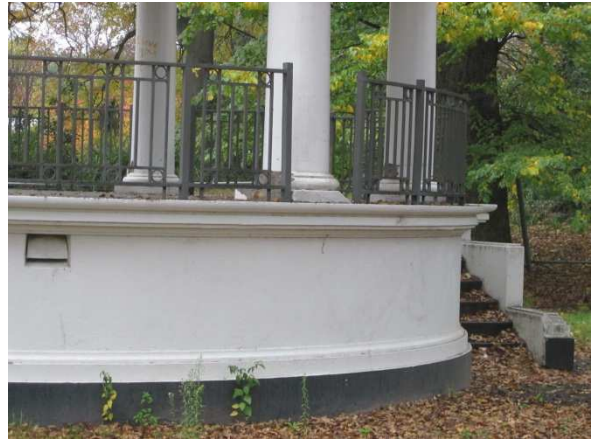
Image 6.

General view of the stair.

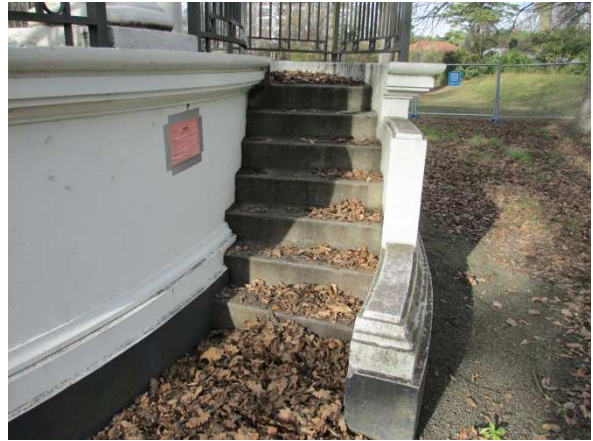
Image 7.

General view of the cellar entry.

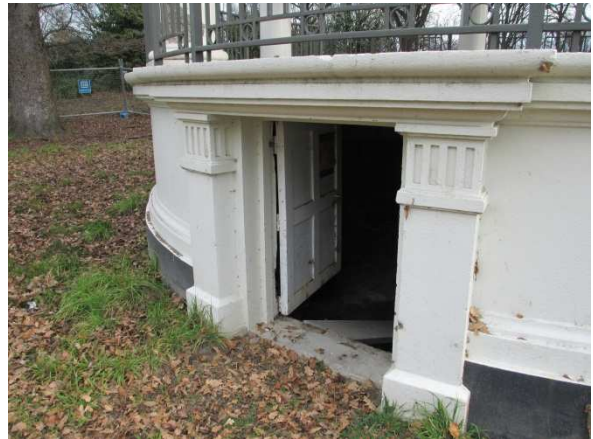
Image 8.

The column elements and their connections suffered serious damage, beyond structurally acceptable levels. There are visible signs that the columns have undergone lateral deformation, which indicates that the vertical reinforcement has yielded beyond structurally acceptable stress limits. The rest of the structure (roof and cellar) was relatively intact and within structurally acceptable levels with only minor repairs required, namely at the column connections.

Detail 1 of Column 1.

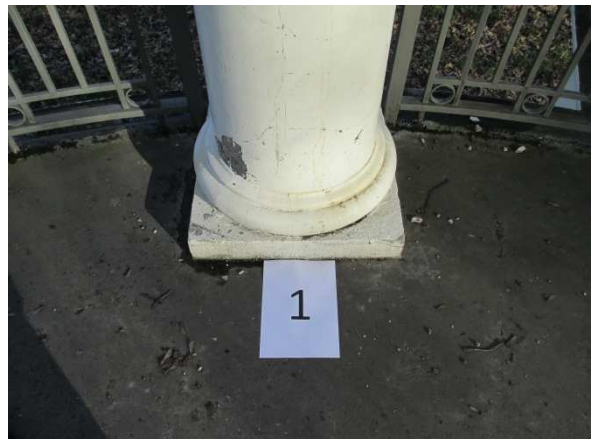
Image 9.
Detail 2 of Column 1.

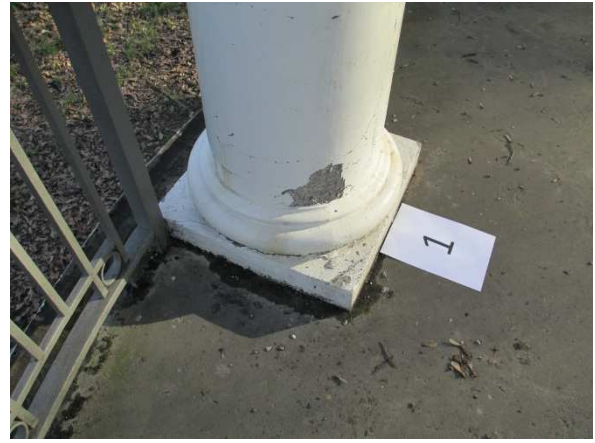
Image 10.
Detail 3 of Column 1.

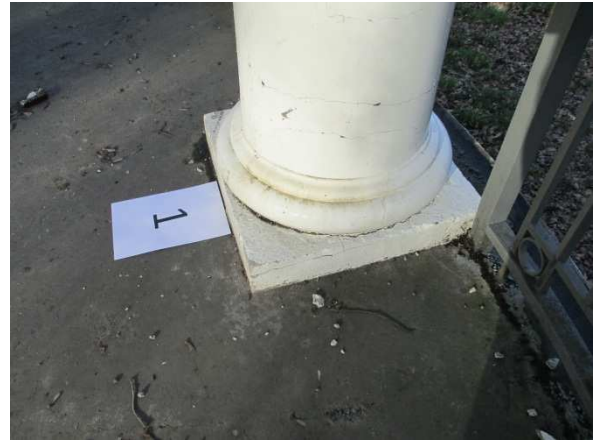
Image 11.
Detail 4 of Column 1.

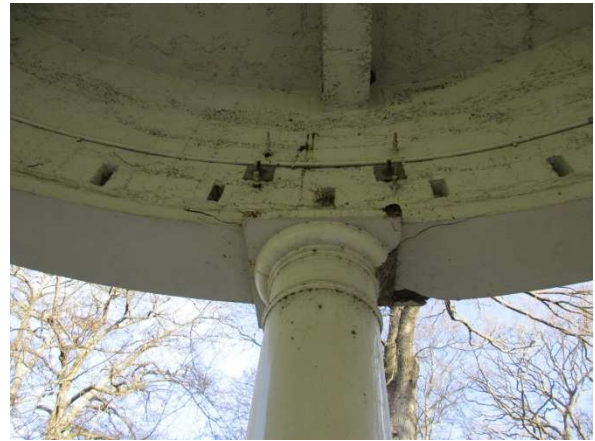
Image 12.
Detail 5 of Column 1.

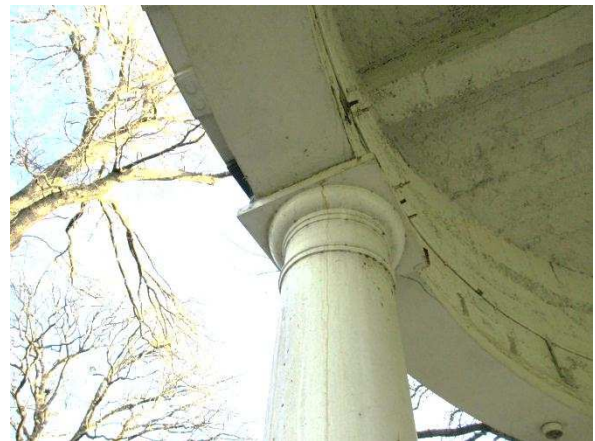
Image 13.
Detail 6 of Column 1.

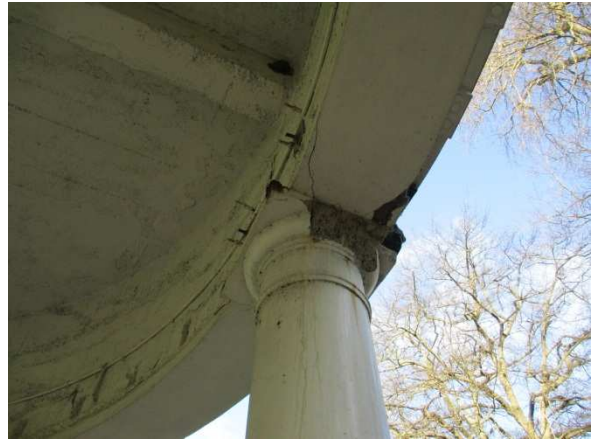
Image 14.
Detail 1 of Column 2.

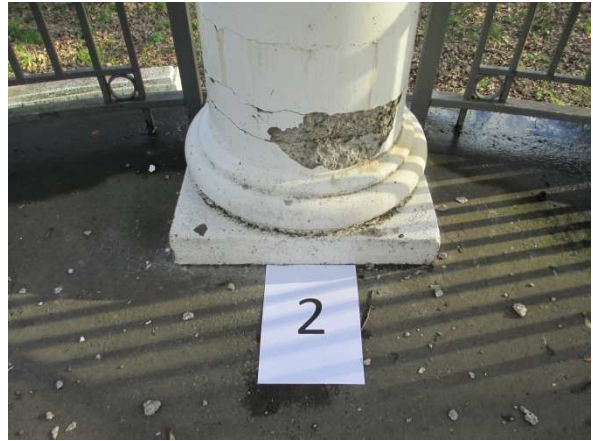
Image 15.
Detail 2 of Column 2.

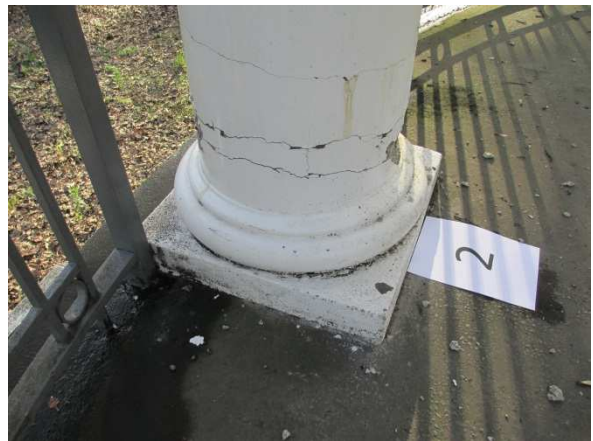
Image 16.
Detail 3 of Column 2.

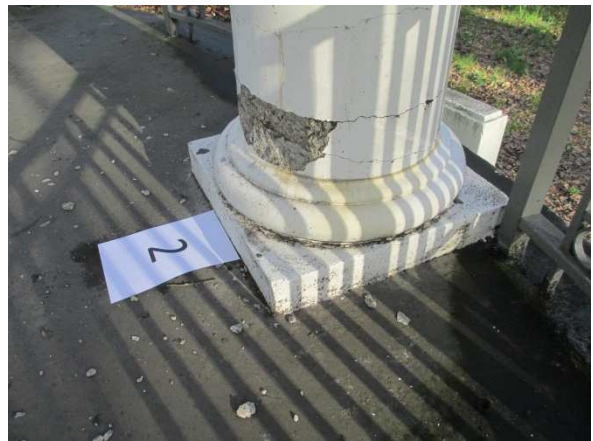
Image 17.
Detail 4 of Column 2.

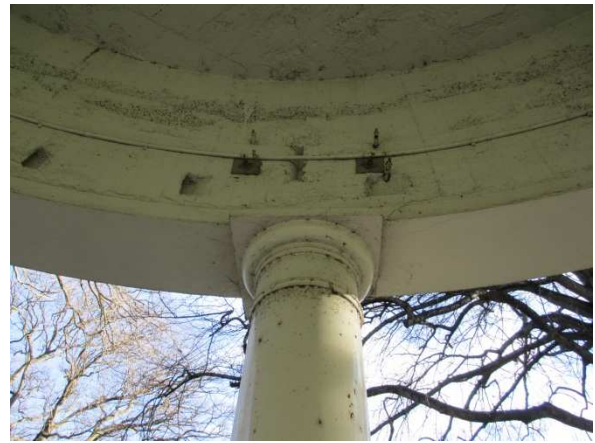
Image 18.
Detail 5 of Column 2.

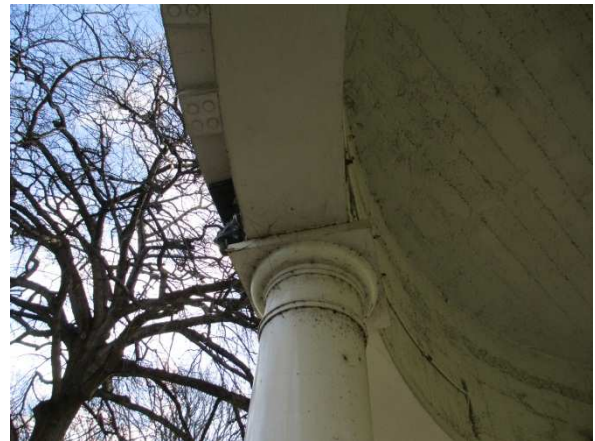
Image 19.
Detail 6 of Column 2.

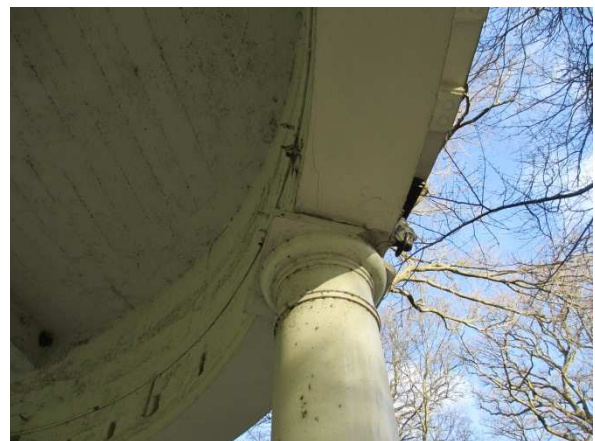
Image 20.
Detail 1 of Column 3.

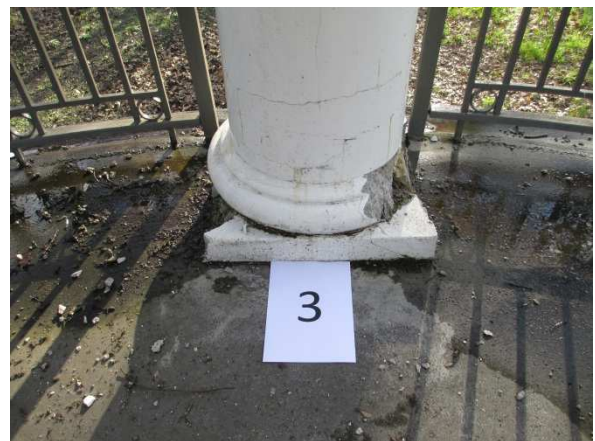
Image 21.
Detail 2 of Column 3.

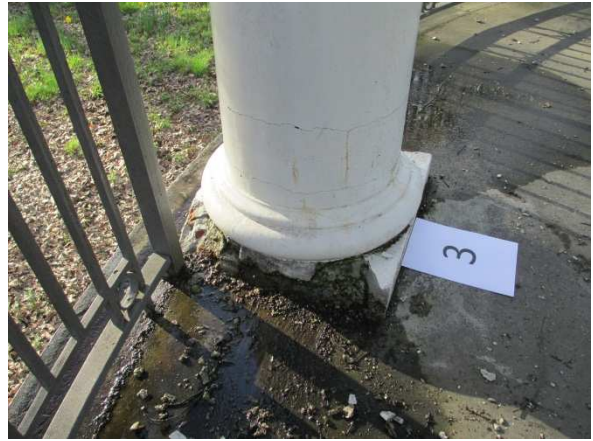
Image 22.
Detail 3 of Column 3.

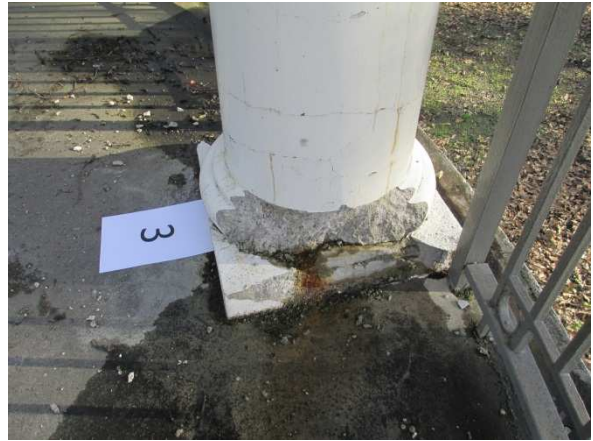
Image 23.
Detail 4 of Column 3.

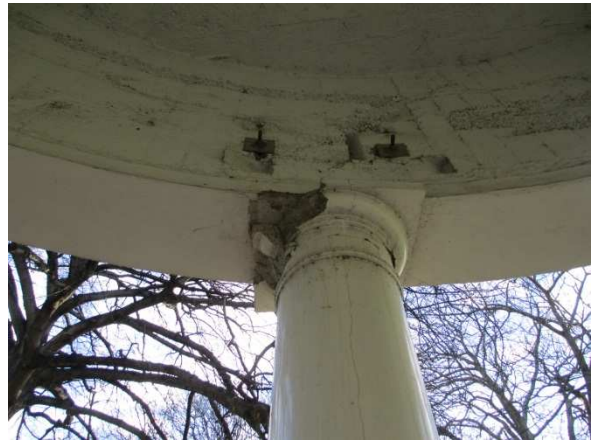
Image 24.
Detail 5 of Column 3.

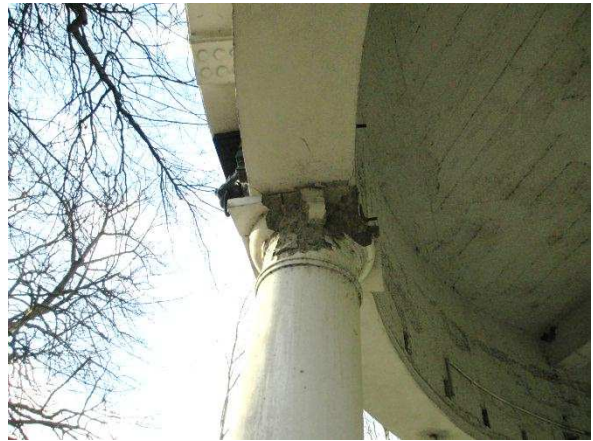
Image 25.
Detail 6 of Column 3.

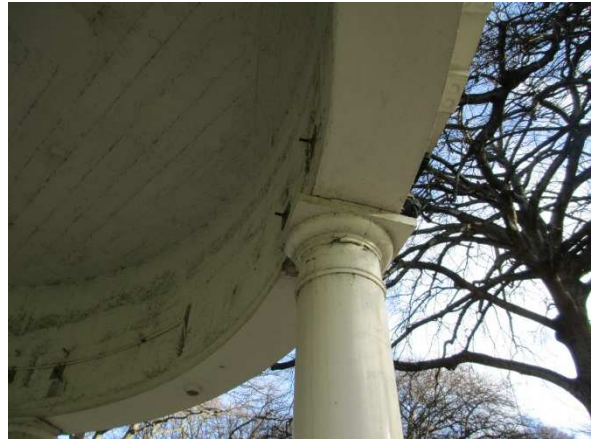
Image 26.
Detail 1 of Column 4.

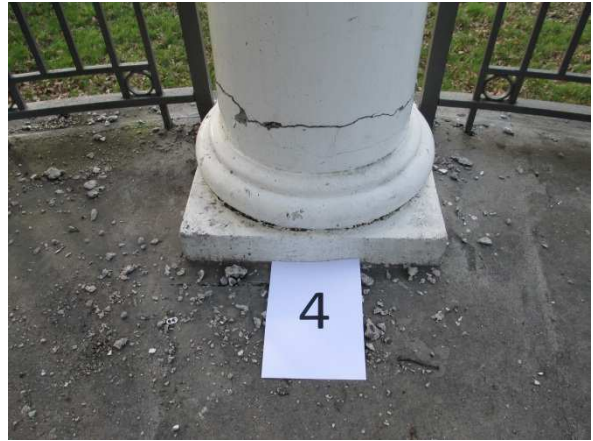
Image 27.
Detail 2 of Column 4.

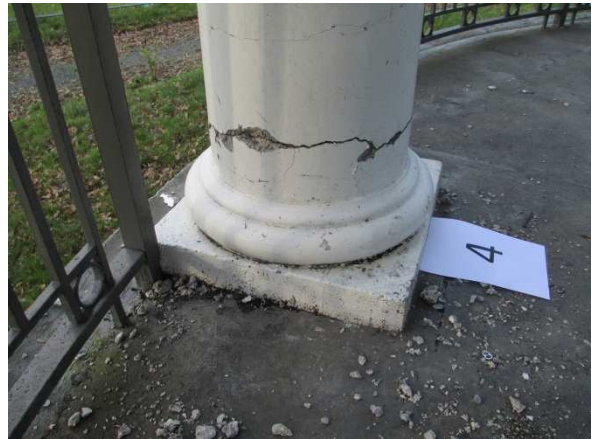
Image 28.
Detail 3 of Column 4.

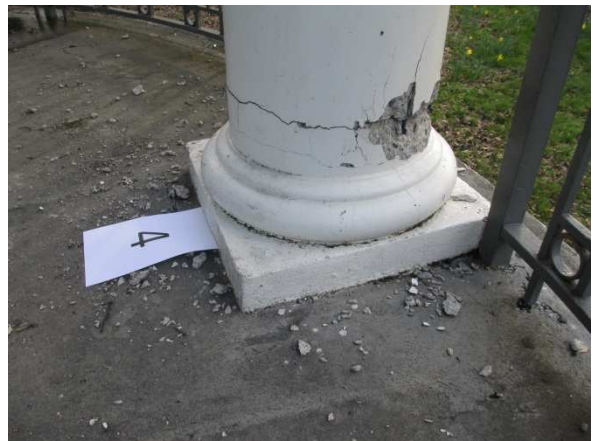
Image 29.
Detail 4 of Column 4.

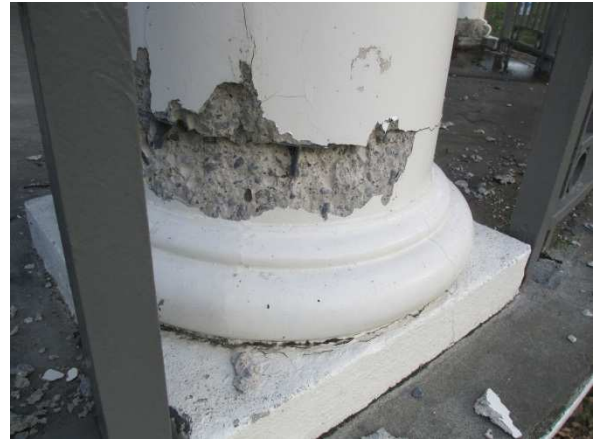
Image 30.
Detail 5 of Column 4.

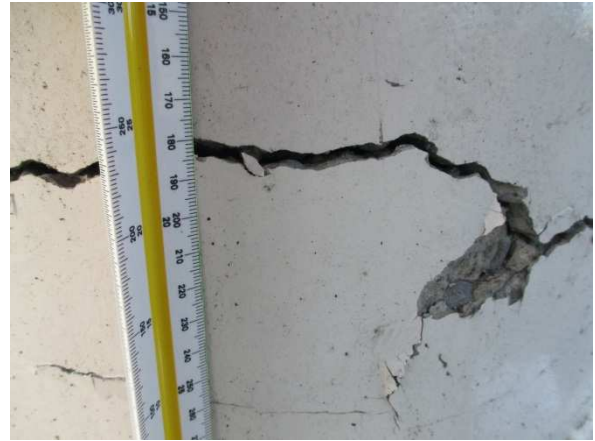
Image 31.
Detail 6 of Column 4.

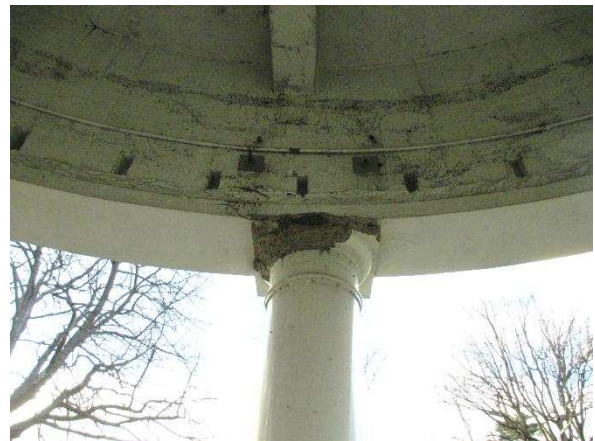
Image 32.
Detail 7 of Column 4.

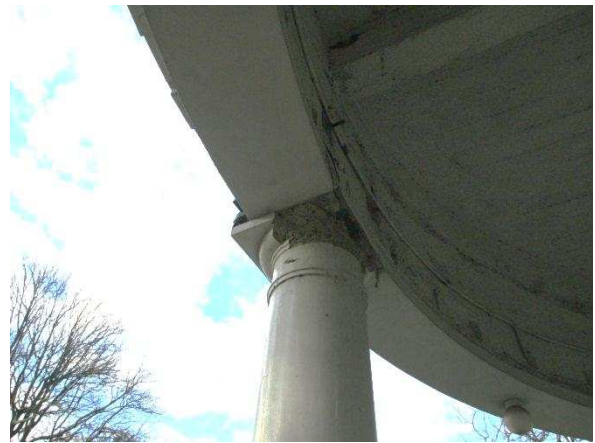
Image 33.
Detail 8 of Column 4.

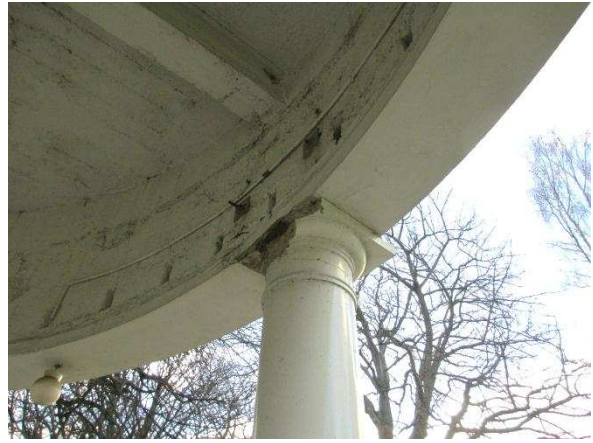
Image 34.
Detail 1 of Column 5.

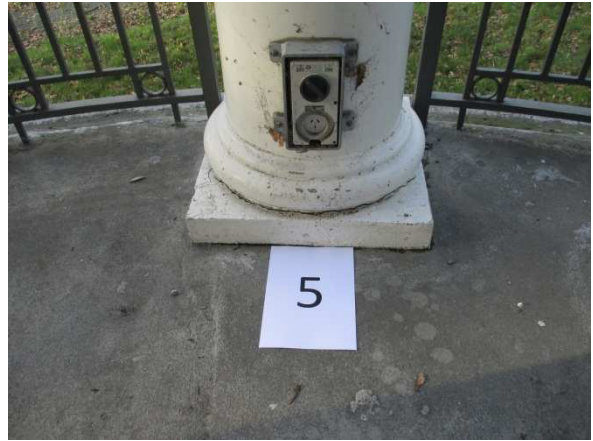
Image 35.
Detail 2 of Column 5.
