**Brougham Village Blocks A to E  
Detailed Engineering Evaluation  
Quantitative Report**

Christchurch City Council

Date: 3 October 2012  
Reference: 6-QUCCC.92

Detailed Engineering Evaluation  
Quantitative Report - SUMMARY  
Version 4 - Final

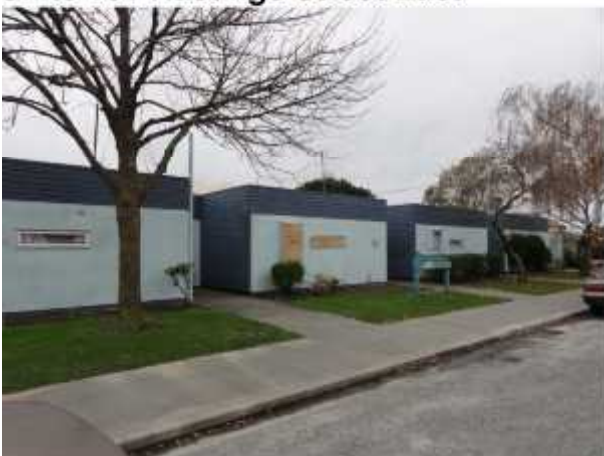
No visible damage, unit 2 yellow stickered due to severe liquefaction

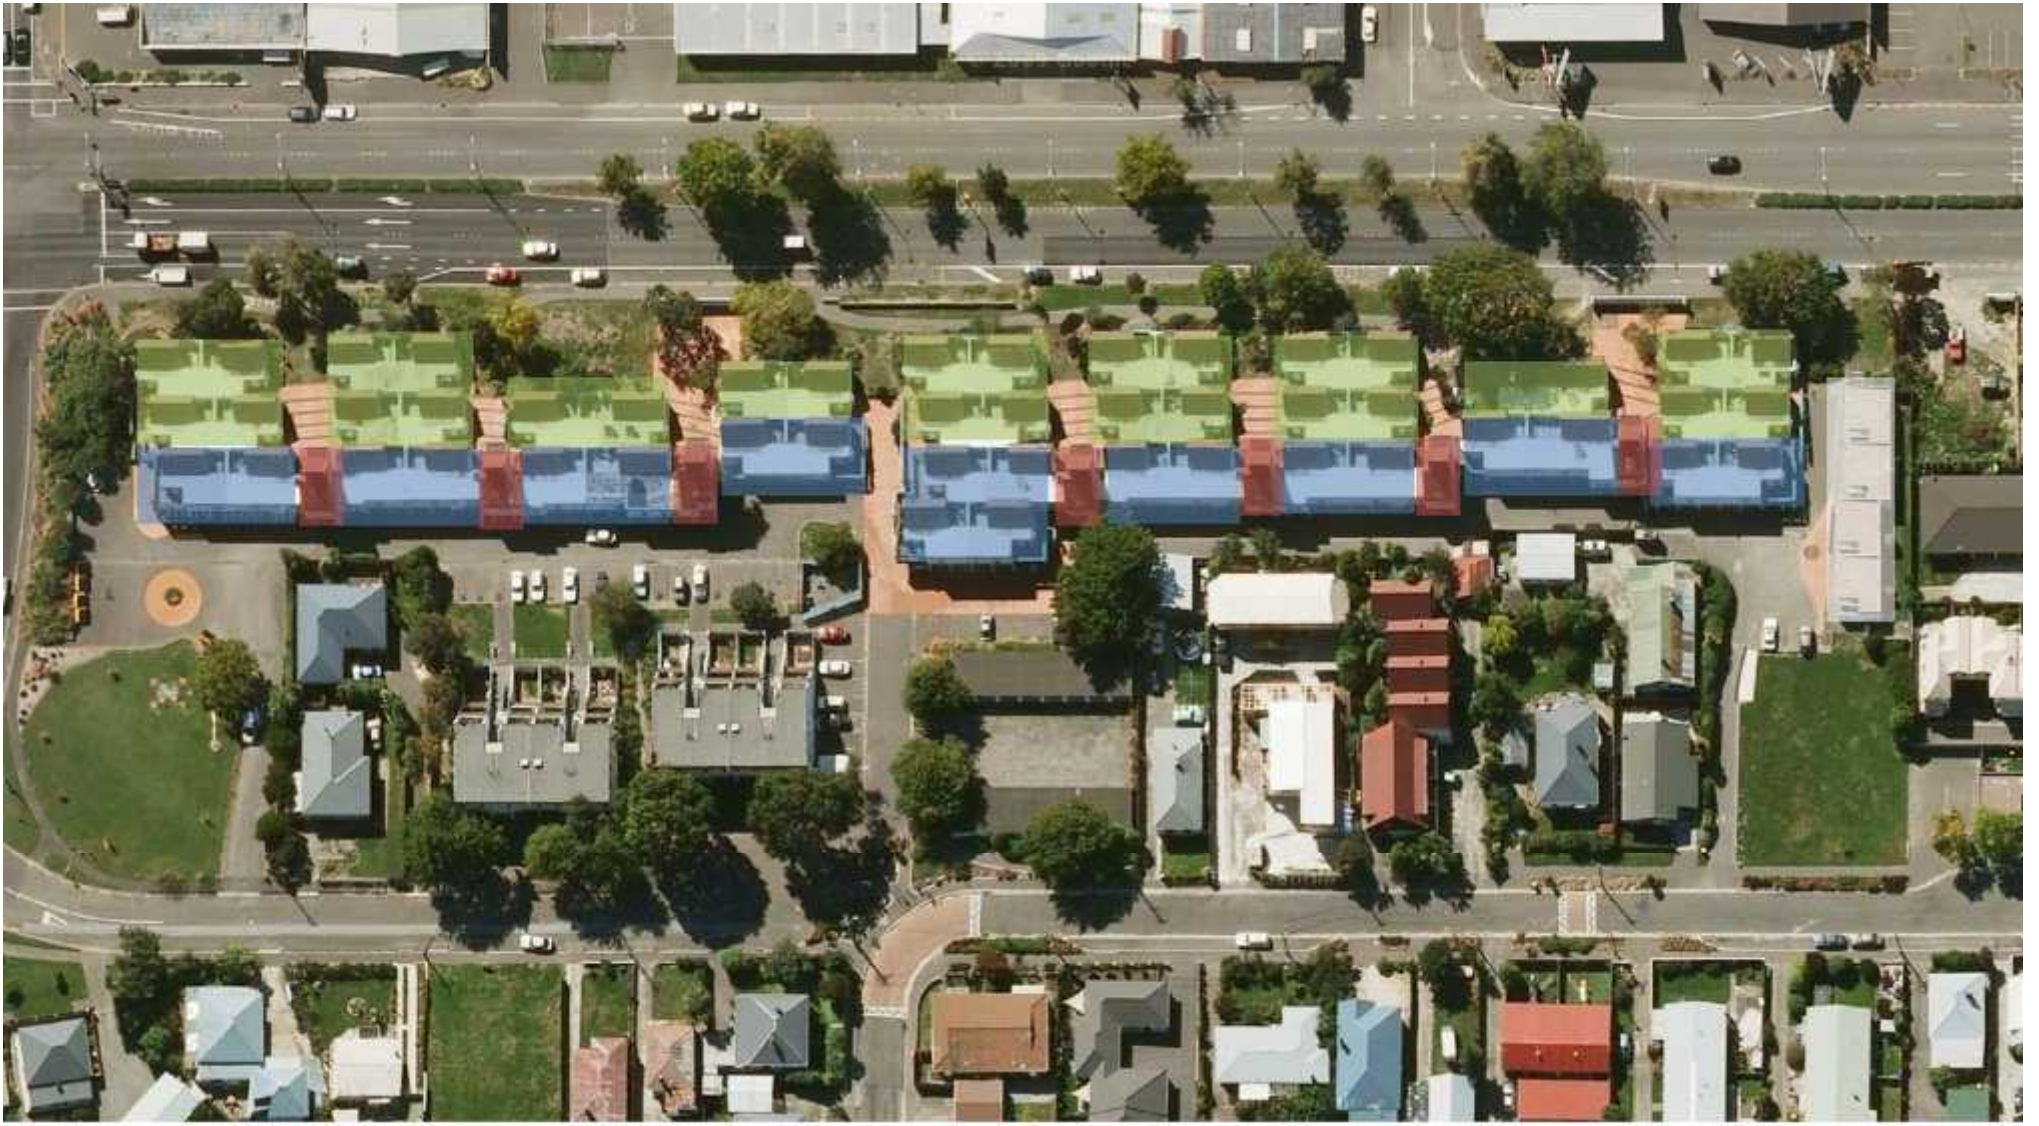
## **Appendix E – Site Location and Damage Plan**

Level of Damage

- (A) Wood heave 80mm
- (B) Damage to carpark area
- (C) Damage to buried services
- (D) Severe cracking in 1st Floor slab.
- (E) Heave in driveway 100mm
- (F) Heave 33 Cracking in ground floor slab.
- (G) Damaged services.

Unit 2 yellow sticker  
Severe liquefaction
