Cresselly Place Housing Complex PRO 0980

**Detailed Engineering Evaluation
Quantitative Assessment Report**

Cresselly Place Housing Complex Quantitative Assessment Report

Wilsons Road, St Martins, Christchurch

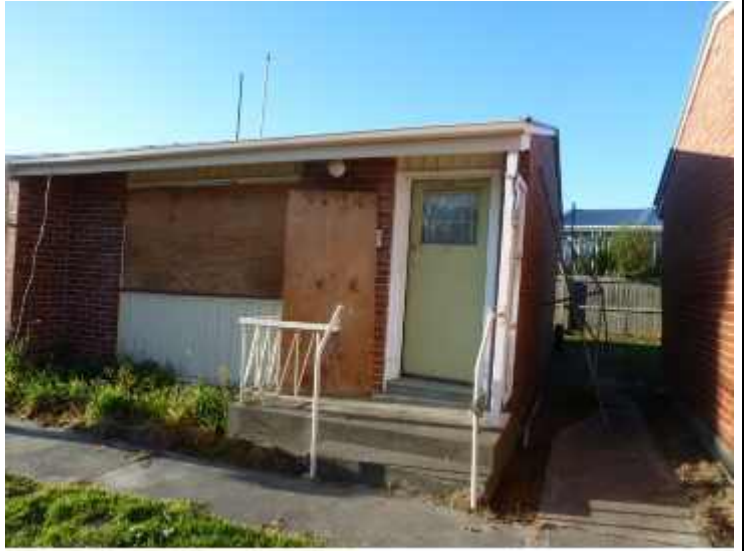
Cresselly Courts Housing Complex		
Residential Units		
1	Typical exterior, front view.

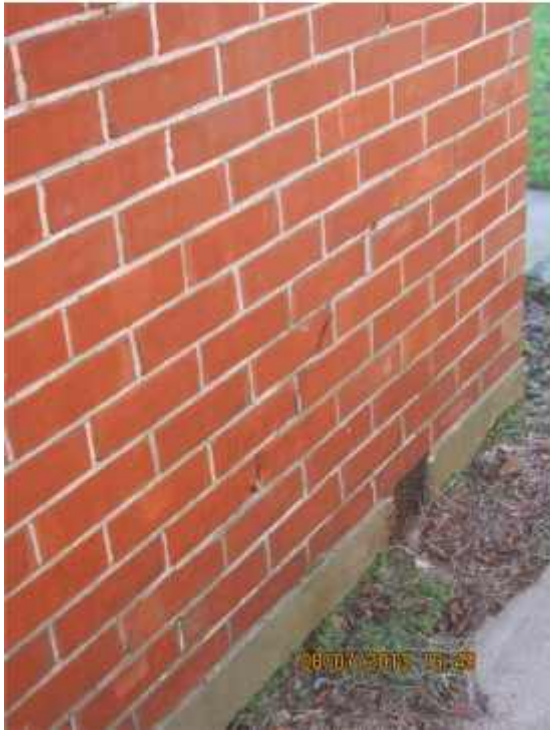
A photograph showing a corner of a brick wall. A white window sill is visible on the left. The brickwork is red with white mortar. There is significant vertical and diagonal cracking in the bricks and mortar joints, particularly around the window sill and in the corner.
11	Typical diagonal cracking, observed in the exterior cladding of several units.

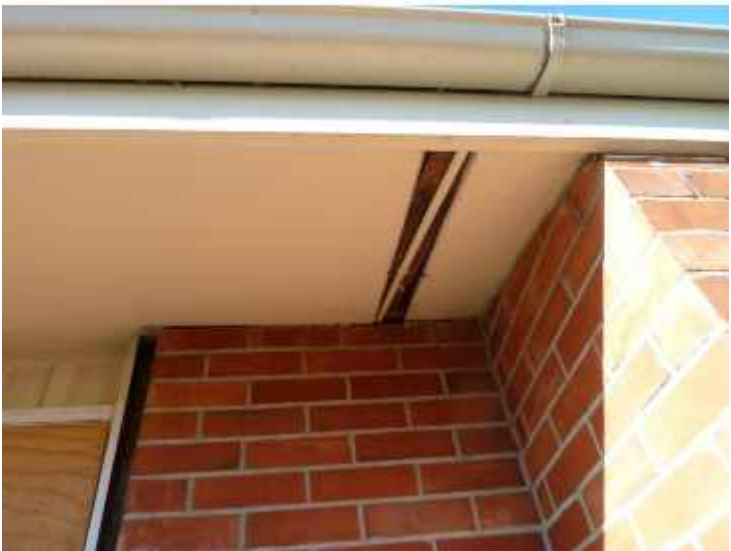
17	Separation of the soffit in Block G due to lateral stretching of the structure.

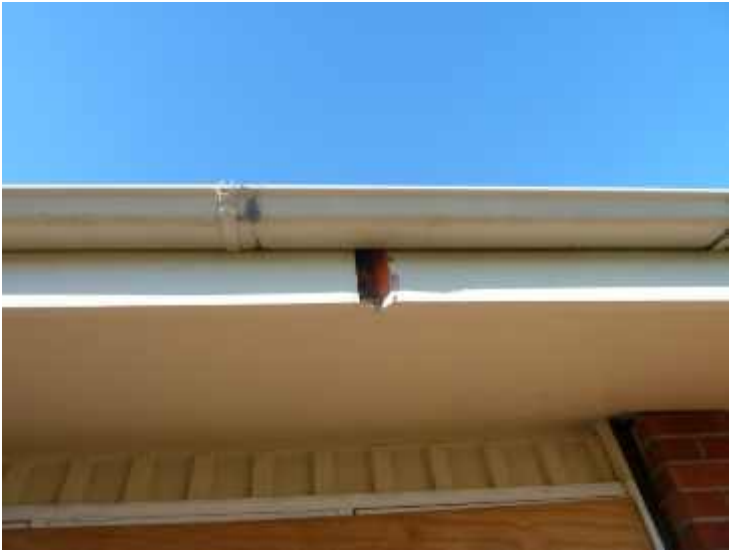
18	Separation of the fascia board in Block G due to lateral stretching of the structure.

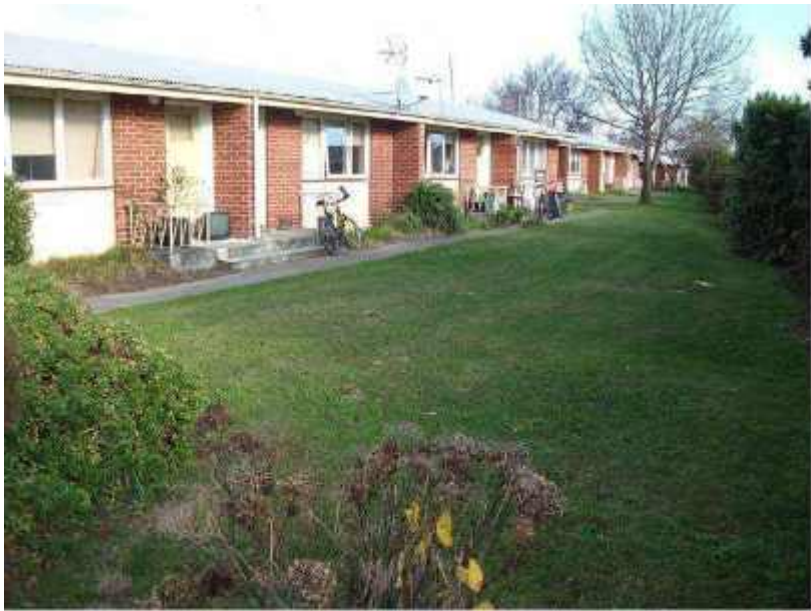
Photo 1: View of Even-Numbered Flats 2-8 Looking Southwest

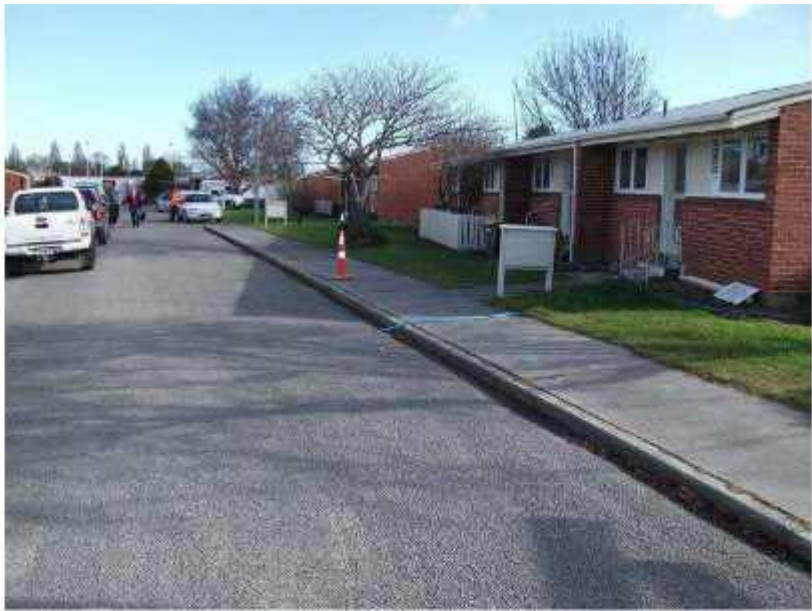
Photo 2: View of Cresselly Place and Even-Numbered Flats 2-8 Looking Northwest

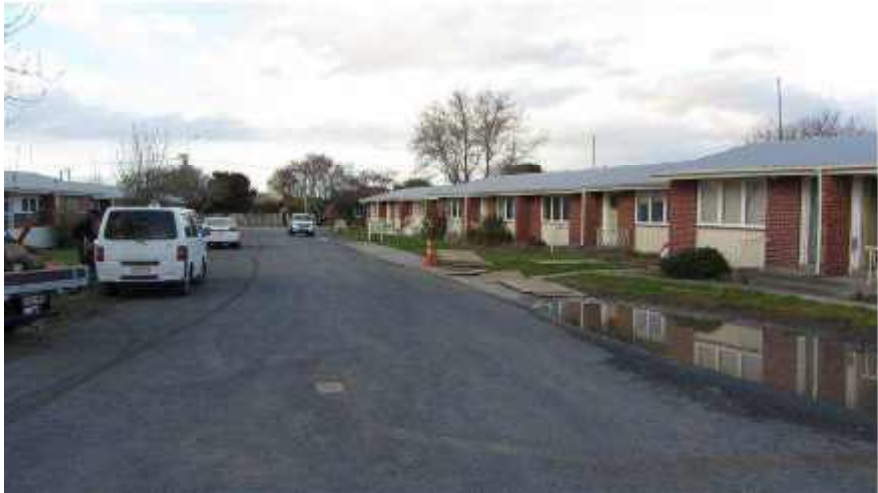
Photo 3: View of Cresselly Place and Odd-Numbered Flats 1-19 Looking East

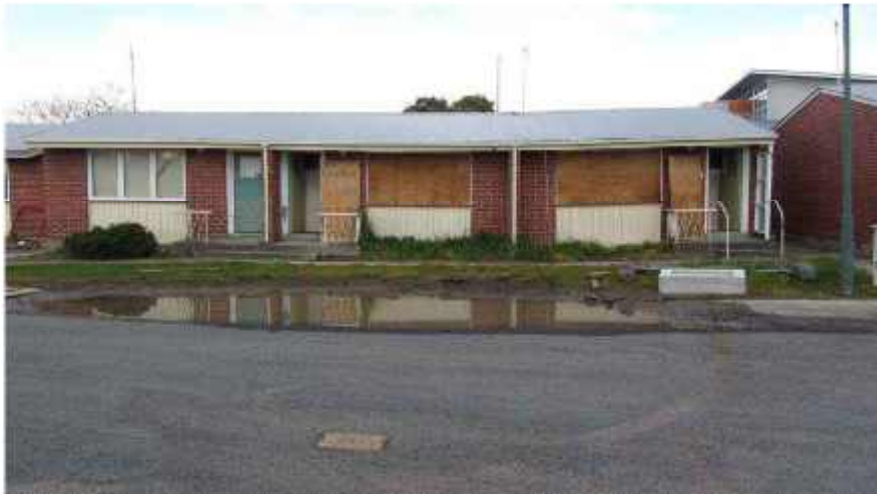
Photo 8: View of Cresselly Place and Odd-Numbered Flats 19-23 Looking South;
Note Depression in Centre of Photo

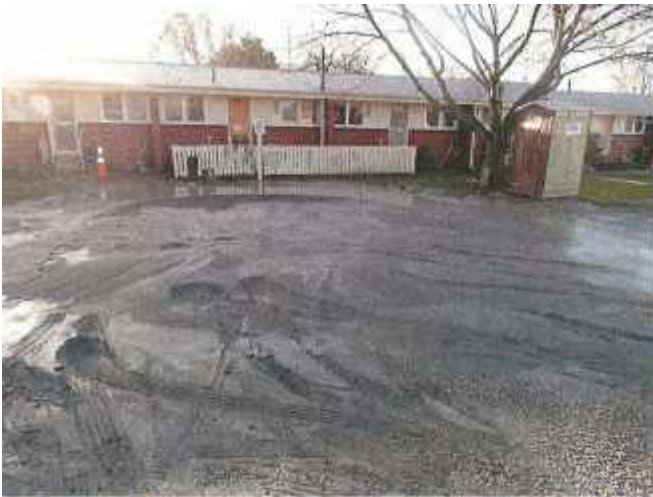
Photo 9: View Liquefaction at Cresselly Place and Even-Numbered Flats 20-26 Looking North-Northeast; Photo taken 14 June 2011

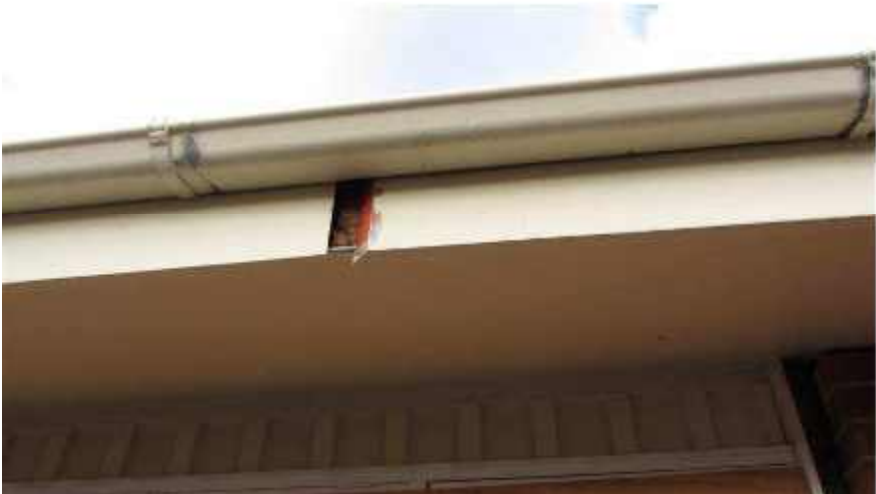
- Stretching separation of the fascia boards at Flats 1, 3, 5, 6, 12, 14, 25, 27, 29 (typified by Photos 18 and 19 in Appendix B)
- Shearing through bricks in exterior veneers at Flats 5, 12, 27, 28 (typified by Photos 21, 22 and 23 in Appendix B)

Photo 19: Stretching Separation of Fascia Boards and Movement of Gutter in its Hangar at Front of Flat 27 Looking South

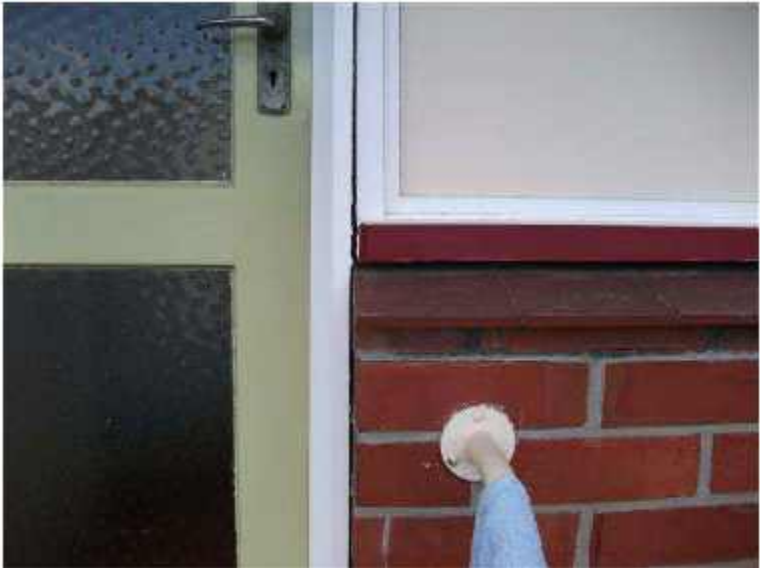
Photo 20: Separation of Doorjamb from Brick Veneer at Back of Flat 5 Looking North-Northwest

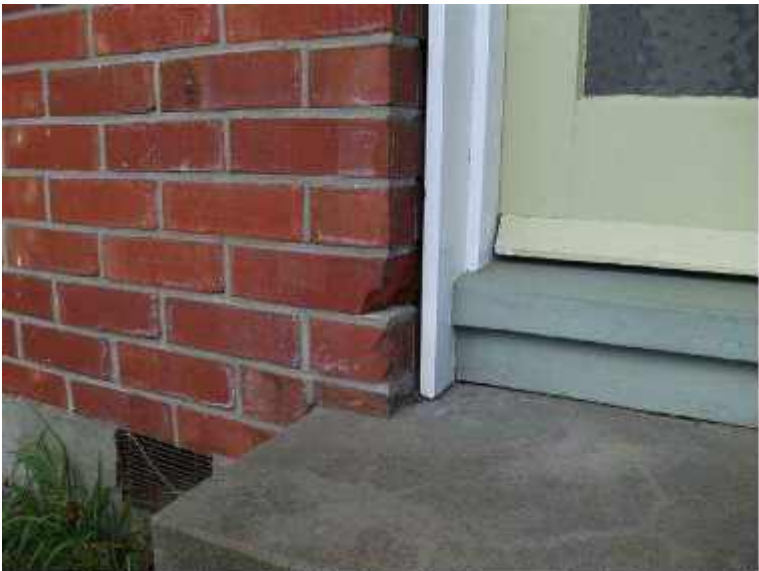
Photo 21: Shearing through Bricks of Exterior Veneer at Back of Flat 5 Looking Northwest

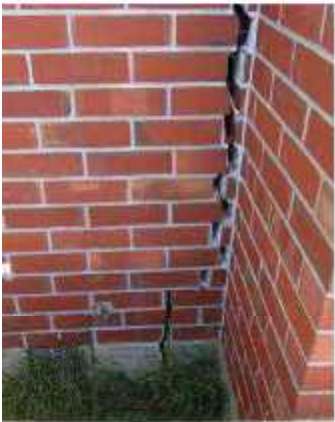
- Severe stretching of walls at Flats 27, 28, 29 (typified by Photos 30 and 31 in Appendix B)
- Separation of downspout connections from the pilasters between Flats 3 & 5, 5 & 7, 10 & 12, 25 & 26 (typified by Photos 32 and 33 in Appendix B)

Photo 31: Severe Stretching of Walls at Rear of Flats 27 and 29 Looking North (Photo 2 of 2)

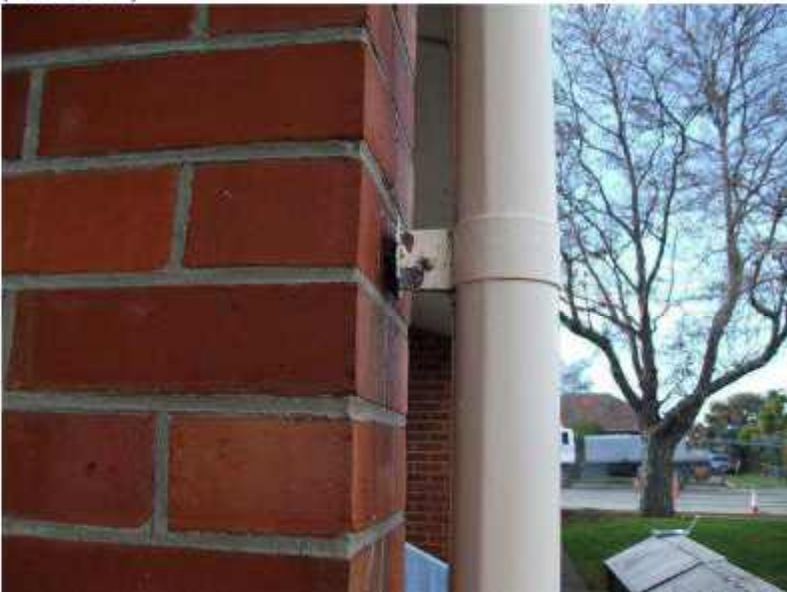
Photo 32: Separation of Downspout Connector from Pilaster at Rear of Flats 5 and 7 Looking East

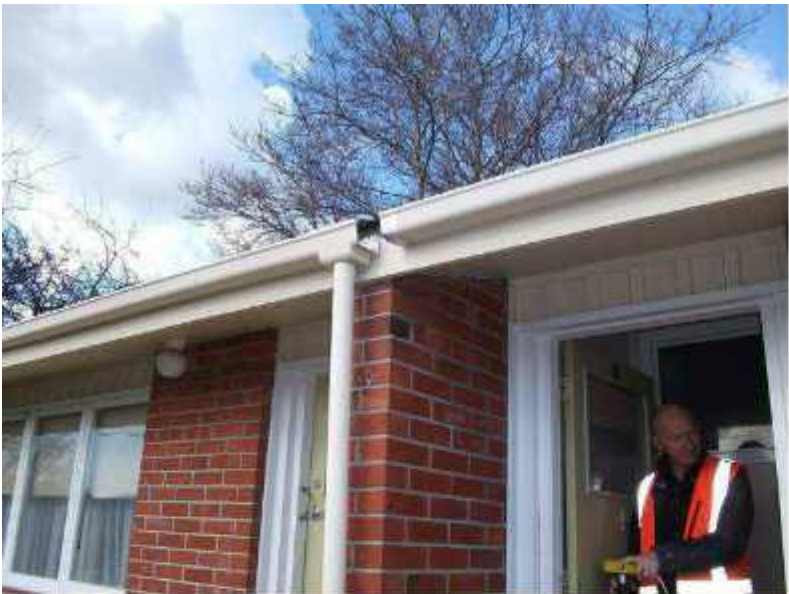
Photo 33: Separation of Downspout Connector from Pilaster and Separation of Gutter Sections at Front of Flats 1 and 3 Looking Southeast

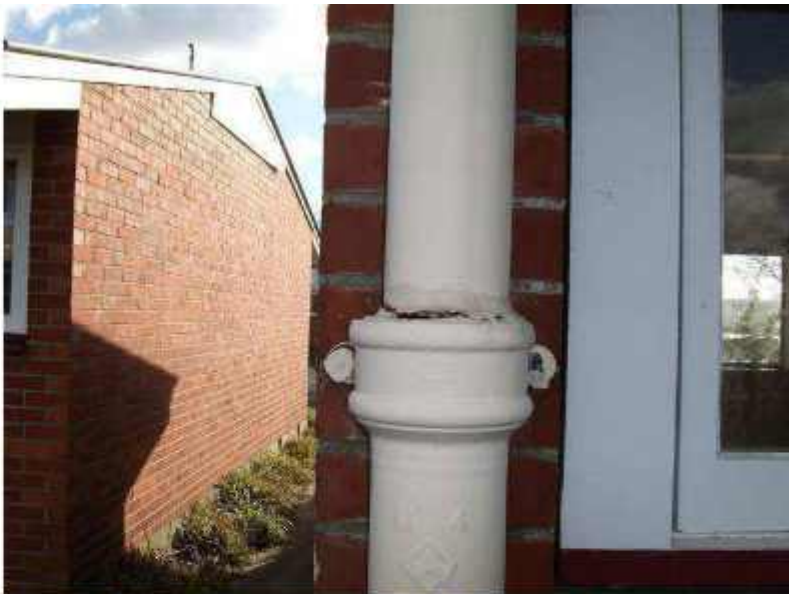
Photo 34: Shearing of Downspout at Rear of Flat 7 Looking Northwest

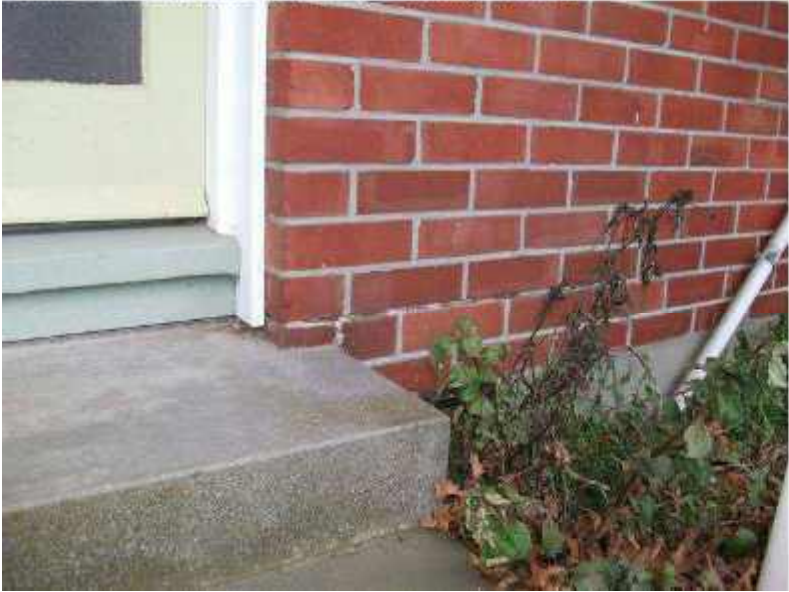
- Shearing through grout within exterior wall veneers of Flats 1, 7, 23, 26, 28, 30 (typified by Photos 35 and 36 in Appendix B)
- Distortion of fencing along the perimeter site boundary behind Flats 9, 11, 25, 27, 28, 30 (typified by Photos 37, 38, 39 and 40 and 16 in Appendix B)

Photo 35: Shearing through Grout between Bricks of Exterior Veneer at Back of Flat 7 Looking North

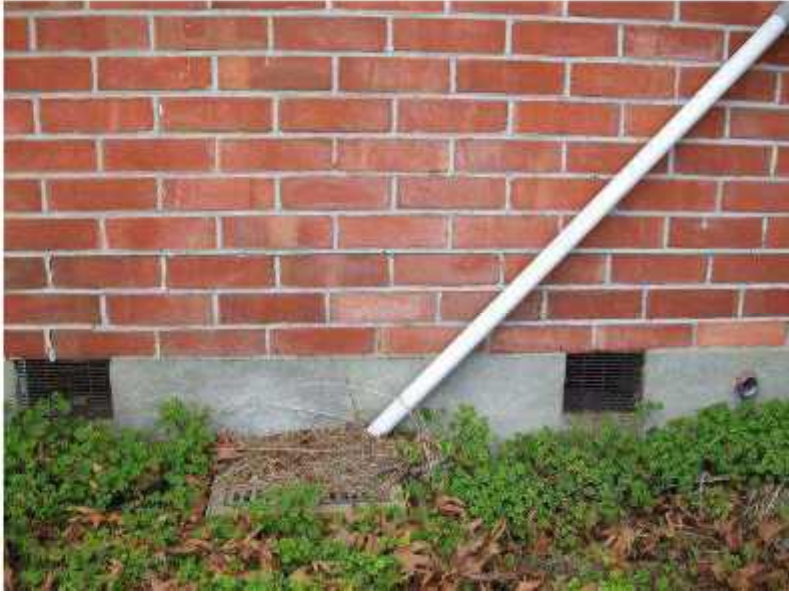
Photo 36: Shearing through Grout between Bricks of Exterior Veneer at Back of Flat 1 Looking Northeast

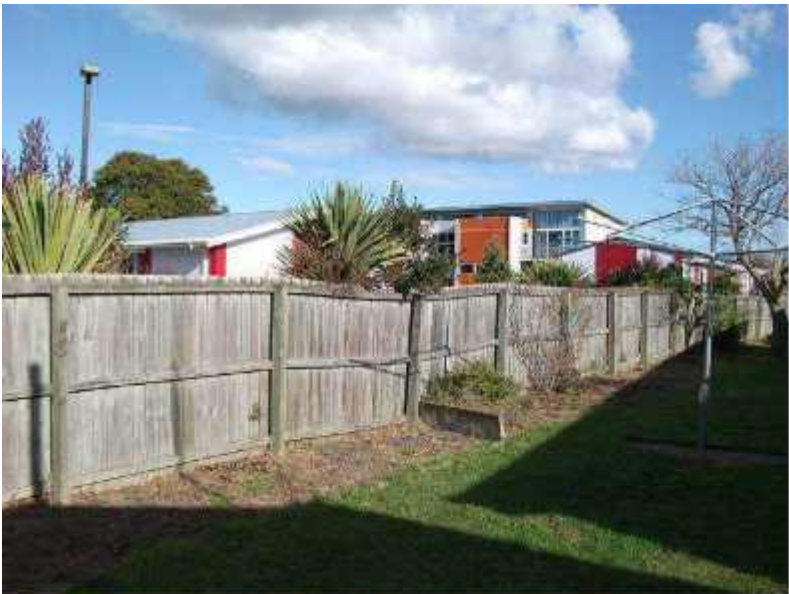
Photo 37: Distortion of Fence along Southern Property Boundary behind Flats 9 and 11 Looking Southwest

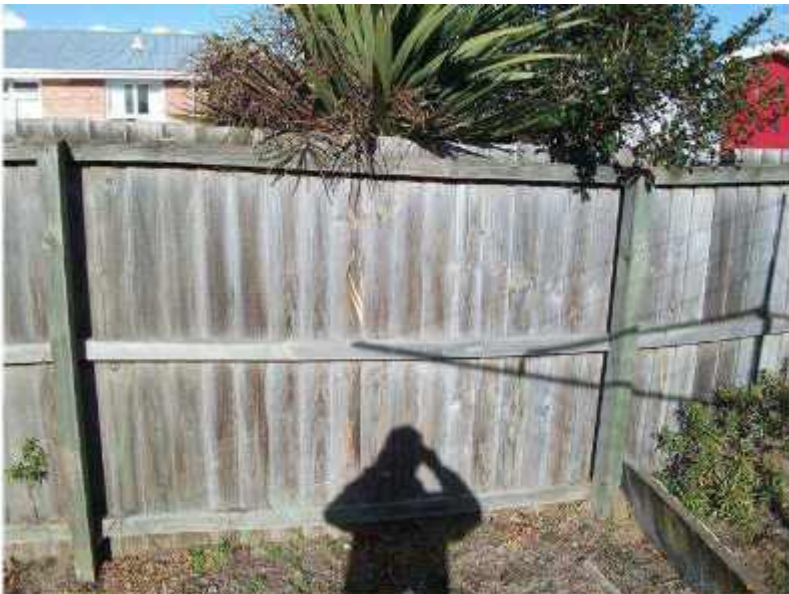
Photo 38: Distortion of Fence along Southern Property Boundary behind Flats 9 and 11 Looking Southeast

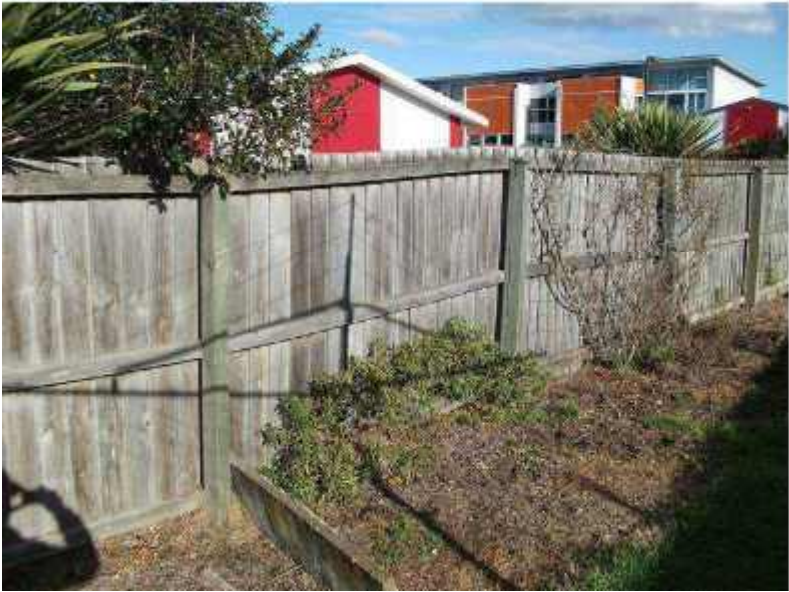
Photo 39: Distortion of Fence along Southern Property Boundary behind Flats 9 and 11 Looking Southwest

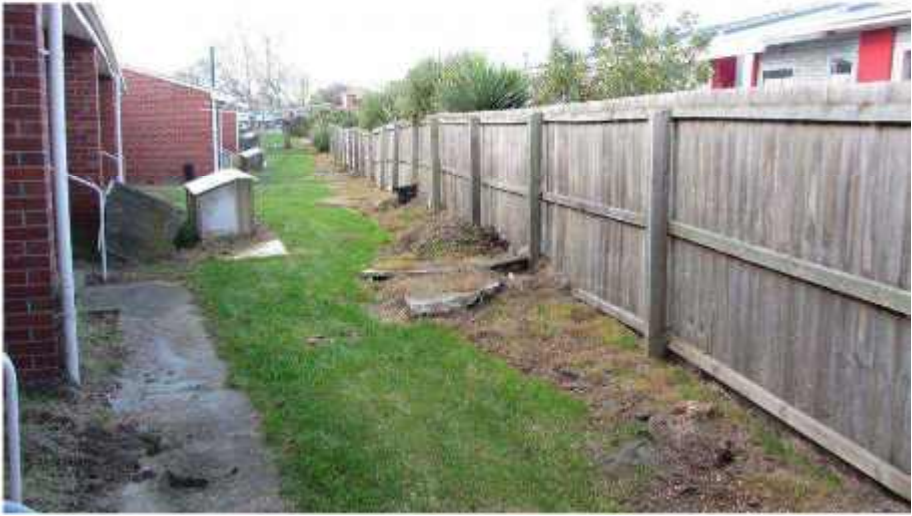
Photo 40: Distortion of Fence along Southern Property Boundary behind Flats Looking Northeast from behind Flat 31

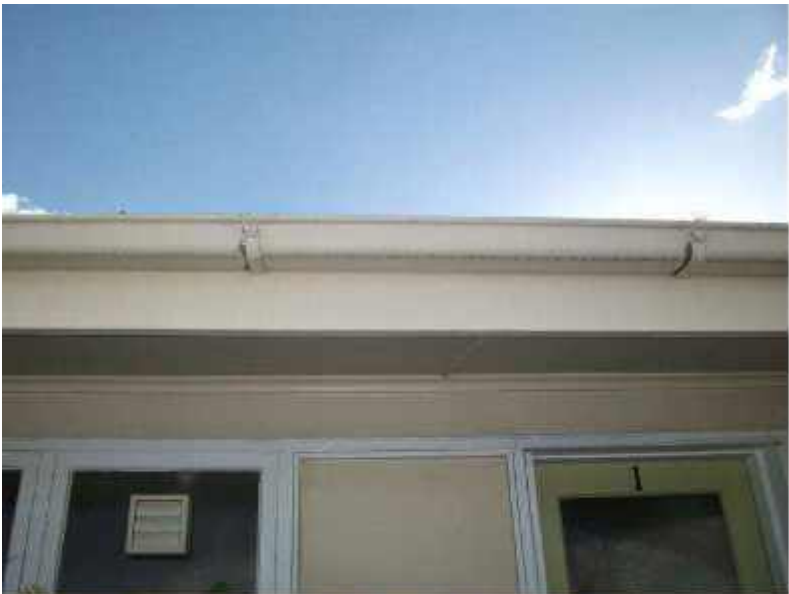
Photo 41: Movement of Gutter in its Hangar at Back of Flat 1 Looking Northwest

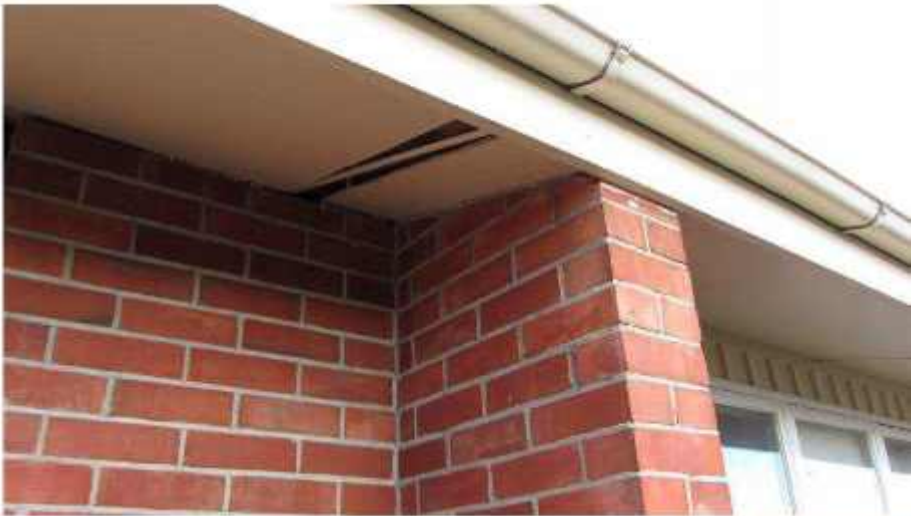
Photo 42: Movement of Gutter in its Hangar and Separation of Eave Joint at Front of Flat 29 Looking South-Southwest

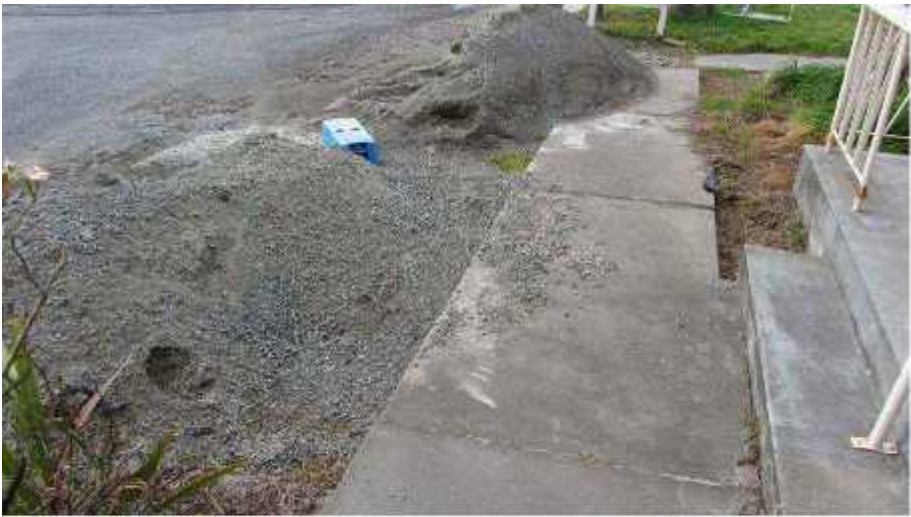
- Differential movement of concrete footpaths behind Flats 16, 17, 18, 19, 20, 26, 28; in front of Flats 8, 10, 14, 20, 25, 26, 27, 28; and to the side of Flats 8, 10, 16, 18, 26, 28 (typified by Photos 44, 45 and 53 in Appendix B)

Photo 45: Differential Movement of Concrete Footpaths in front of Flat 25 Looking Northeast

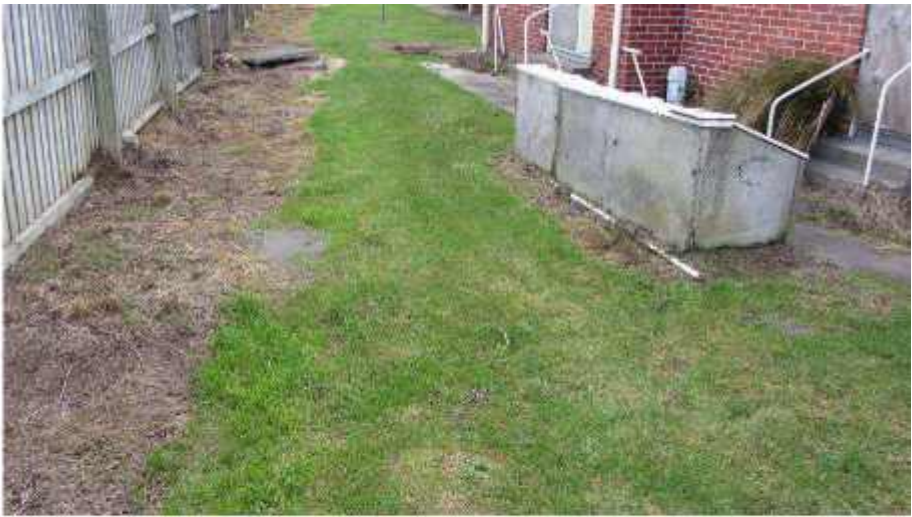
- Grey SILT/SAND ejecta behind Flats 6, 14, 16, 18, 20, 21, 22, 24, 26, 28, 30, 31; in front of Flats 12, 14, 25; and beside Flats 18, 26 (typified by Photos 46, 47 and 48 in Appendix B)

Photo 46: SILT/SAND Ejecta behind Flat 21 Looking Southwest

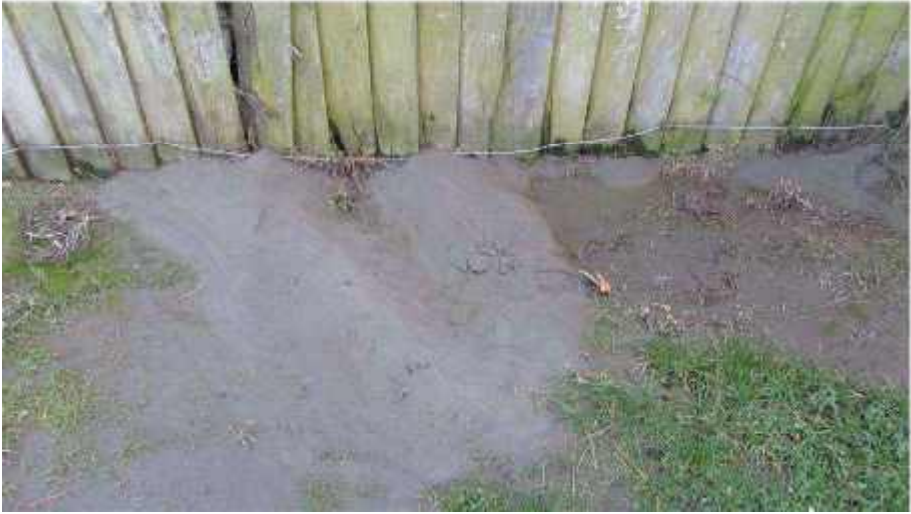
Photo 47: SILT/SAND Ejecta behind Flat 26 Looking Northwest

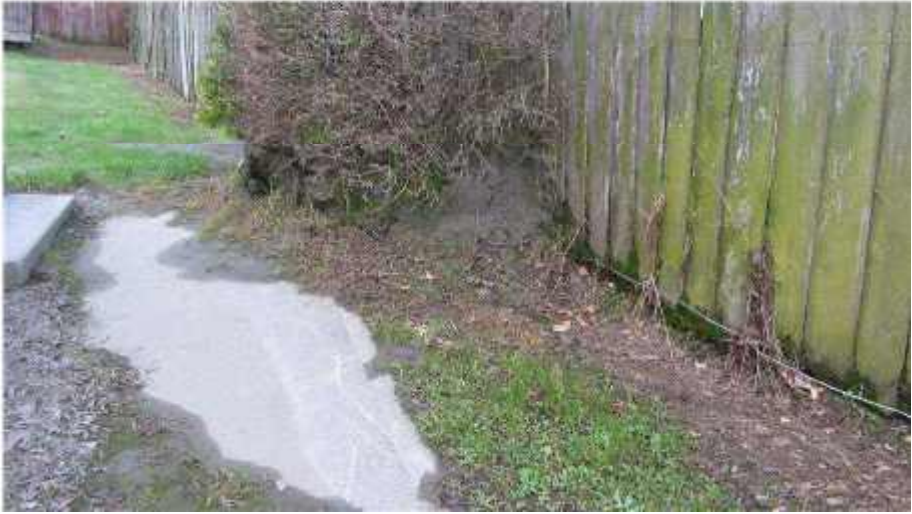
Photo 48: SILT/SAND Ejecta behind Flat 26 Looking West

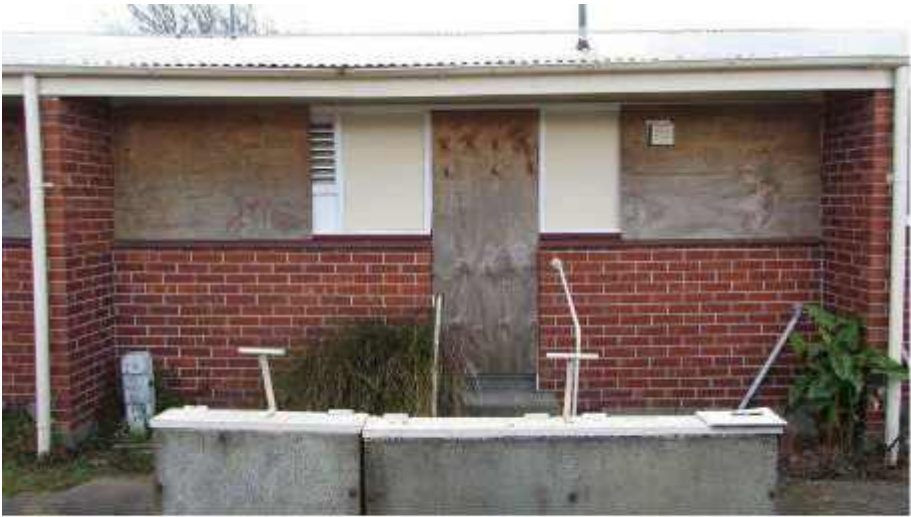
- Differential settlement of Flats 18, 21, 23, 25, 27, 28, 29 (typified by Photos 49, 50, 51 and 52 in Appendix B)
- Ground settlement in Front of Flats 15, 17, 19 (refer to Photos 50 and 54 in Appendix B)

Photo 49: Differential Settlement at Back of Flat 21 Looking Northwest

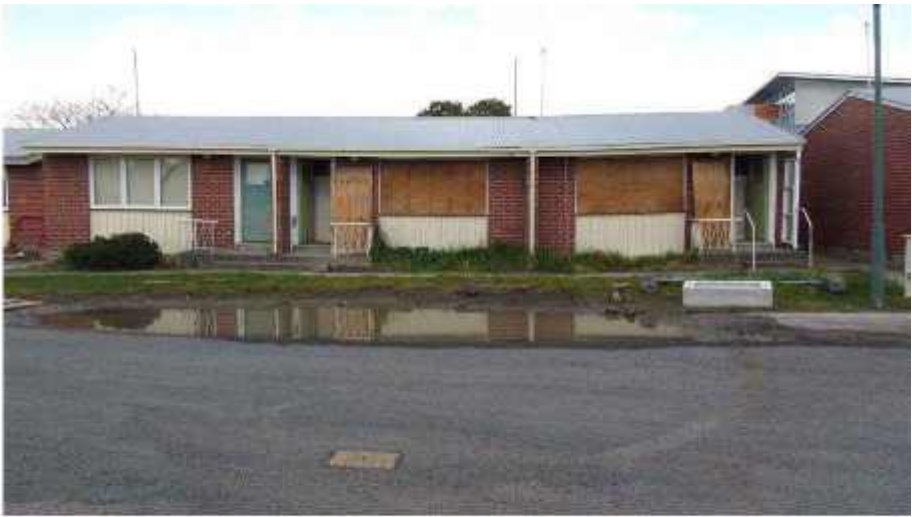
Photo 50: Depression and Differential Settlement at Front of Flats 21 and 23 Looking Southeast

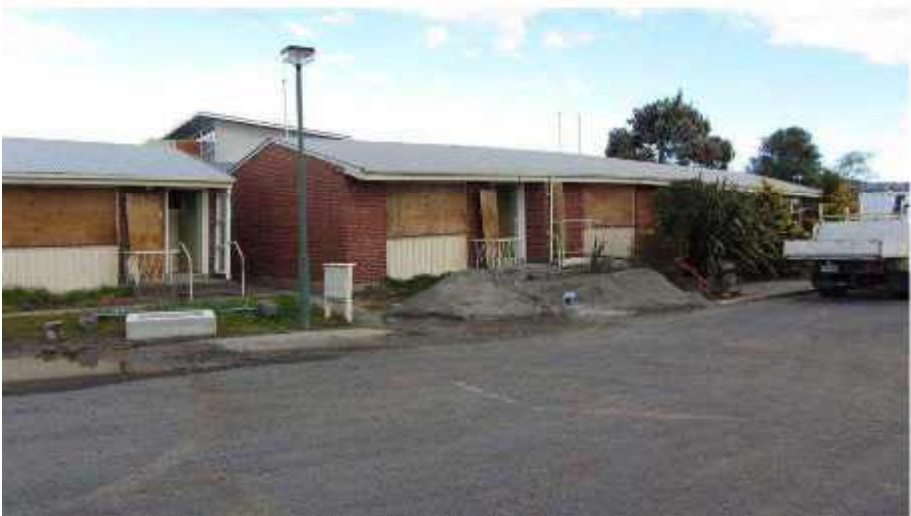
Photo 51: Depression and Differential Settlement at Front of Flats 23, 25, 27 and 29 Looking South-Southwest

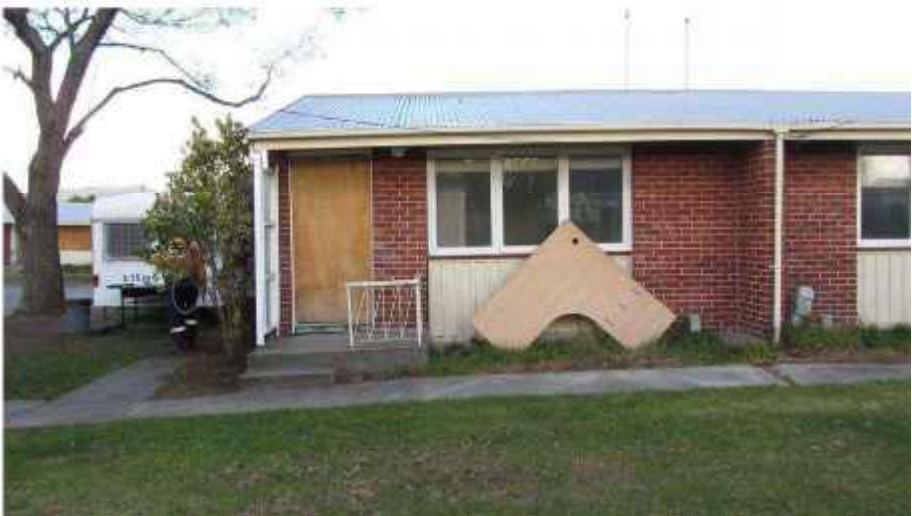
Photo 52: Differential Settlement at Back of Flat 28 Looking Southeast

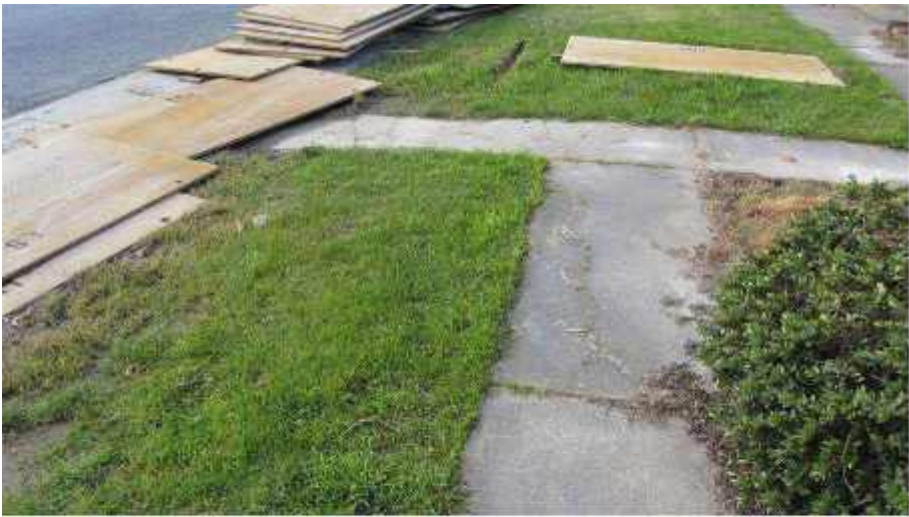
Photo 53: Depression, Differential Settlement and Distortion of Concrete Footpath in Front of Flats 23 and 25 Looking Northeast

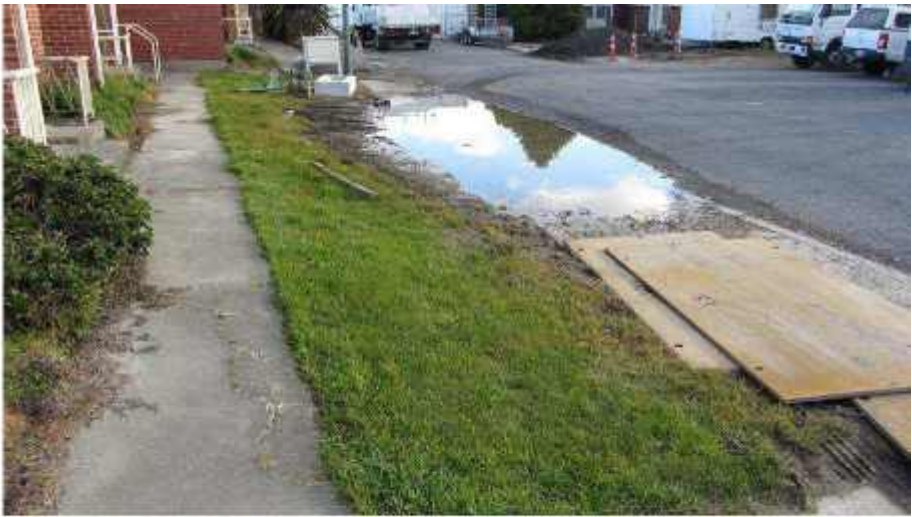
Photo 54: Depression, Differential Settlement and Distortion of Concrete Footpath and in Cresselly Place in Front of Flats 19, 21, 23 and 25 Looking Southwest

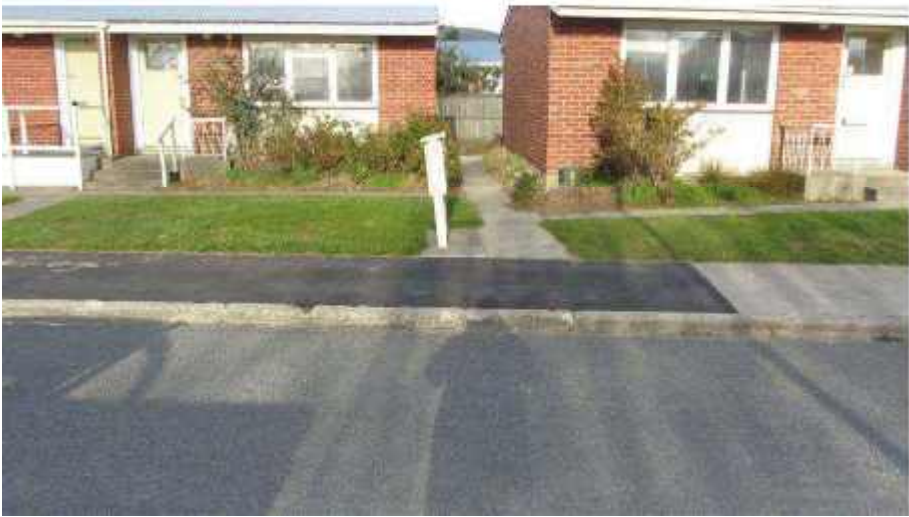
Photo 55: Leaning Letterboxes and New Asphalt Footpath in Front of Flats 5, 7 and 9 Looking Southeast
