**Halswell Courts
Housing Complex
PRO 1630**

**Detailed Engineering Evaluation
Quantitative Assessment Report**

Halswell, Christchurch

Date: November 2013
Reference: 6-QC355.00
Status: Final

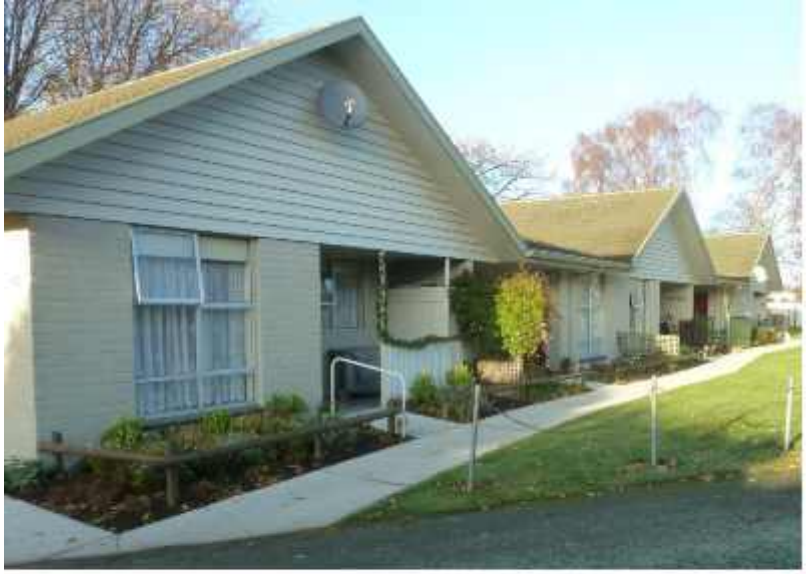
Halswell Courts Housing Complex		
No.	Item description	Photo
Unit Blocks		
1	Front elevation, typical.

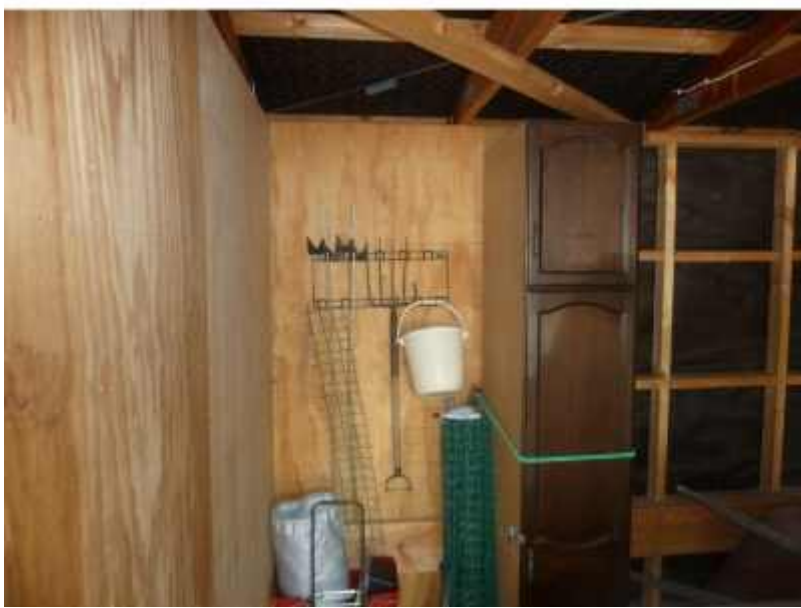
plywood. Drawings indicate that this plywood covers all internal walls. However, inspection on site showed that the walls are only partially lined, with a large portion of the rear wall unlined (as indicated in Figure 6).

13	Internal view showing dragon tie, roof strap bracing and rear wall with partial plywood coverage.

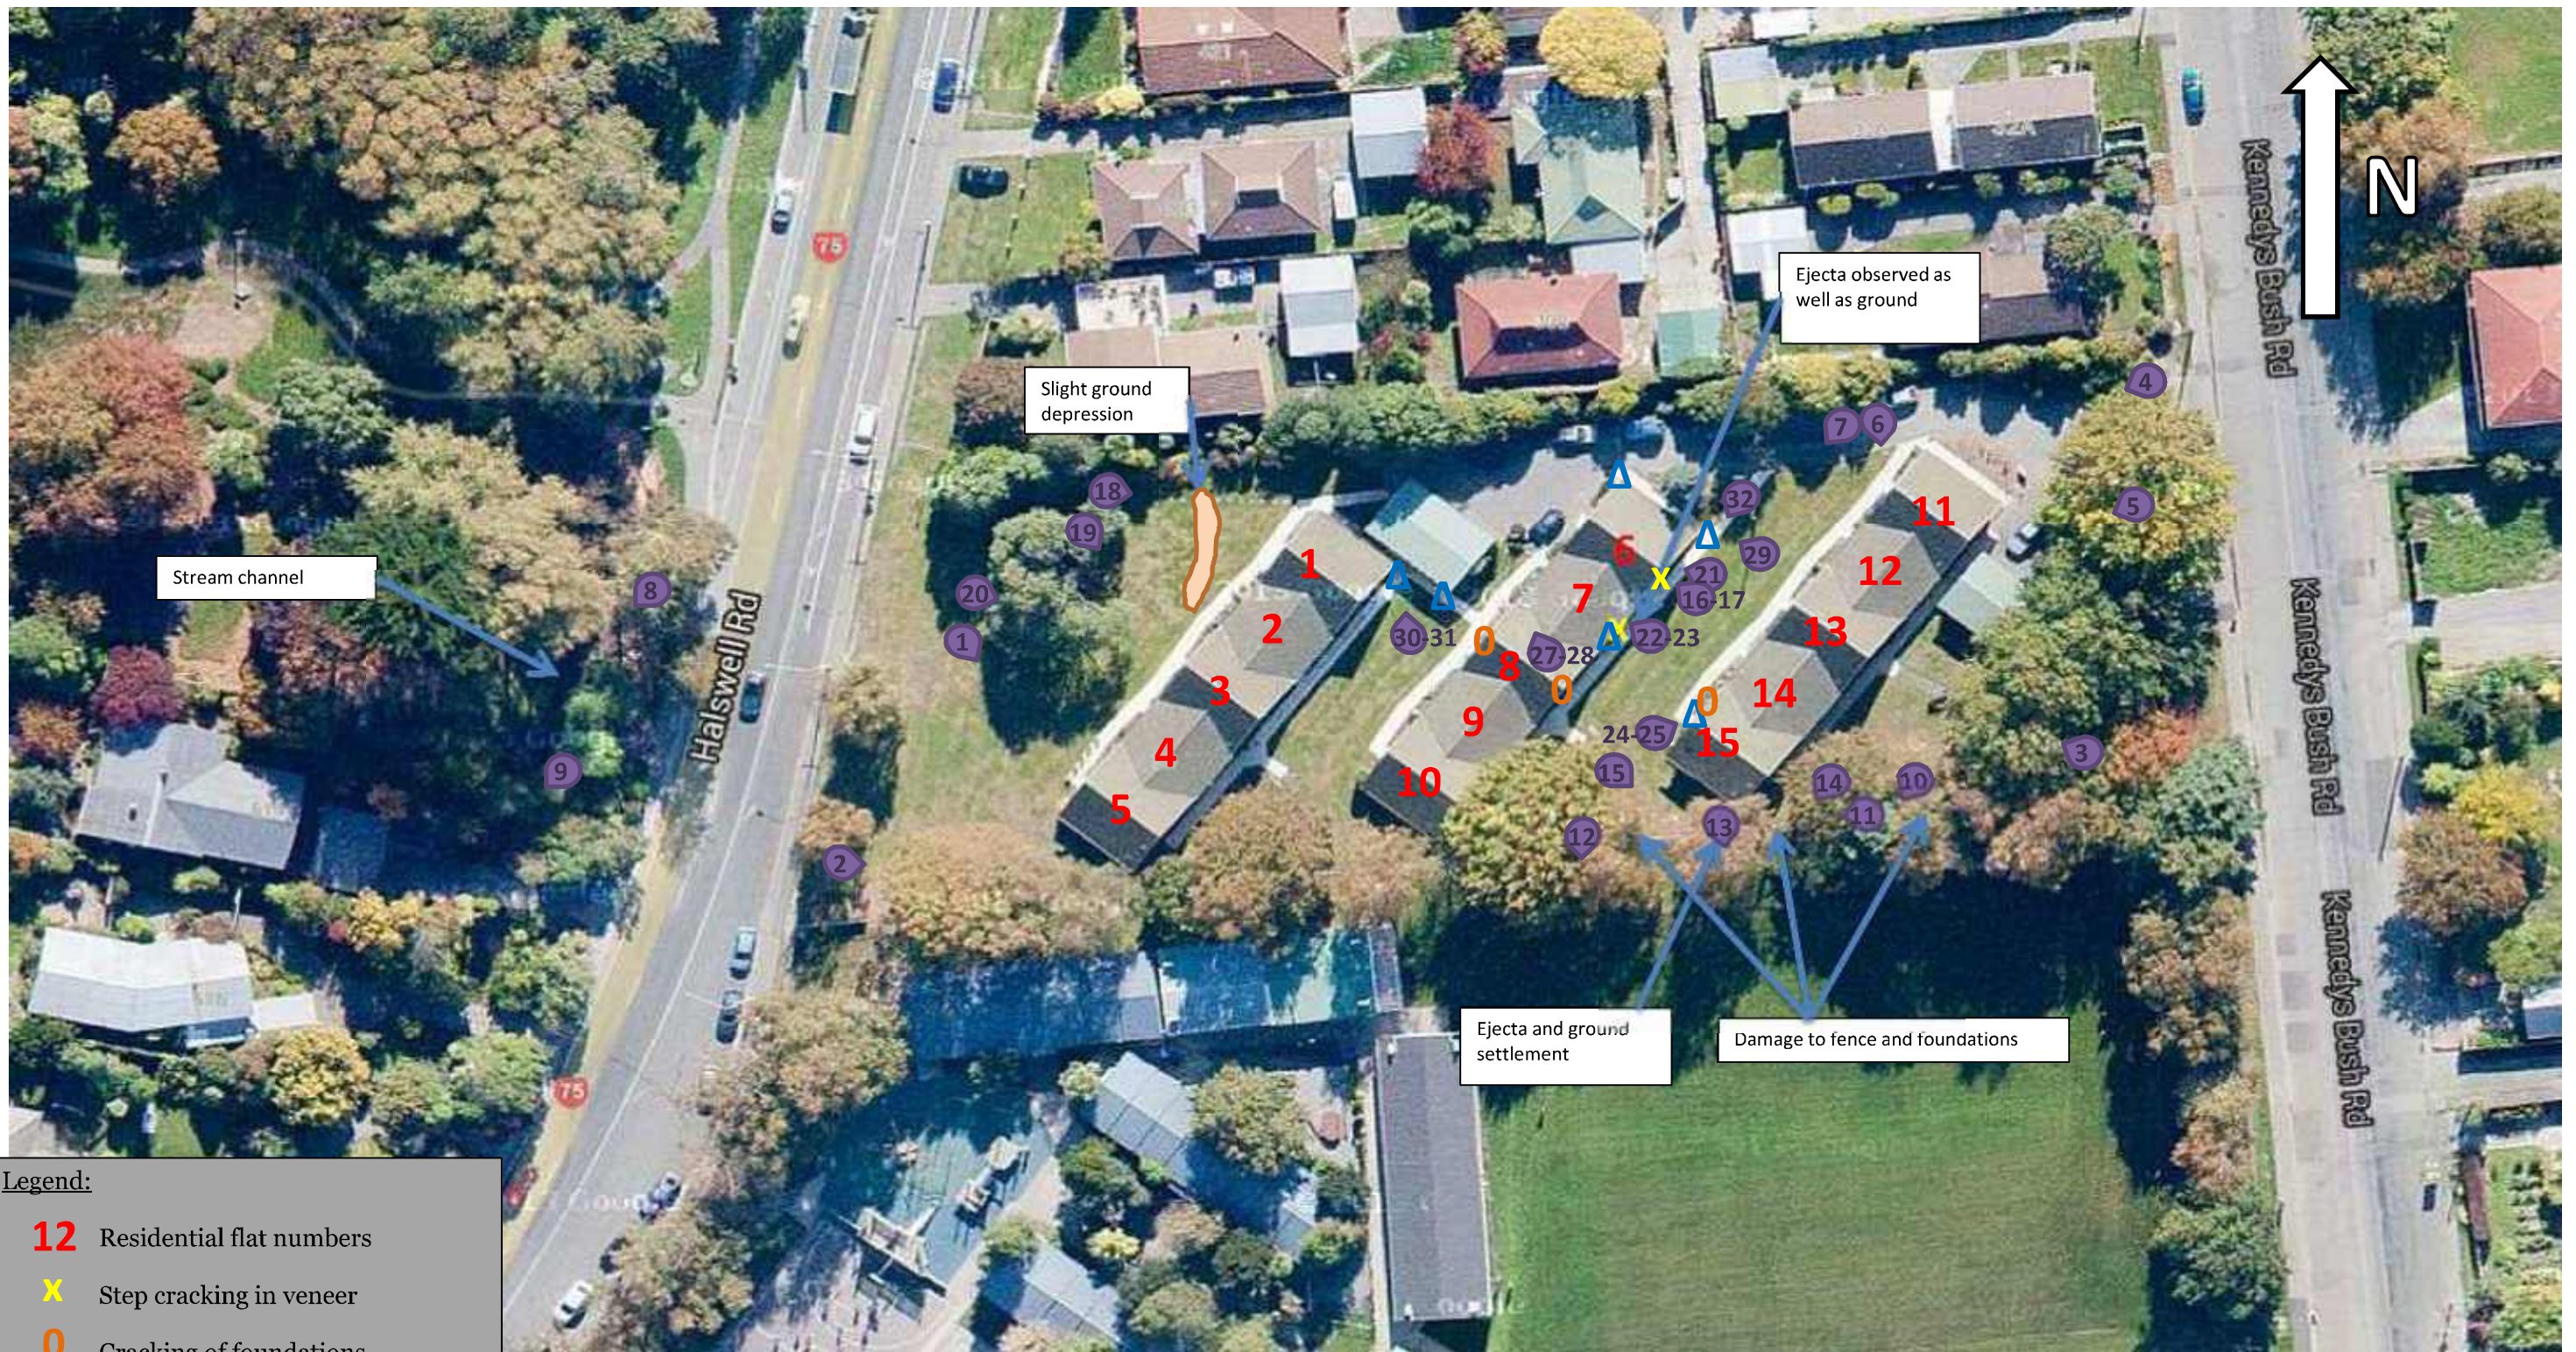
Figure 03: Site Walkover Plan

- Legend:**
- 12** Residential flat numbers
 - X** Step cracking in veneer
 - O** Cracking of foundations
 - Δ** Cracking of footpaths
 - 4** Approximate photo location and direction of view (refer to Appdx B for Photos)

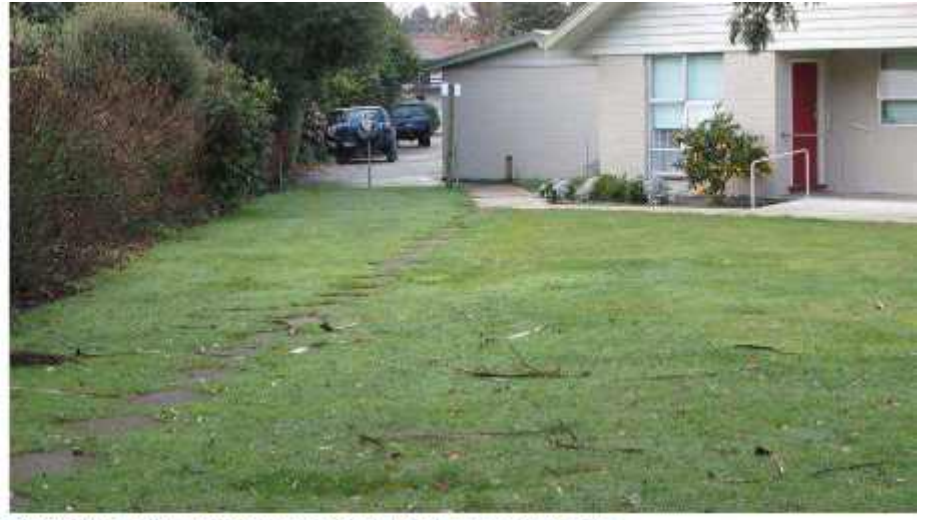
- Shallow ground depression in front of Flats 1-3 (refer to Photos 18 and 19 in Appendix B)

Photo 18: Shallow Depression in Front of Flat 1, Looking East
