Riccarton House

Detailed Engineering Evaluation Report

14th February 2012

Re: Riccarton House Detailed Engineering Evaluation

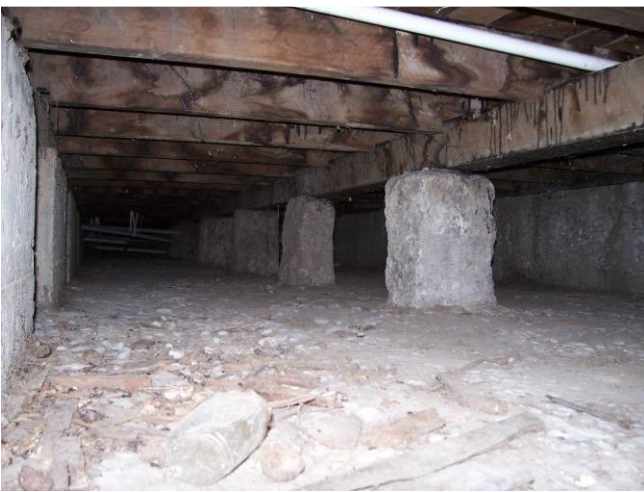
Subfloor space

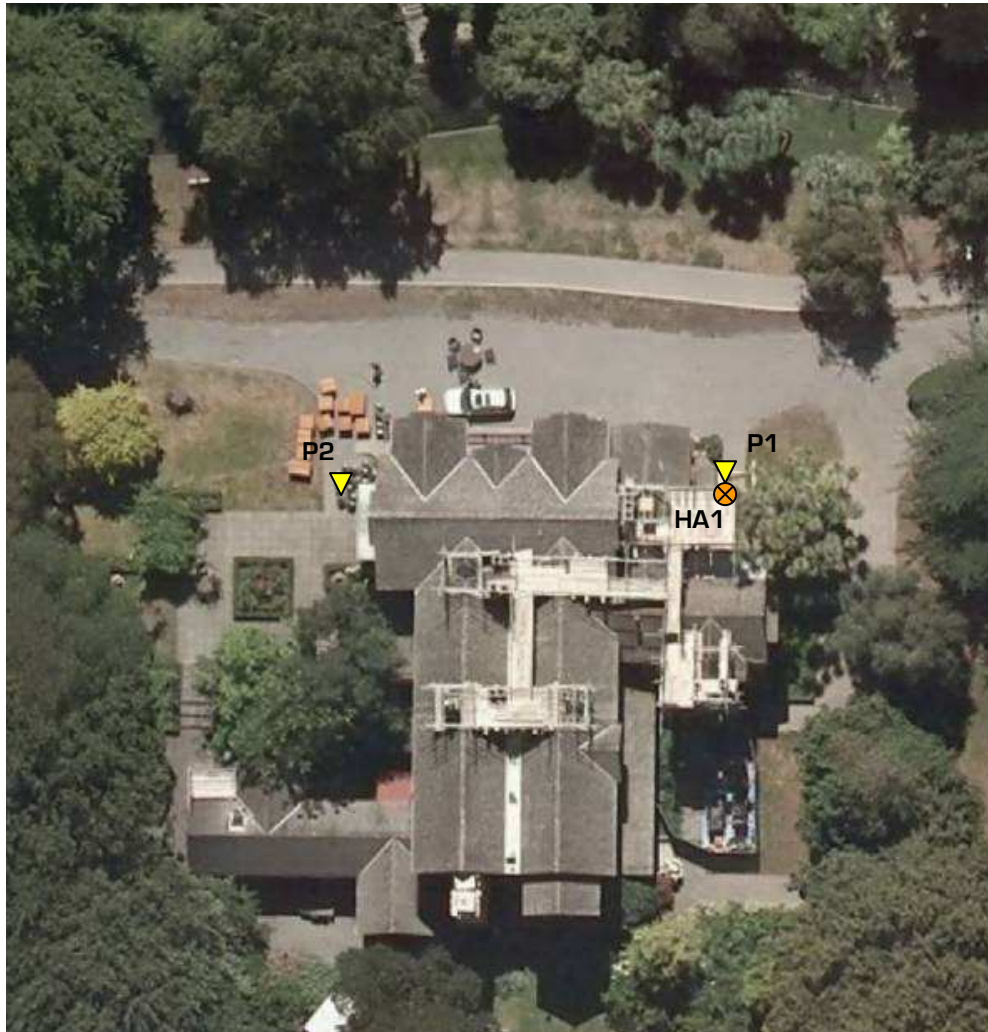
Figure 2: Investigation locations

The locations of the subsurface investigations are shown in Figure 2. Logs of the borehole and penetrometer tests are appended.
