# HP Smith Courts

## Detailed Engineering Evaluation Report

**Prepared for Christchurch City Council (Client)**

**By Beca Carter Hollings & Ferner Ltd (Beca)**

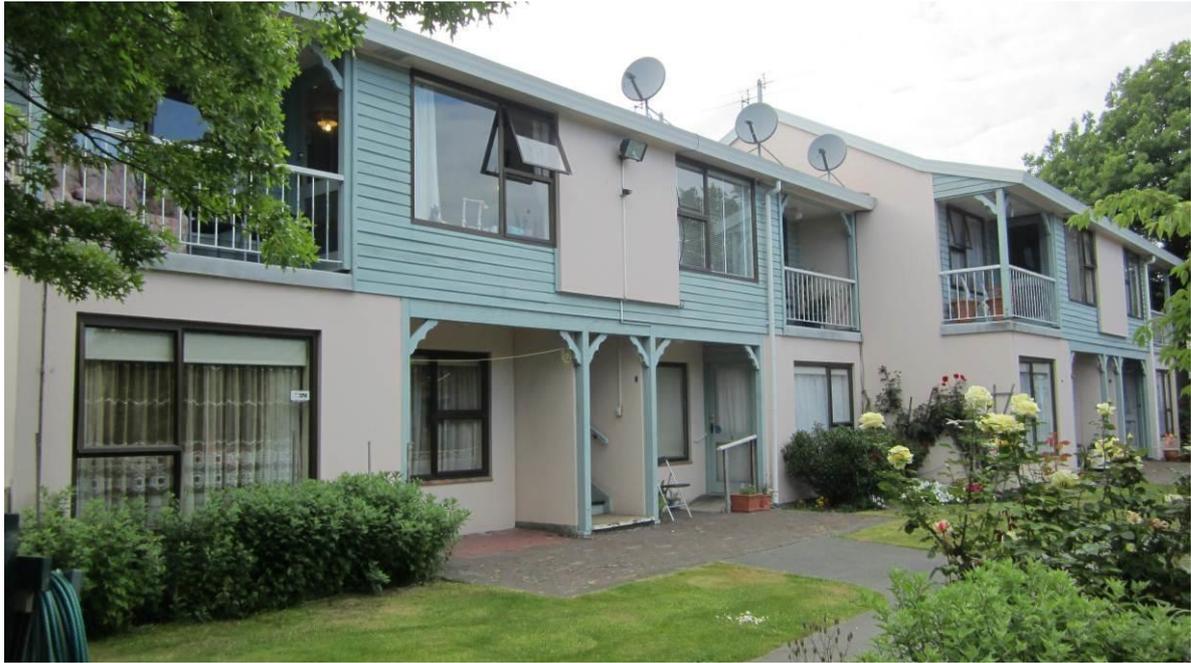
**Photo 1:** External view of Block A from north-west.

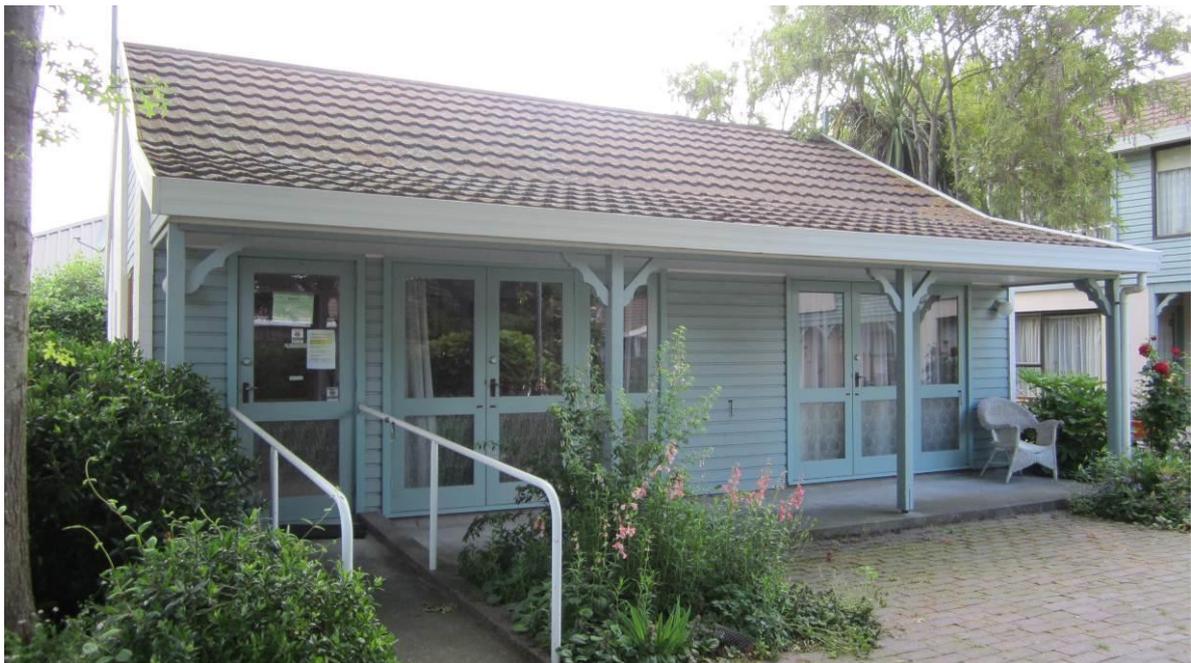
**Photo 2:** External view of Residents' Lounge from west.

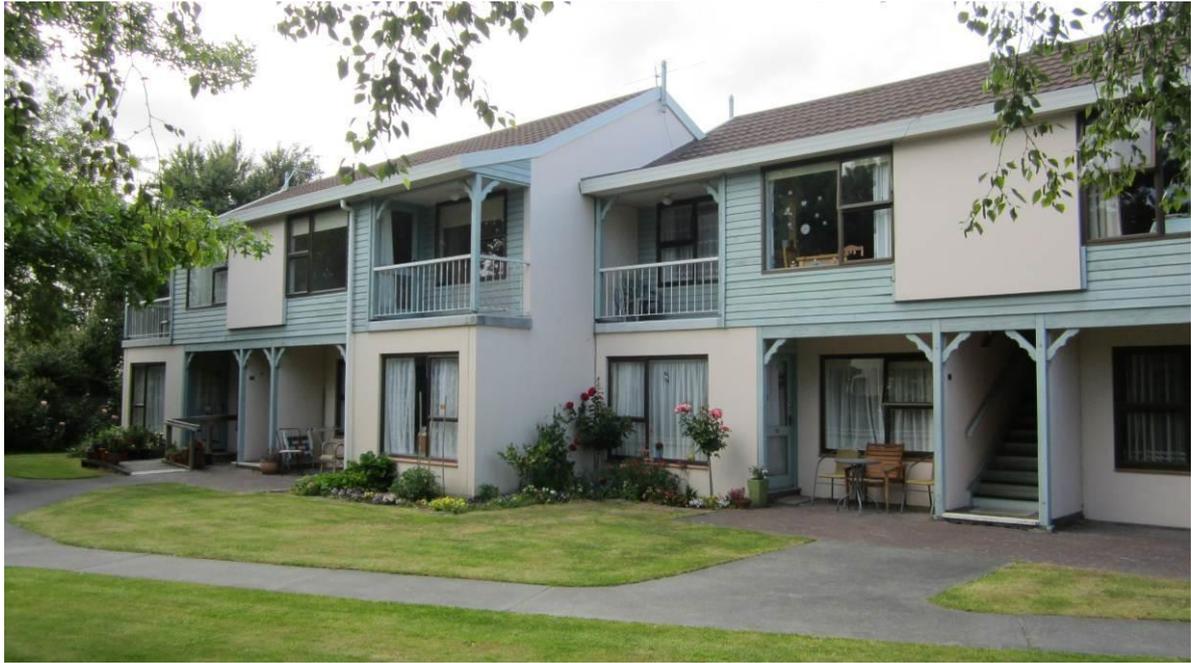
**Photo 3:** External view of Block B from north-west.

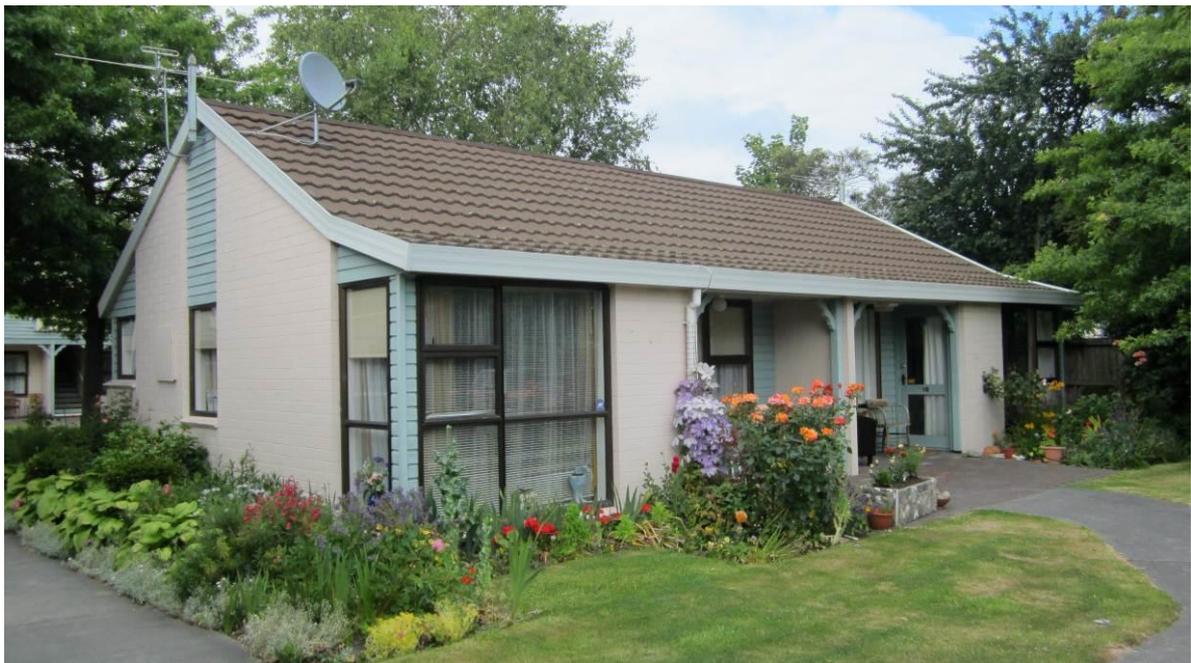
**Photo 4:** External view of Block C from north-east.

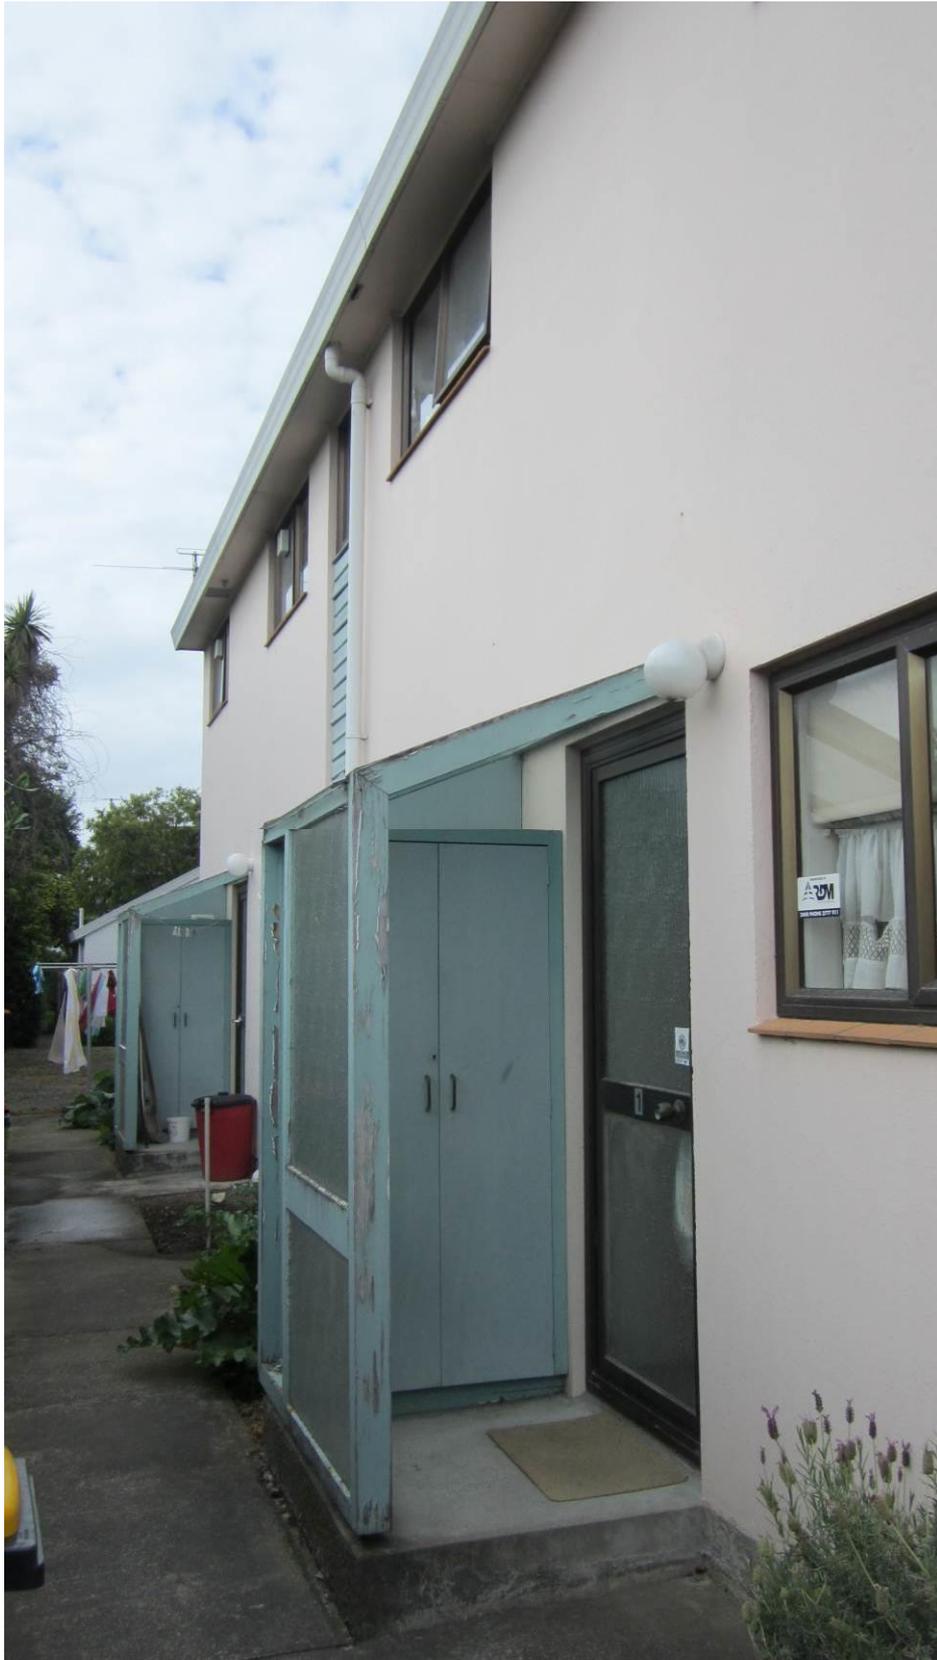
**Photo 5:** External view of rear of Block A from north-east. Details are typical for Block B also.

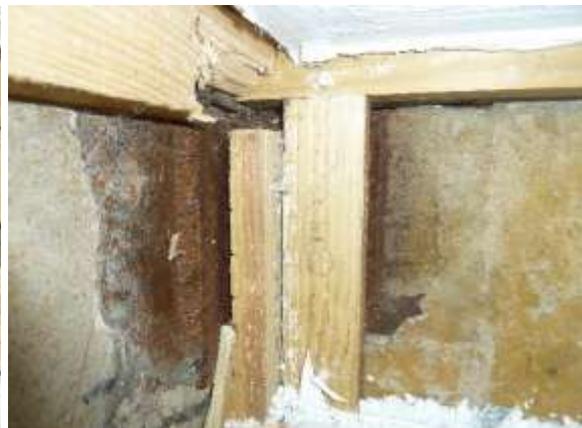
Unit 6 weld plate showing 2 welded sides

The drawing specifies that the weld is all round (implying at least 3 sides are welded). Block A has good contact between the cast in plate and the angle bracket. However the vertical alignment is such that only two sides of the bracket could be welded. In unit 4 the weld along the top was very small. There were no visible signs of damage in or around the weld plates.

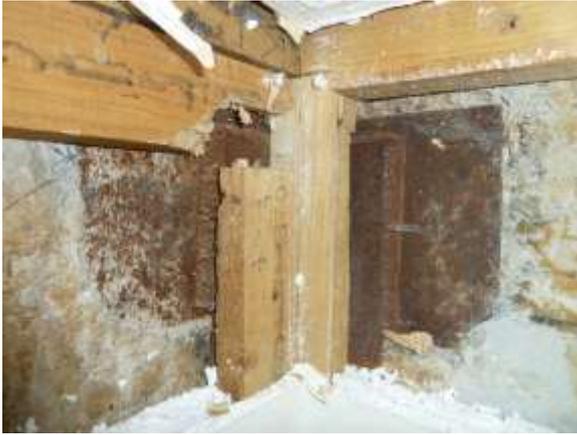
Unit 4 weld plate showing 3 welded sides
