# **Lyn Christie Place Complex BE 0727 EQ2**

**Detailed Engineering Evaluation  
Quantitative Assessment Report**

**30 Wildwood Ave, Wainoni, Christchurch**

Date: January 2013  
Reference: 6-QUCC2.13  
Status: Final

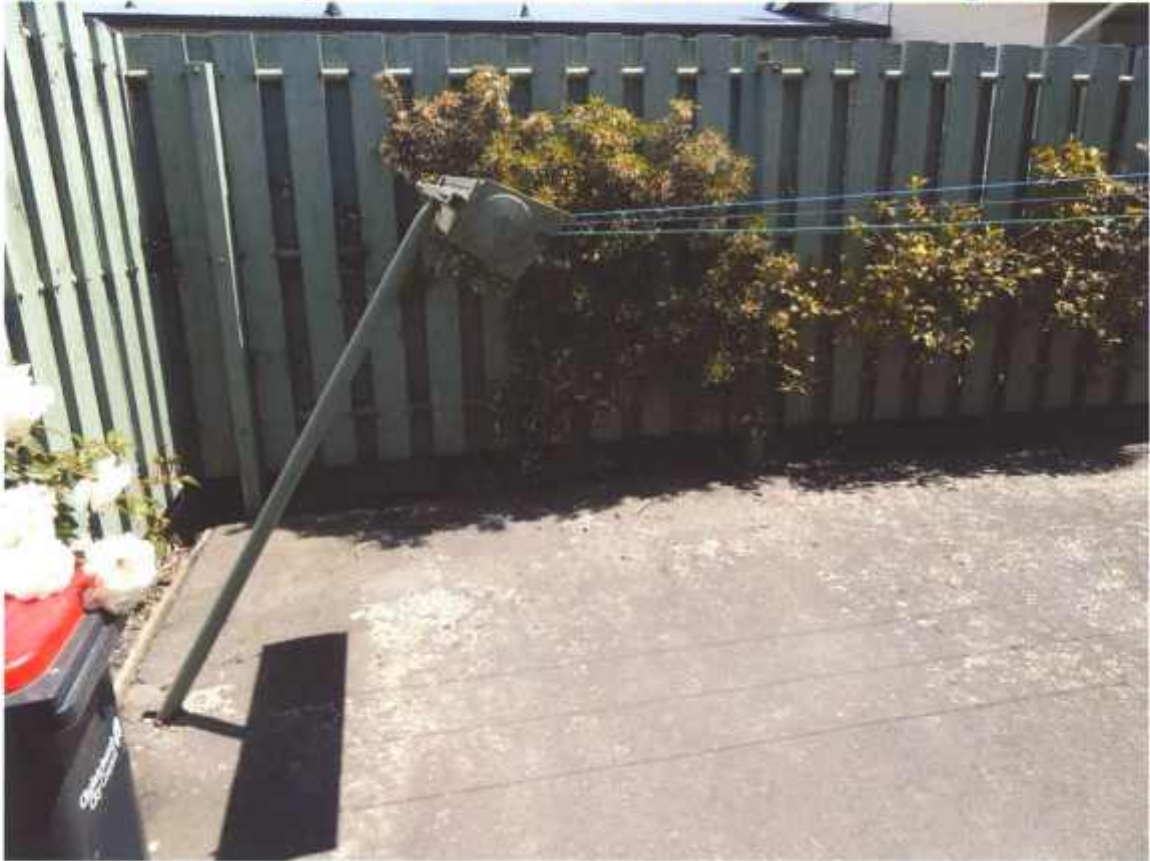
Figure 7 Rotation of the pole of the clothesline (west of unit No 2 Block A facing west)

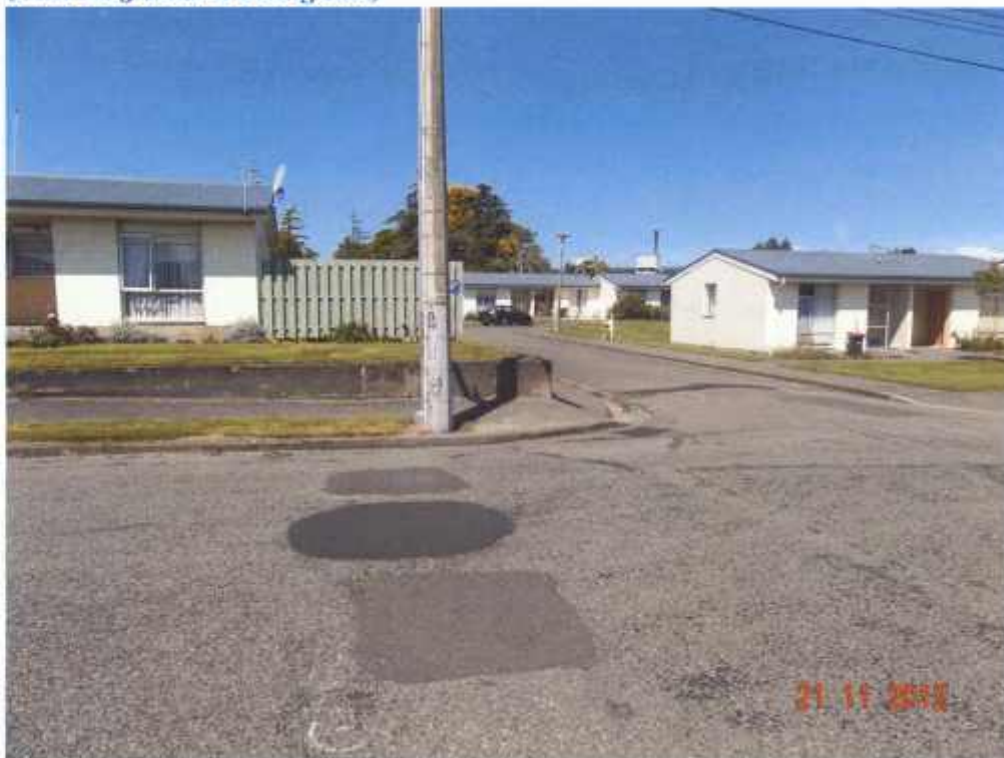
**Figure 14 Bend on the end of drive way facing east, various repair work of asphalt cracks  
(Unit No 3 block B facing east)**

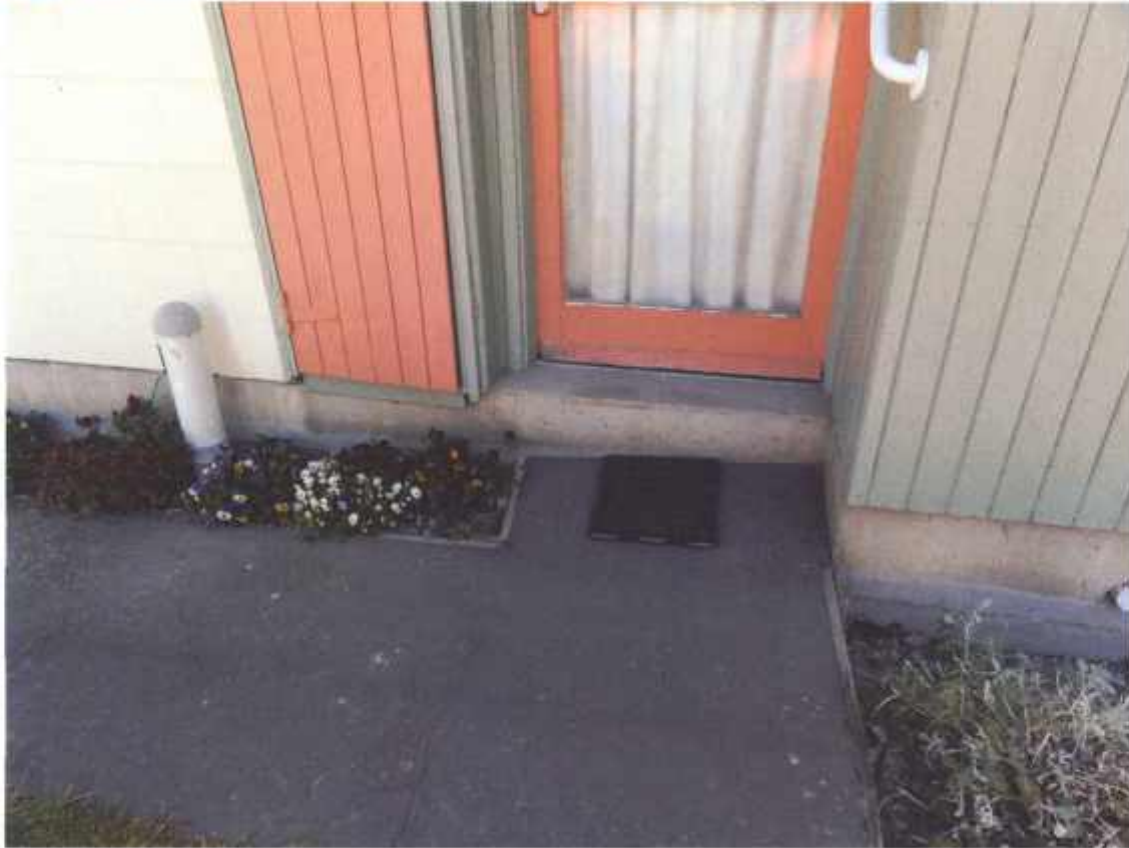
Figure 20 Differential settlement (total  $\pm 10$  cm) of doorstep unit No 5 Block B

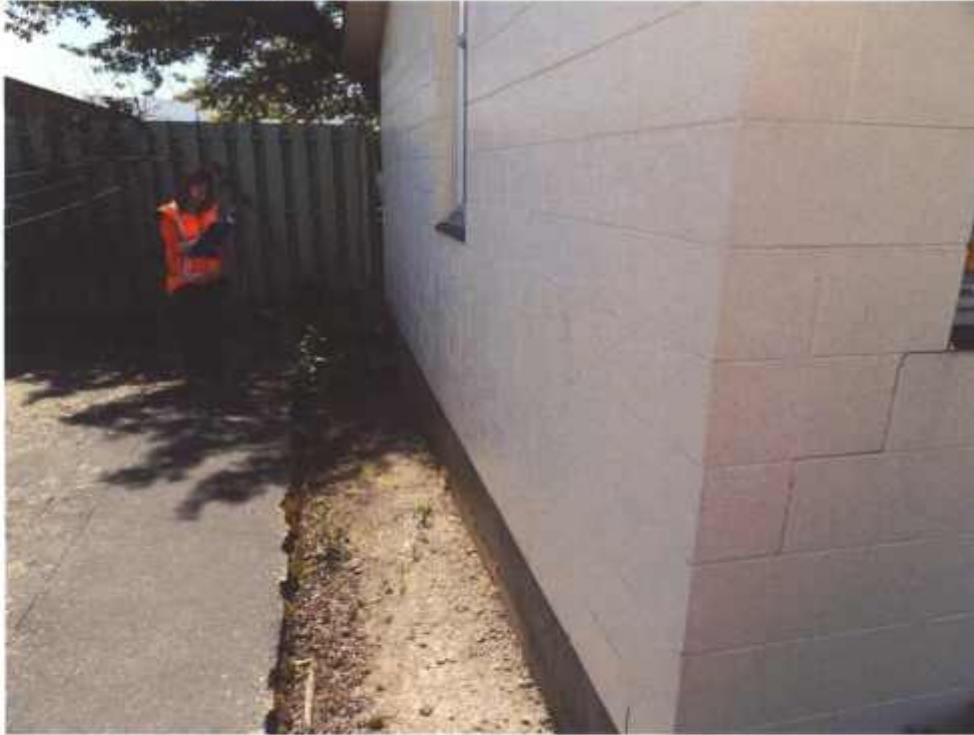
Figure 23 45 degrees crack visible in the mortar of the concrete masonry wall (south-east corner of unit No 3, facing west)

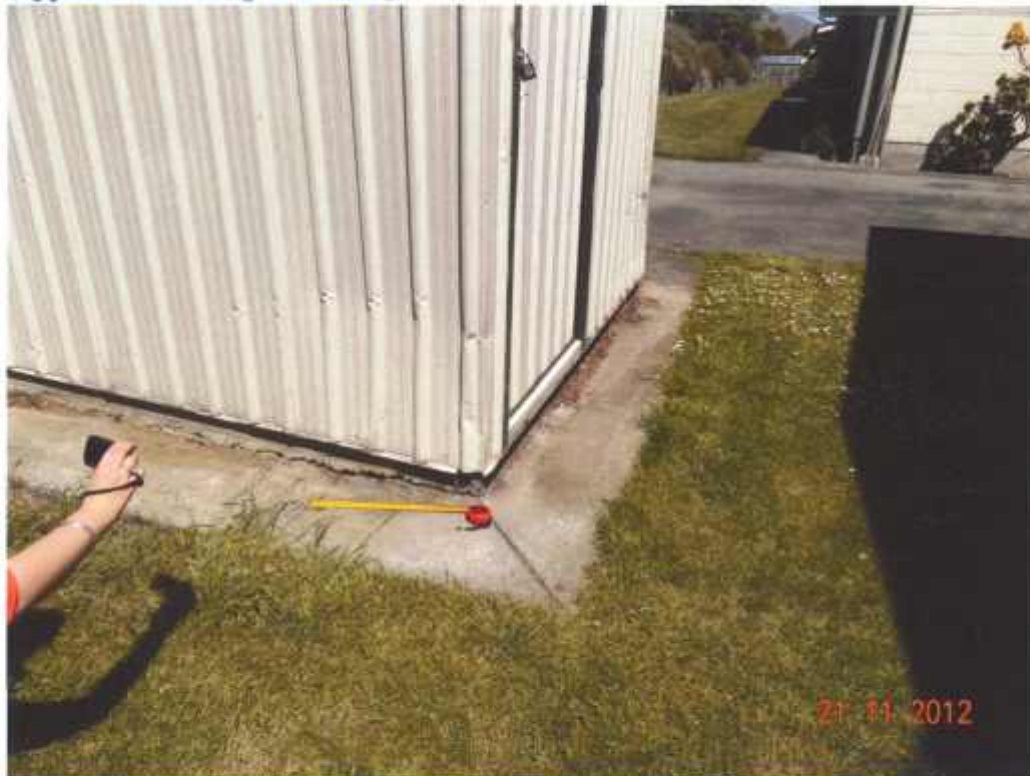
Figure 25 Settlement under west side of the mini-container, also cracks along the concrete (opposite unit No 13 of Block C)

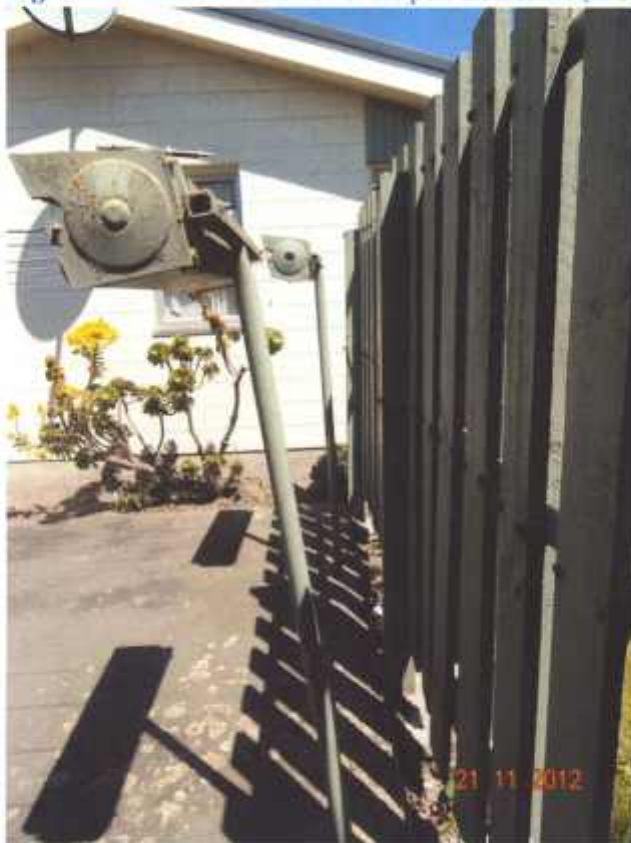
**Figure 26** Distinctive rotation of the pole clothesline (in between unit No 13 and No 14, block C and D)

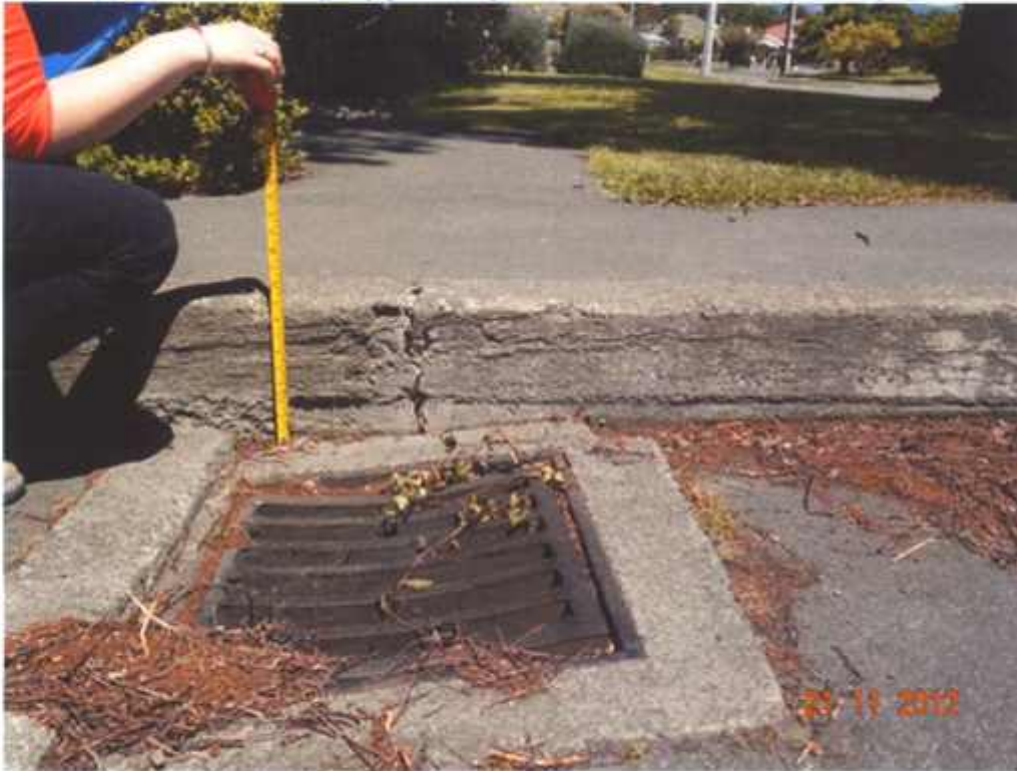
Figure 33 Rotation of the gully pot (car park north of unit No 7, Block B/C)

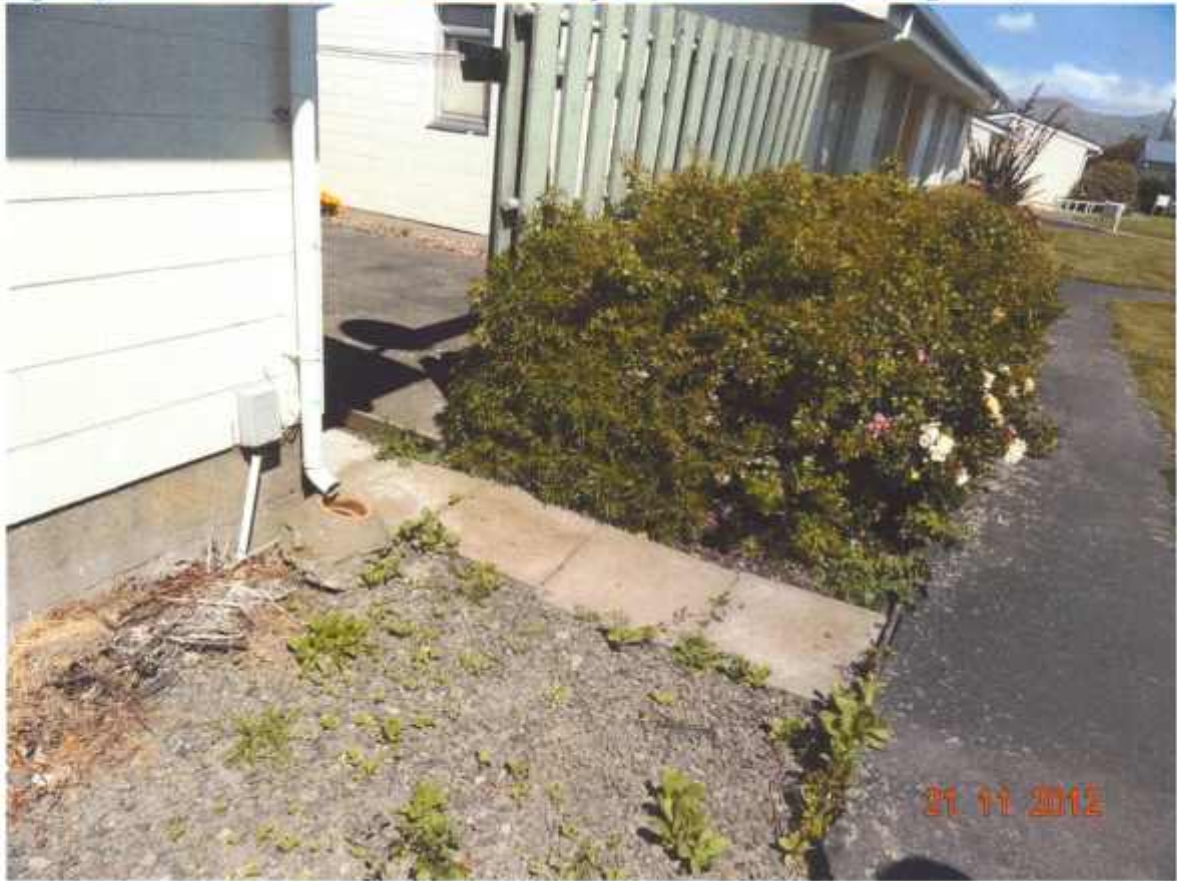
Figure 38 Settlement under the waste water trap (unit No 16 Block D, facing south)

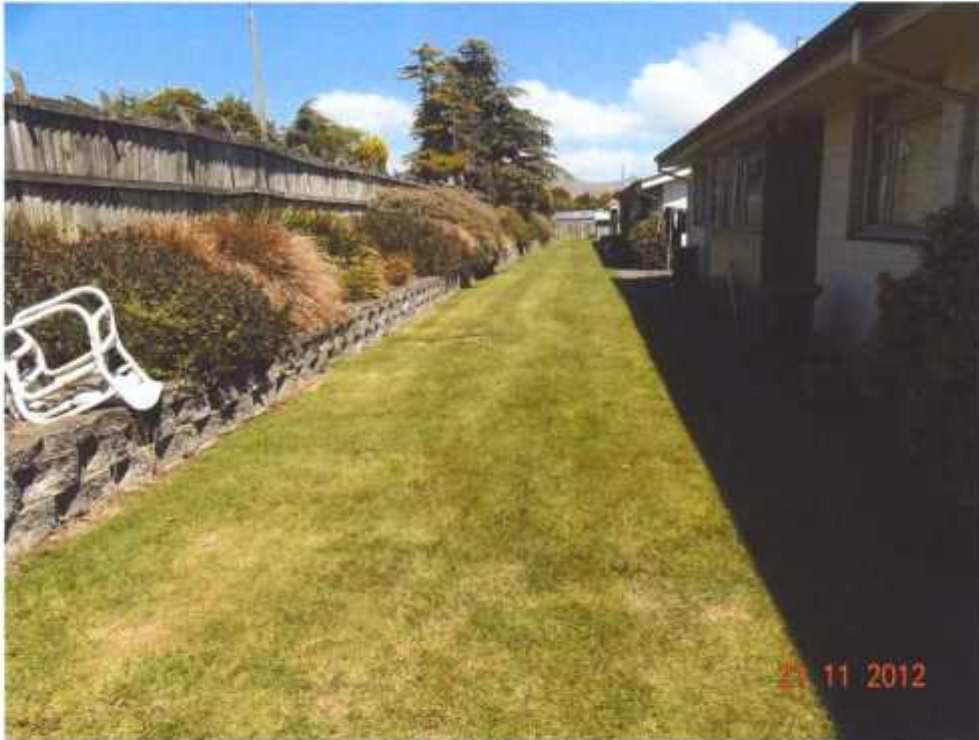
Figure 41 Retaining wall next to lawn, grass lawn is bumpy (east of block C – F facing south, no obvious visual indication of movement observed)

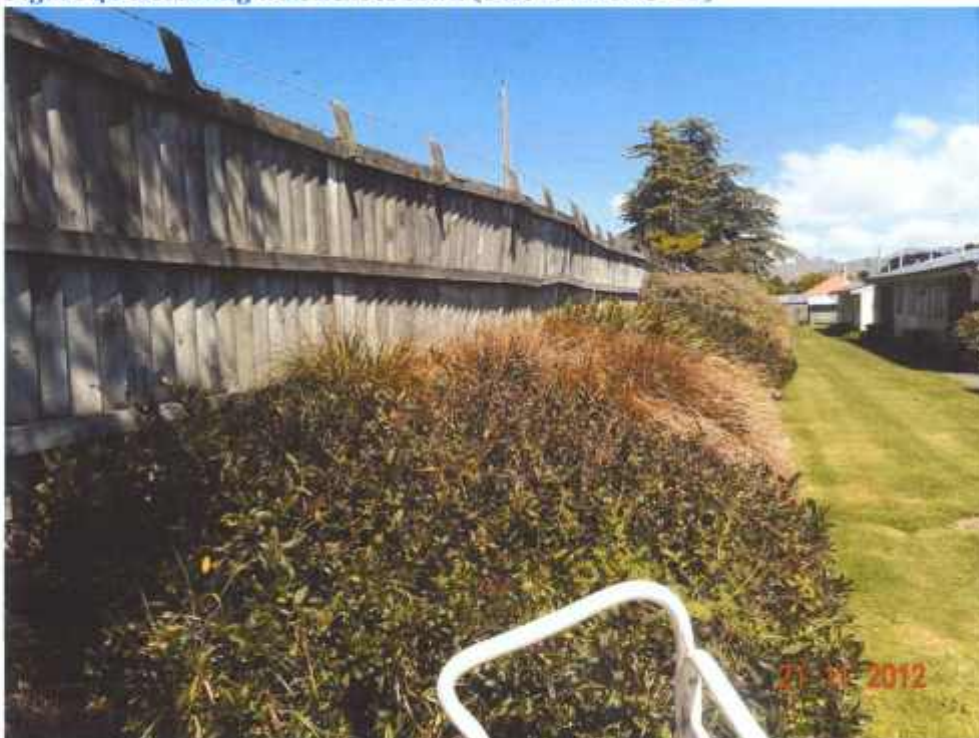
Figure 42 Retaining wall next to lawn (east of block C – F)

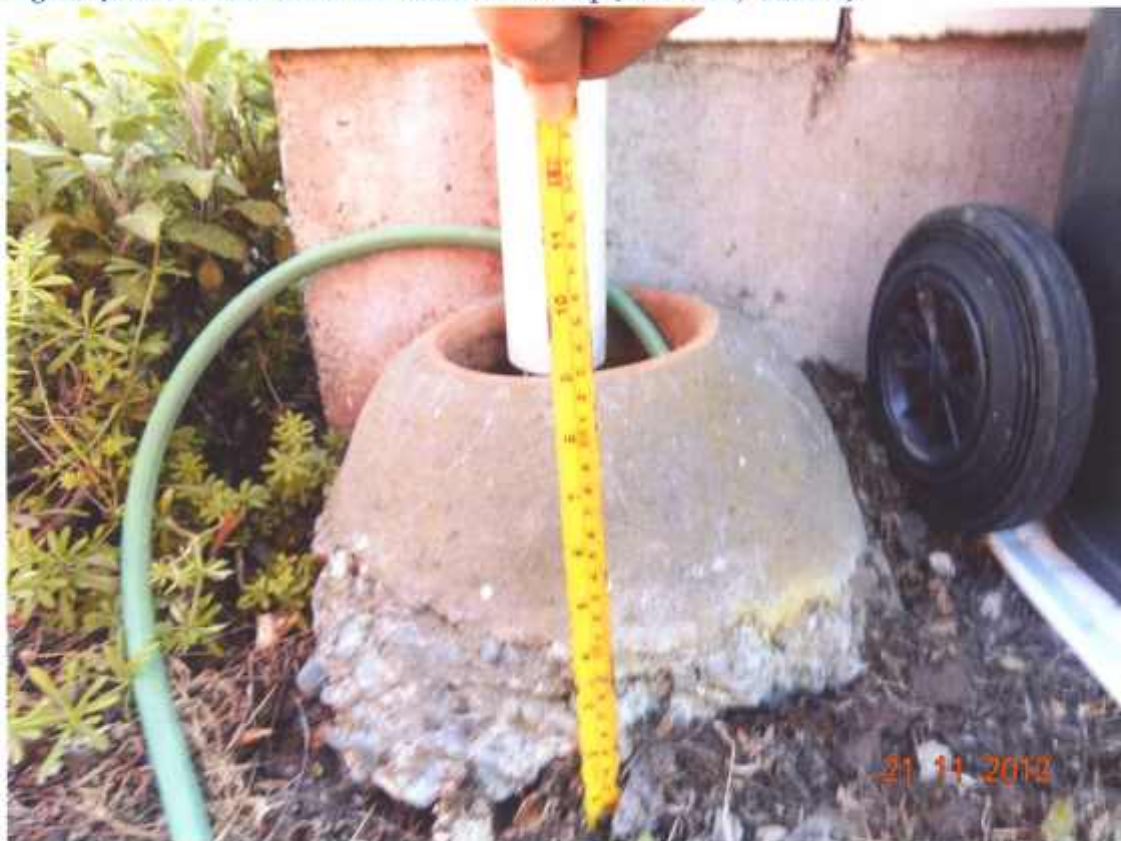
Figure 46 Settlement under the waste water trap (near no 17 block E)

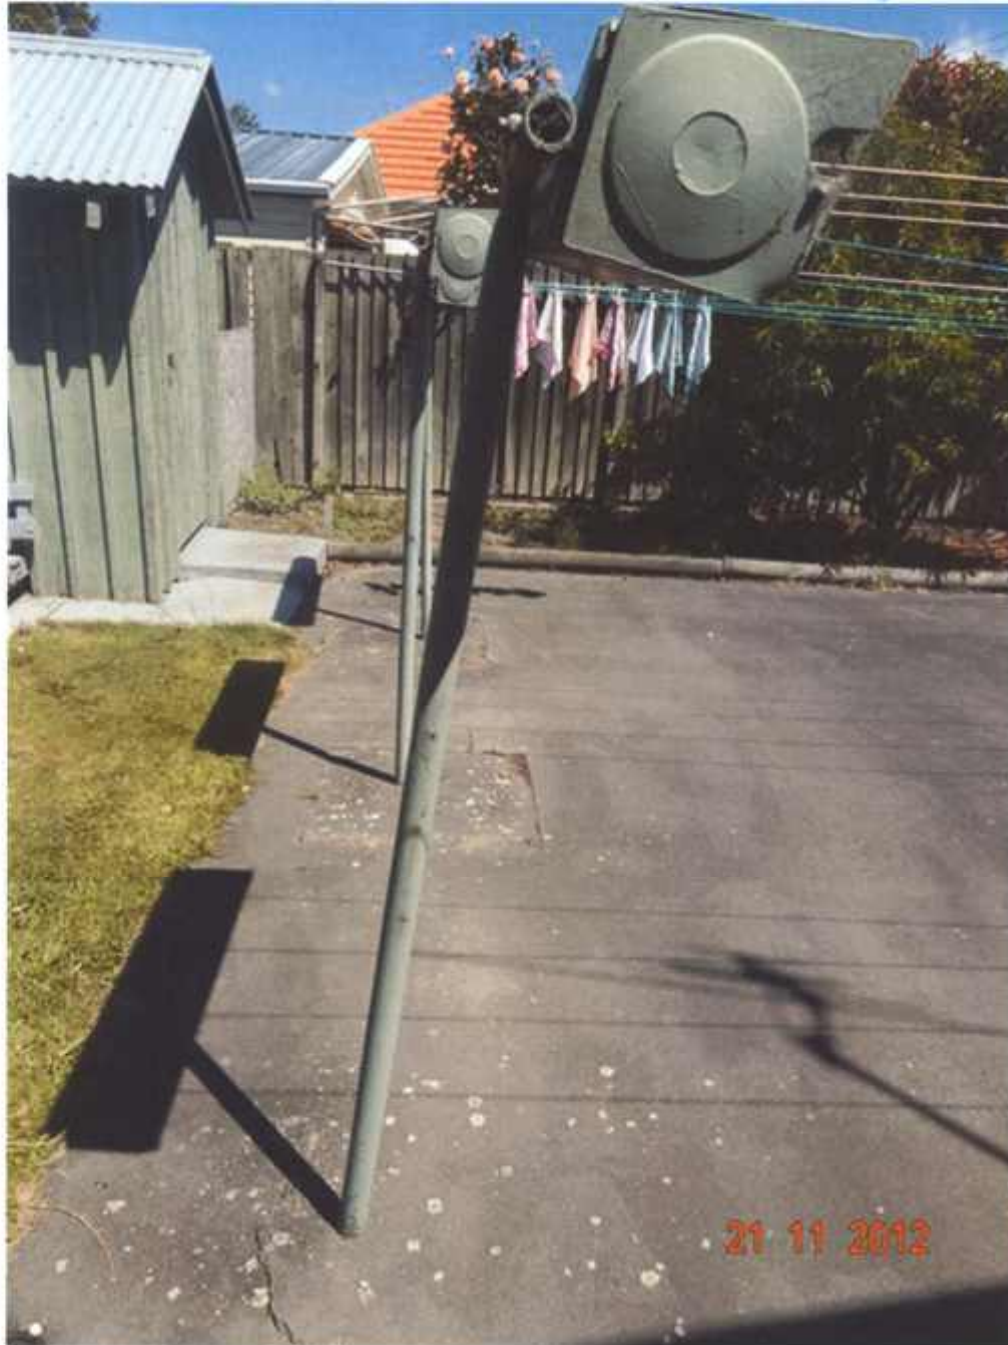
Figure 49 Rotation of the pole of the clothesline (No 23 of block F facing south)

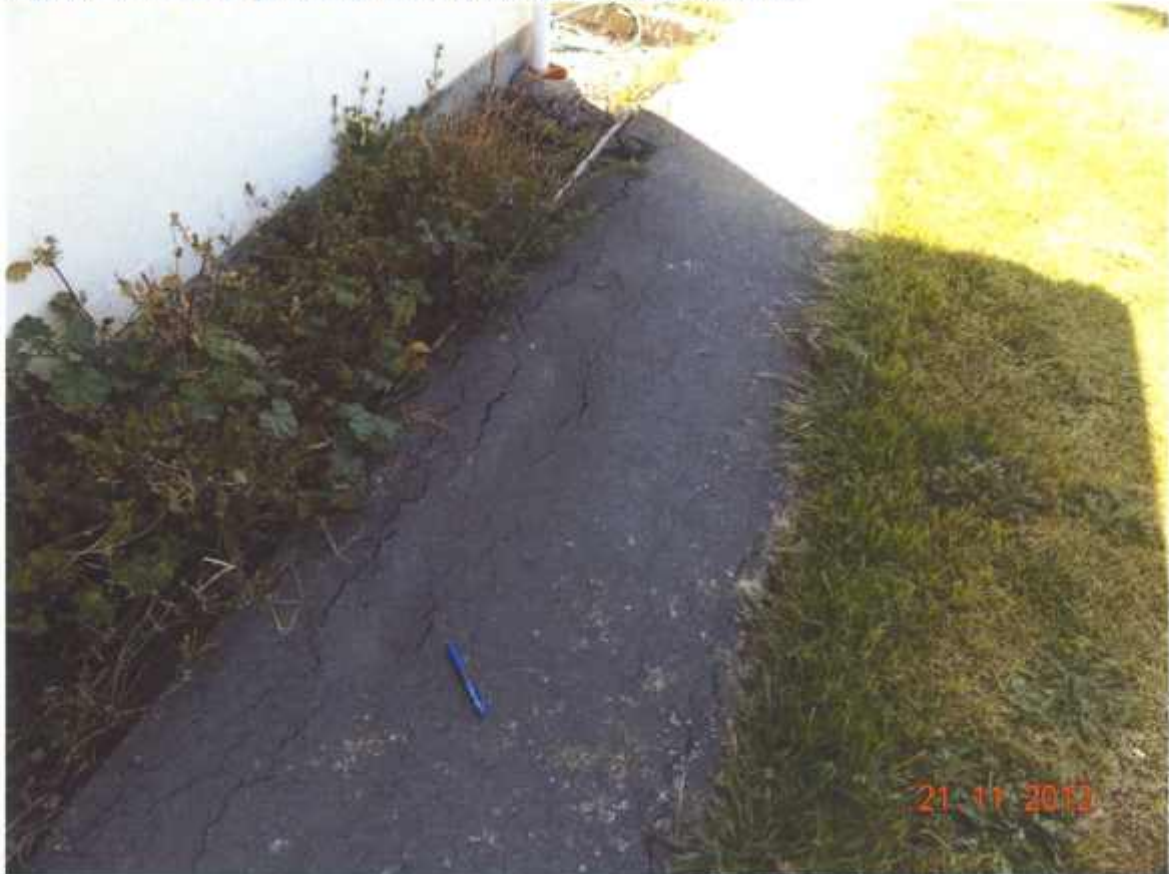
Figure 60 Cracks in pavement (next to No 29 and No 30 block H)
