# City Care Milton Street Depot – Works Operation Administration Detailed Engineering Evaluation BU 1141-003 EQ2 Quantitative Report

**Prepared for Christchurch City Council (Client)**

**By Beca Carter Hollings & Ferner Ltd (Beca)**

3 July 2013

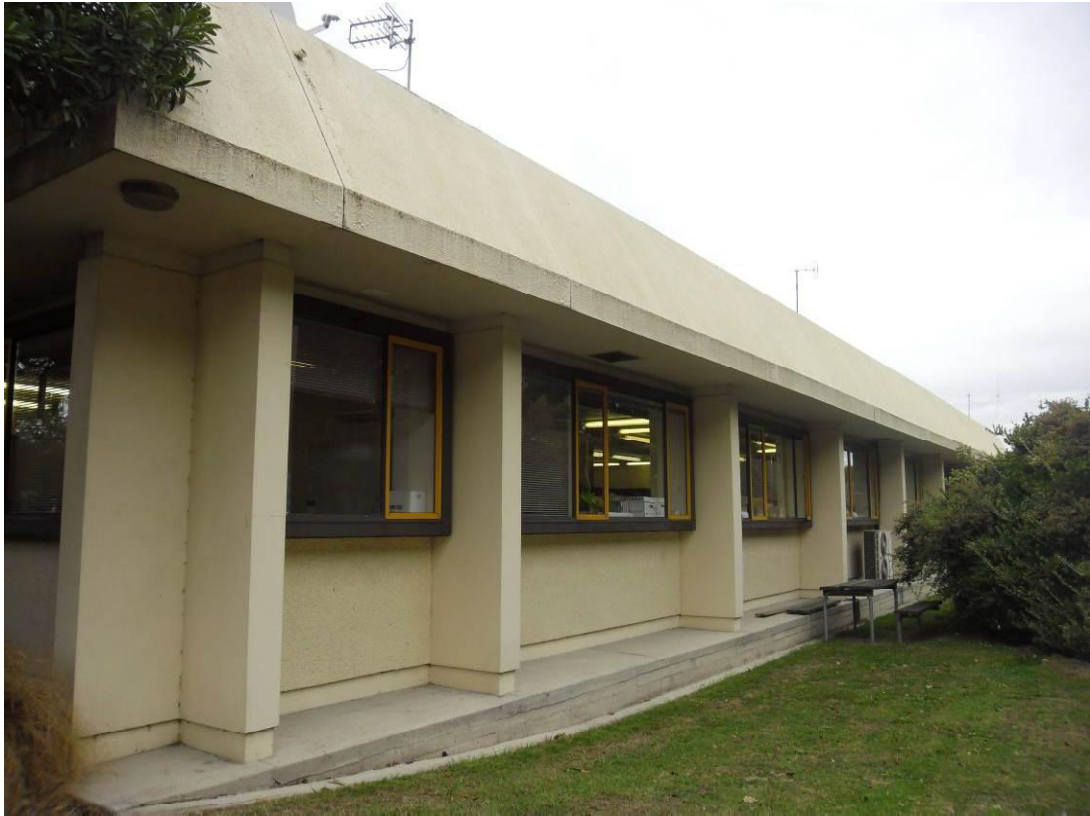
Exterior view of Works Operation Administration (north side)

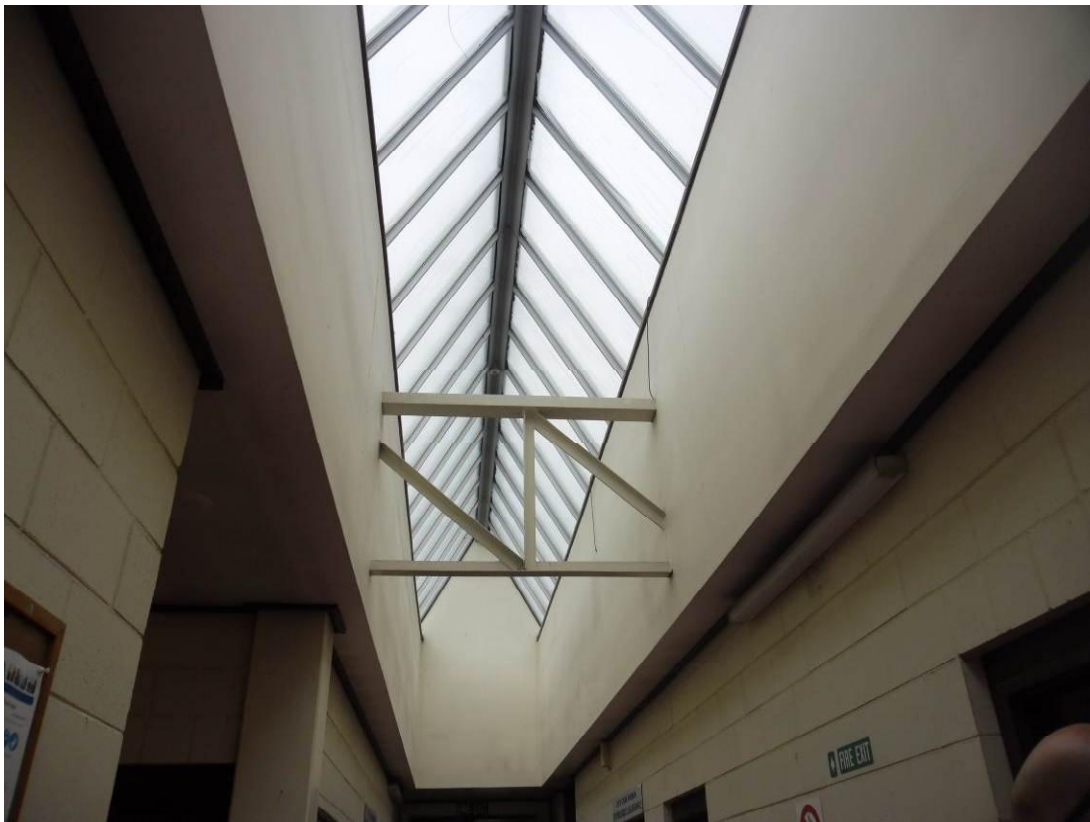
Interior view of Work Operation Administration
