CHRISTCHURCH CITY COUNCIL
PRK_1474_BLDG_001 EQ2
Scarborough Lifeboat Shed
2 Scarborough Beach

QUALITATIVE ASSESSMENT REPORT

- Rev B
- 25 January 2013

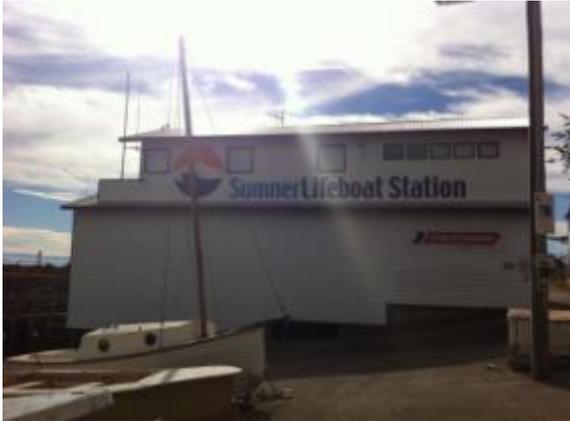
<p>Photo 1: South Elevation</p>	<p>Photo 2: East Elevation</p>

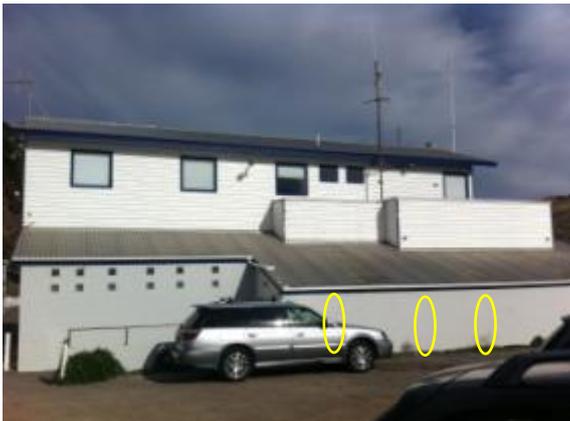
<p>Photo 3: North Elevation and Cracking to Block Wall</p>	<p>Photo 4: West Elevation</p>

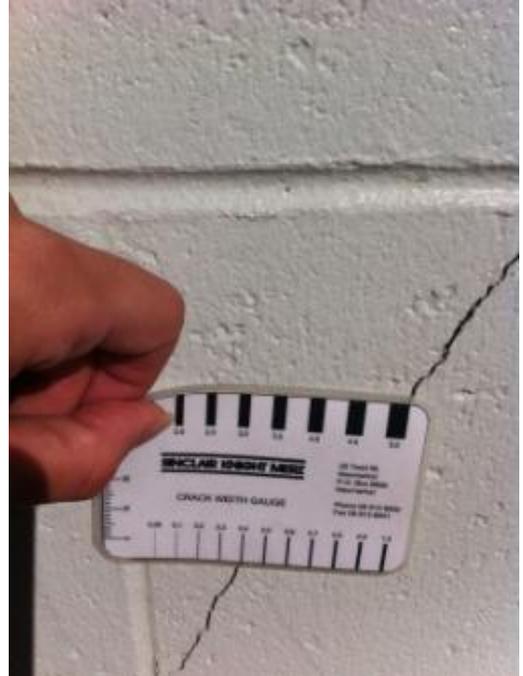
Photo 16: Close up of Photo 17

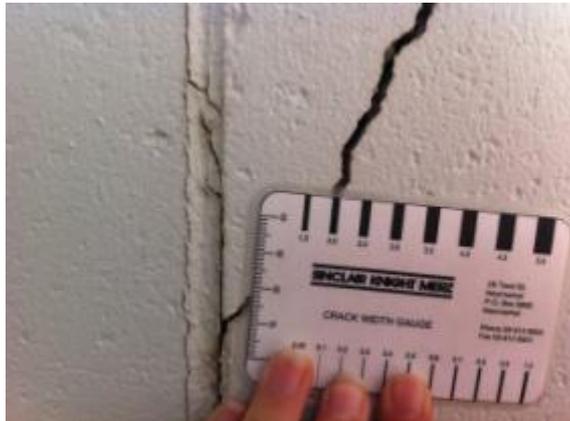
- 3) Various cracking present at the western end of the concrete block balustrade wall. Cracks range from 0.2mm – 1.0mm wide (PHOTO 17, 18 & 19). Cracking present along construction joint mortar where the concrete retaining wall and the northern block wall meet, crack width is approximately 5.0mm (PHOTO 20).

Photo 19: Close up of Cracking to Block Wall Balustrade

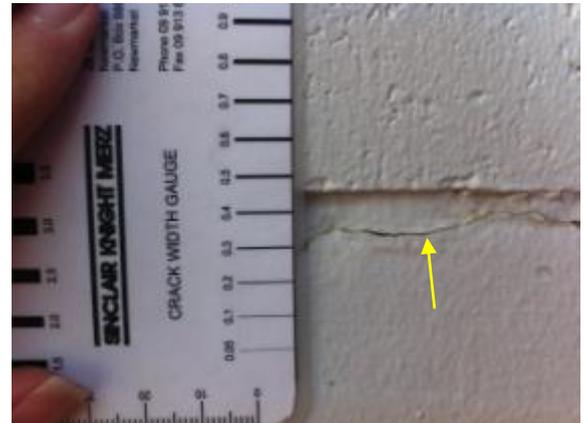
- 4) South side of Driveway: - Horizontal hairline cracking present along the concrete block and concrete foundation mortar joint, cracking continues around north-east corner (PHOTO 21 & 22).

Photo 22: Close up of Photo 21

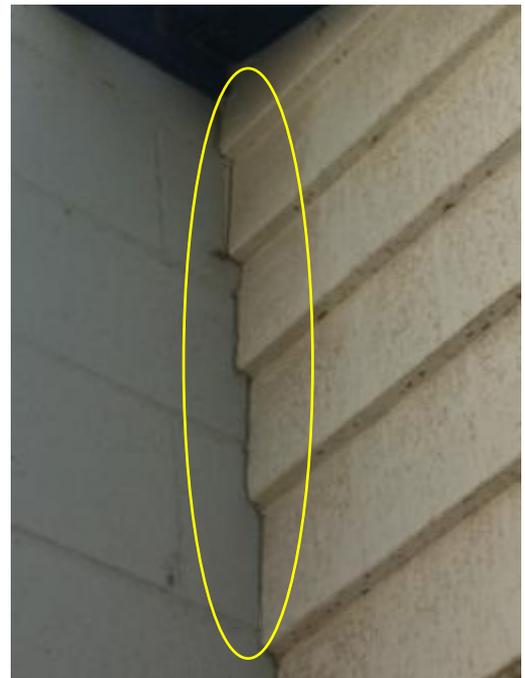
- 5) South side of Driveway: - Hairline cracking present along the block wall and timber wall joint in the northern corner (PHOTO 23 & 24).

Photo 24: Close up of Photo 23

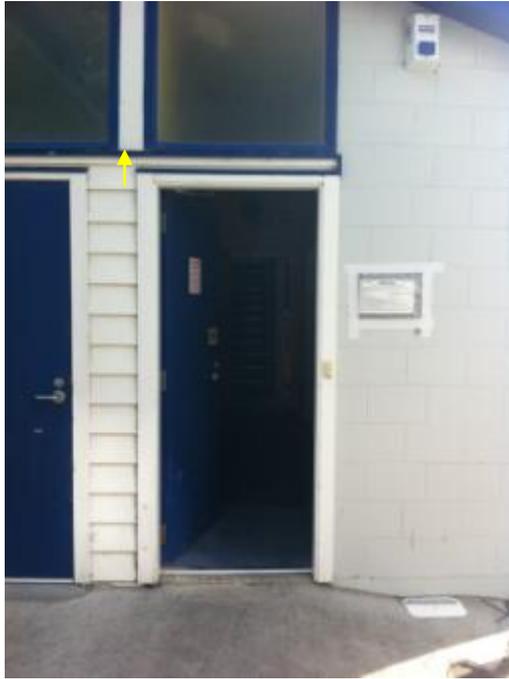
- 1) Vertical weatherboards joints have opened up above the eastern door. This type of damage is typical on all weatherboard clad walls (PHOTO 25 & 26).
- 2) Joints in timber door frame and architrave have opened up on the northern door (PHOTO 27).
- 3) Cracking and splitting present to the bottom weatherboard in the south-east corner. This appears to be existing damage that has been exacerbated by the earthquake. (PHOTO 28 & 29).
- 4) Hairline cracking around pipe penetration in the south-east corner (PHOTO 30 & 31).

Photo 25: Opening up of Joints in Weatherboards

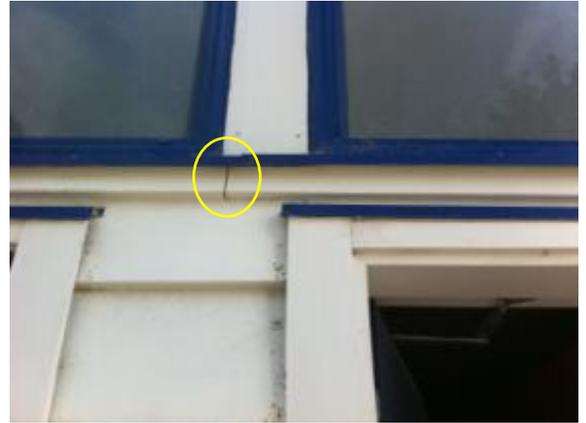
Photo 26: Close up of Photo 26

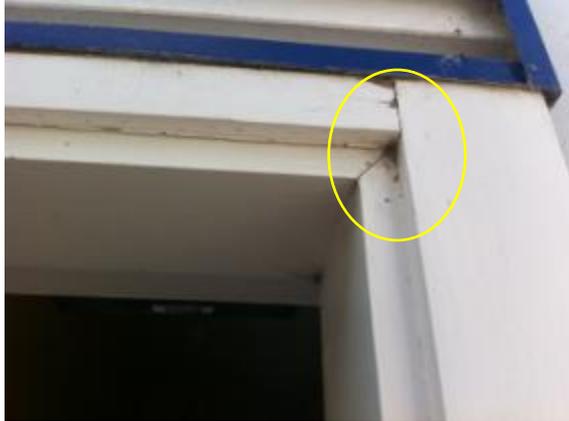
Photo 27: Timber Door Frame and Architrave Joints have Opened up

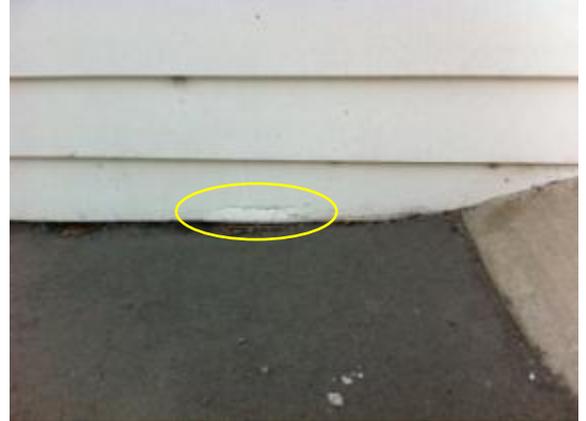
Photo 28: Cracking and Splitting of Weatherboard near SE Corner

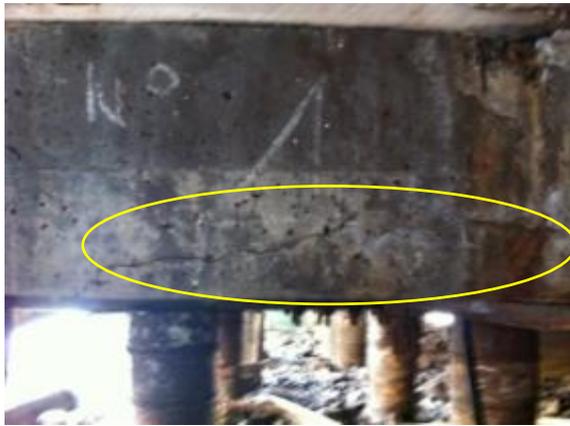
- 2) Minor spalling around cracking present in the middle of the 2nd concrete bearer from the east. Cracking was approximately 0.5mm wide. Note that not all bearers were checked for damage due to access and safety issues (PHOTO 34, 35 & 36).
- 3) Minor spalling and cracking present on the concrete pile located on the southern perimeter of the building, 2nd pile from the east. Cracking approximately 0.5mm wide. Note not all concrete piles were checked for damage (PHOTO 37 & 38).

Photo 35: Close up of Photo 34

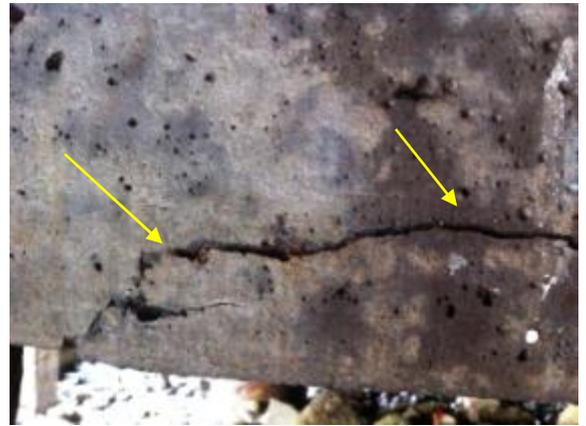
Photo 36: Close up of Photo 35

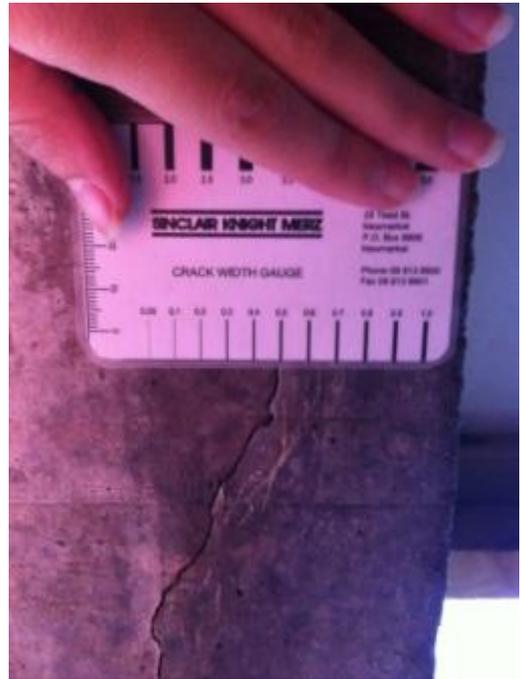
Photo 38: Close up of Photo 37

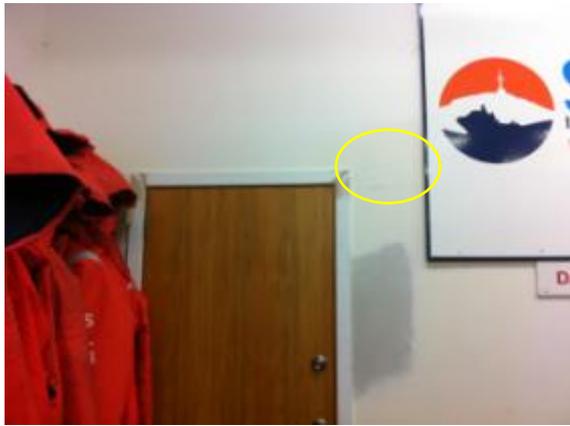
- Diagonal and horizontal cracks radiating out from the top corners of the northern door (PHOTO 51 & 52).

Photo 51: Cracking in Wall Lining above Door near NE Corner of Main Boat Shed

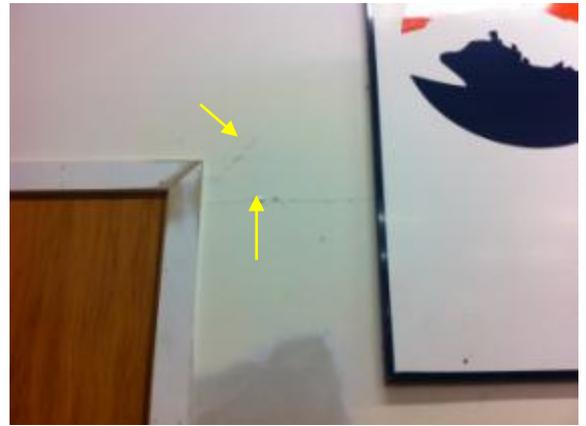
Photo 52: Close up of Photo 51

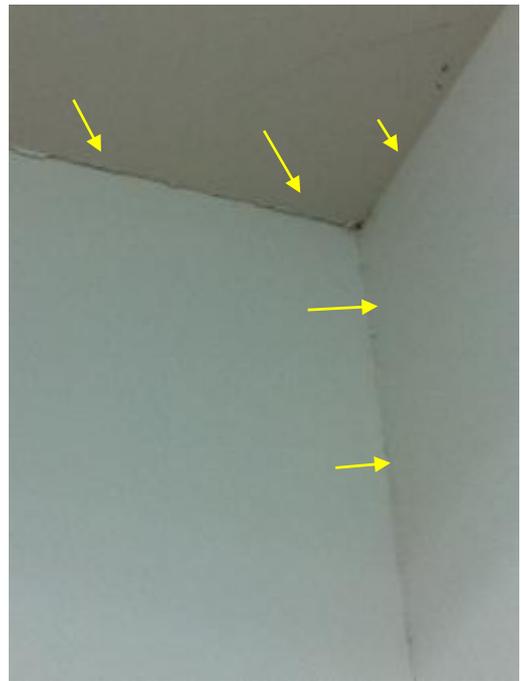
- Hairline cracking present along the lining joints in the north-east corner (PHOTO 53 & 54).
- 3) The following damage was observed on the north wall: -
- Vertical hairline crack at wall lining joint above personnel door (PHOTO 55).
 - Cracking present between the floor beam lining and both the ceiling lining and wall lining joints (PHOTO 56 & 57).
 - Hairline cracking at ceiling lining joints radiating out from the underside of the stairs (PHOTO 58).
 - Hairline cracking present around the steel UB portal column and the ceiling lining joint (PHOTO 59).

Photo 54: Close up of Photo 53

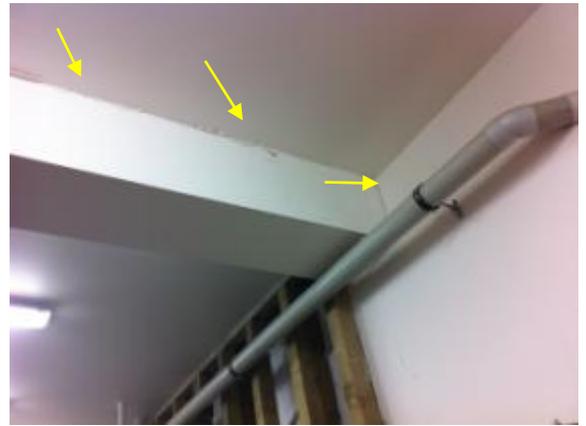
Photo 56: Cracking Between Floor Beam Lining and the Ceiling and Wall Lining Joints – North Wall of Main Boat Shed

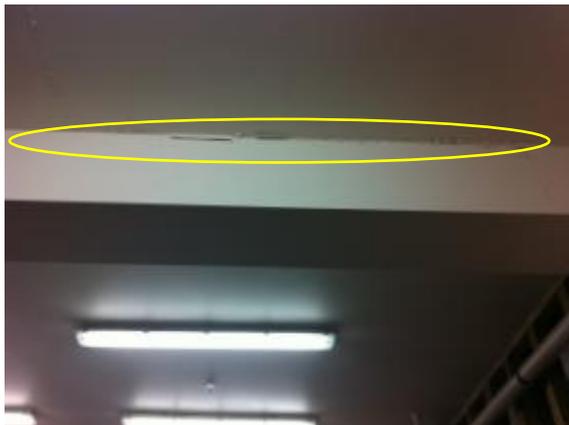
Photo 57: Close up of Photo 56

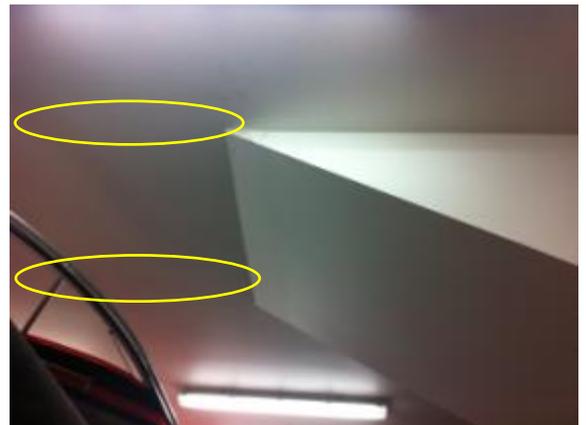
Photo 58: Hairline Cracking at Ceiling Lining Joints

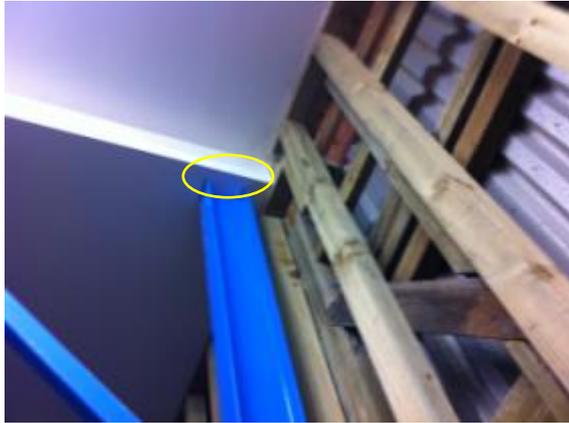
Photo 59: Hairline Cracking around Portal Column in Main Boat Shed

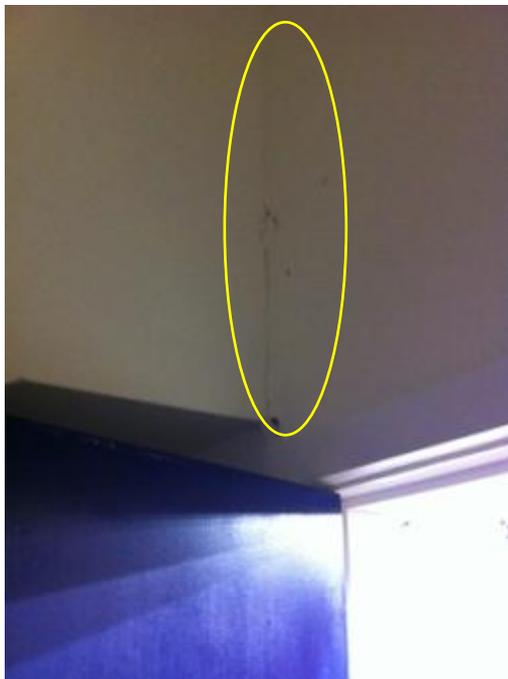
- 1) Hairline cracking at wall lining joint in the south-west and south-east corners (PHOTO 60, 61 & 62).
- 2) Diagonal cracking to wall lining at the stair re-entrant corner (PHOTO 63).
- 3) Vertical hairline crack at the wall lining joint located on the northern side of the east wall door (PHOTO 64).
- 4) Hairline cracking in wall linings radiating out from the top north corner of the east wall door (PHOTO 64).

Photo 61: Close up of Photo 60

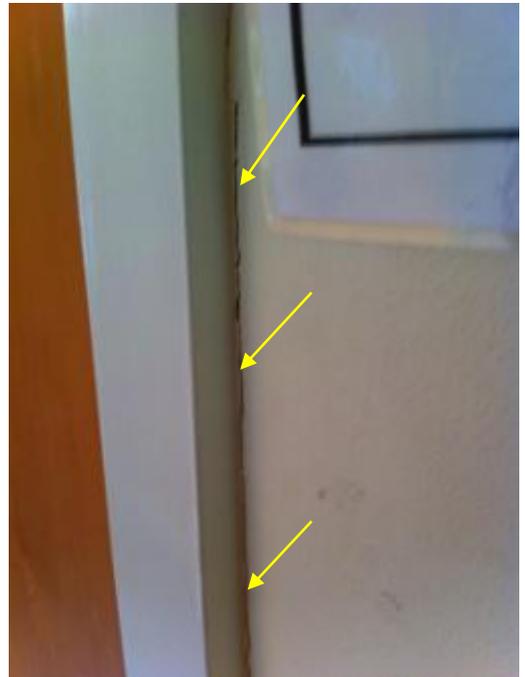
- 1) Cracking present along the timber stair skirting and the wall lining joint, typical (PHOTO 66).
- 2) Hairline cracking present between the main boat shed door architrave and the wall lining joint (PHOTO 67 & 68).
- 3) Severe diagonal cracking in the wall lining on the south wall (PHOTO 69, 70 & 71).
- 4) Horizontal hairline crack along wall lining joint on the north wall (PHOTO 72 & 73).
- 5) Vertical crack in wall lining near the north-west corner of the mid-height stair landing (PHOTO 74).
- 6) Vertical hairline crack in wall lining joint on the east wall of the mid-height stair landing (PHOTO 75).
- 7) Hairline cracking around ceiling bulkhead and the wall lining in the south-east corner of the mid-height stair landing (PHOTO 76).

Photo 68: Close up of Photo 67

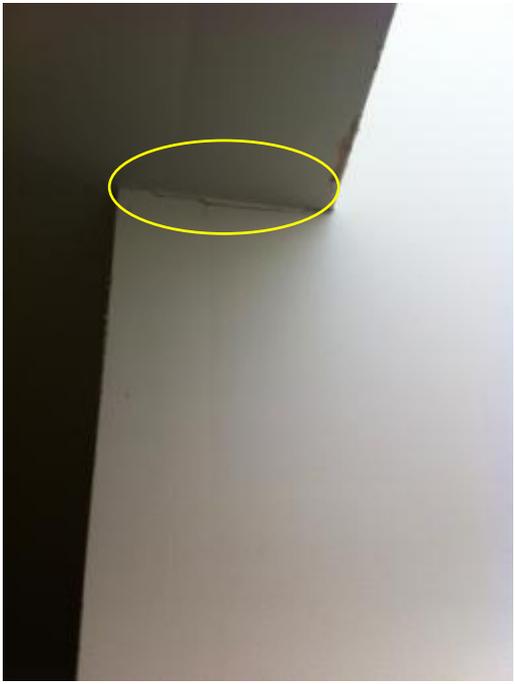
<p>Photo 75: Vertical Crack at Wall Lining Joint on East Wall of Mid-Height Stair Landing</p>	<p>Photo 76: Hairline Cracking around Ceiling Bulkhead and Wall Lining Joint</p>

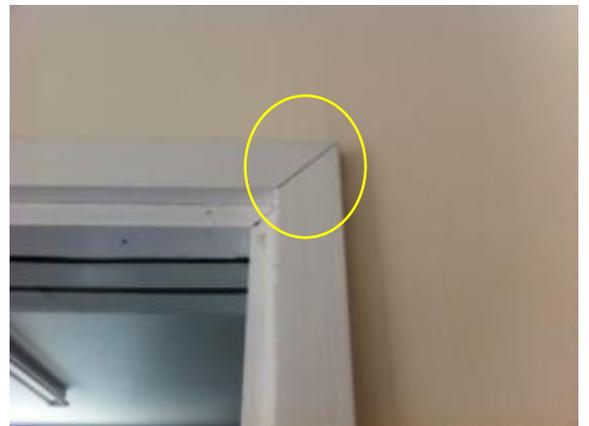
Photo 80: Close up of Photo 79

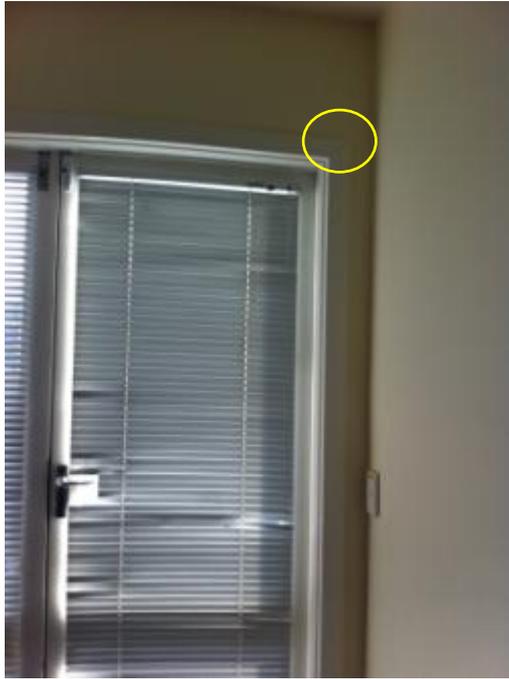
Photo 81: Mitre Joints on Window and Door architraves in the Kitchen have Opened up

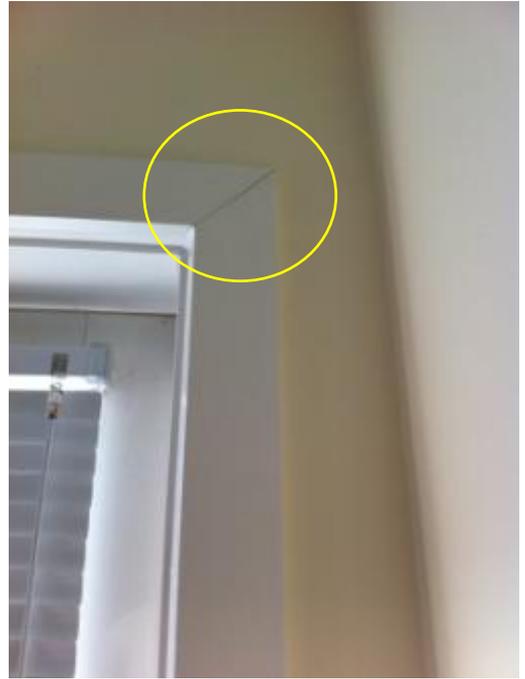
- 1) Mitre joints on the west wall door and window architraves have opened up (PHOTO 81 & 82).
- 2) Vertical hairline crack in the wall lining joint above the south wall window (PHOTO 83).
- 3) Hairline cracking present between the ceiling lining and the manhole trim.
- 4) Hairline cracking in wall lining joint in the south-west corner (PHOTO 84).

Photo 82: Close up of Photo 81

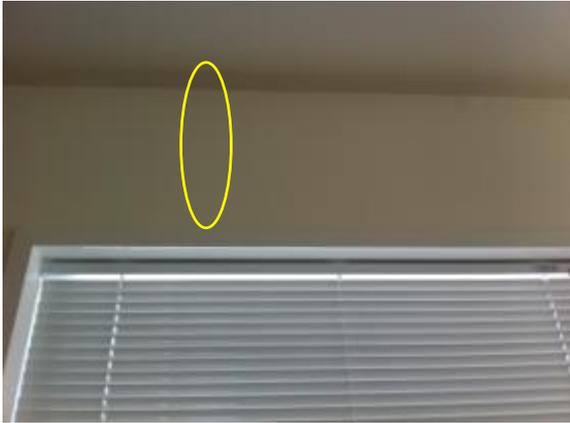
- 1) Vertical hairline crack in wall lining joint above the south wall window near the kitchen (PHOTO 85 & 86).
- 2) Hairline crack in wall lining joint above the north corner of the concertina door (PHOTO 87).
- 3) Hairline crack in wall lining joint under the central window on the northern wall (PHOTO 88).
- 4) Hairline crack in the wall lining joint next to the east window on the northern wall (PHOTO 89 & 90).
- 5) Hairline crack in the plasterboard lining near the top of the south stair (PHOTO 92 & 93).

<p>Photo 85: Vertical Hairline Crack at Wall Lining Joint on South Wall in L1 Main Room</p>	<p>Photo 86: Close up of Photo 85</p>

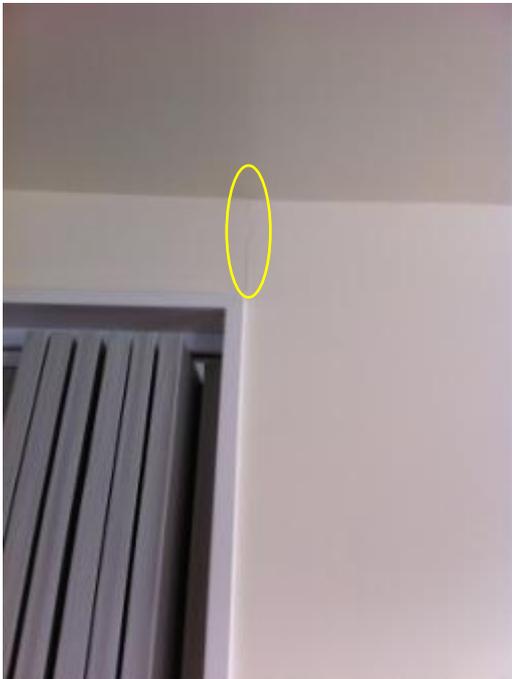
<p>Photo 87: Hairline Crack at wall Lining Joint above Corcertina door</p>	<p>Photo 88: Vertical Hairline Crack on North Wall of L1 Main Room</p>

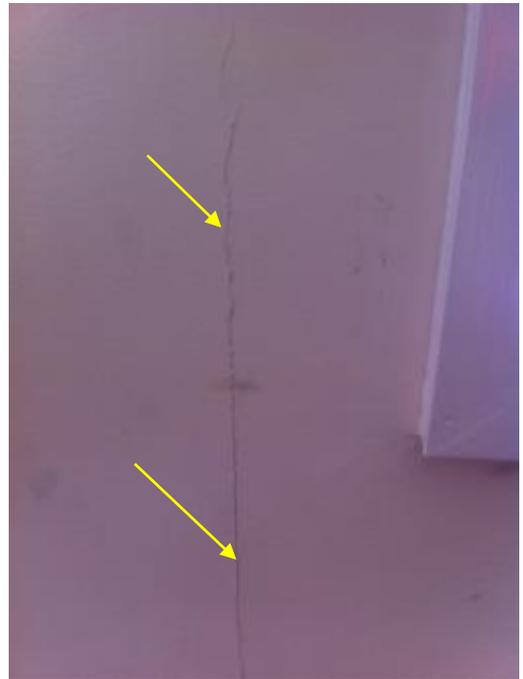
Photo 89: Vertical Hairline Crack on North Wall of L1 Main Room

Photo 90: Close up of Photo 89

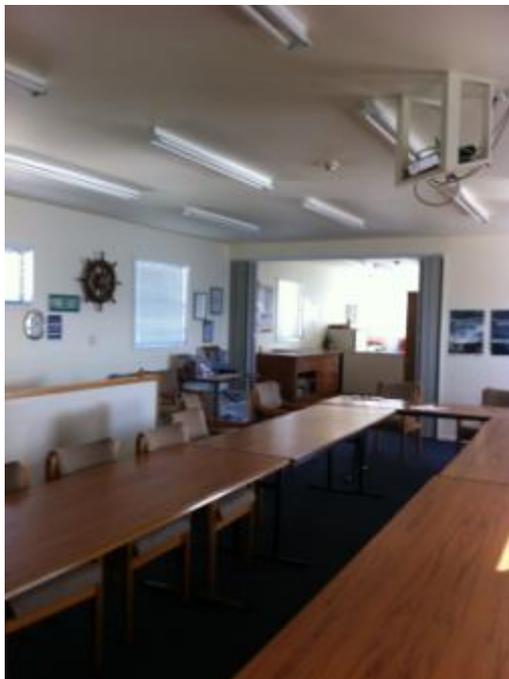
Photo 91: Internal View of L1 Main Room

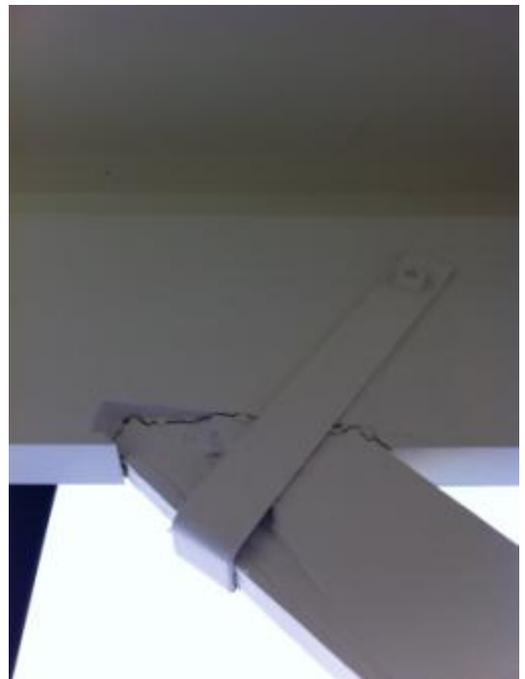
- 1) Cracking in wall lining on the south wall around the ceiling bulkhead (PHOTO 94).
- 2) Cracking between timber beam and timber brace joint on the east wall (located at the mid-height stair landing) (PHOTO 95 & 96).
- 3) Cracking present to the east wall window architrave in the south-east corner of the mid-height stair landing (PHOTO 97 & 98).
- 4) Cracking present in wall lining above east wall exit door at the base of the stair. Cracking radiates out from the south corner of the door and continues up to the window architrave (PHOTO 99).
- 5) Cracking present between the west wall exit door architrave and the wall lining joint (PHOTO 100 & 101).
- 6) Mitre joints on the first aid room door architrave have opened up (PHOTO 102).

Photo 95: Cracking around Timber Brace in South Stair

Photo 96: Close up of Photo 95

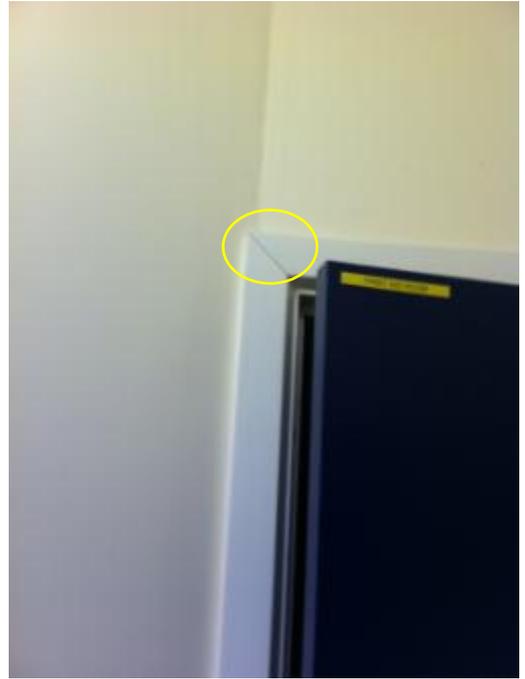
Photo 102: Mitre Joints in First aid Room Door architrave have Opened up

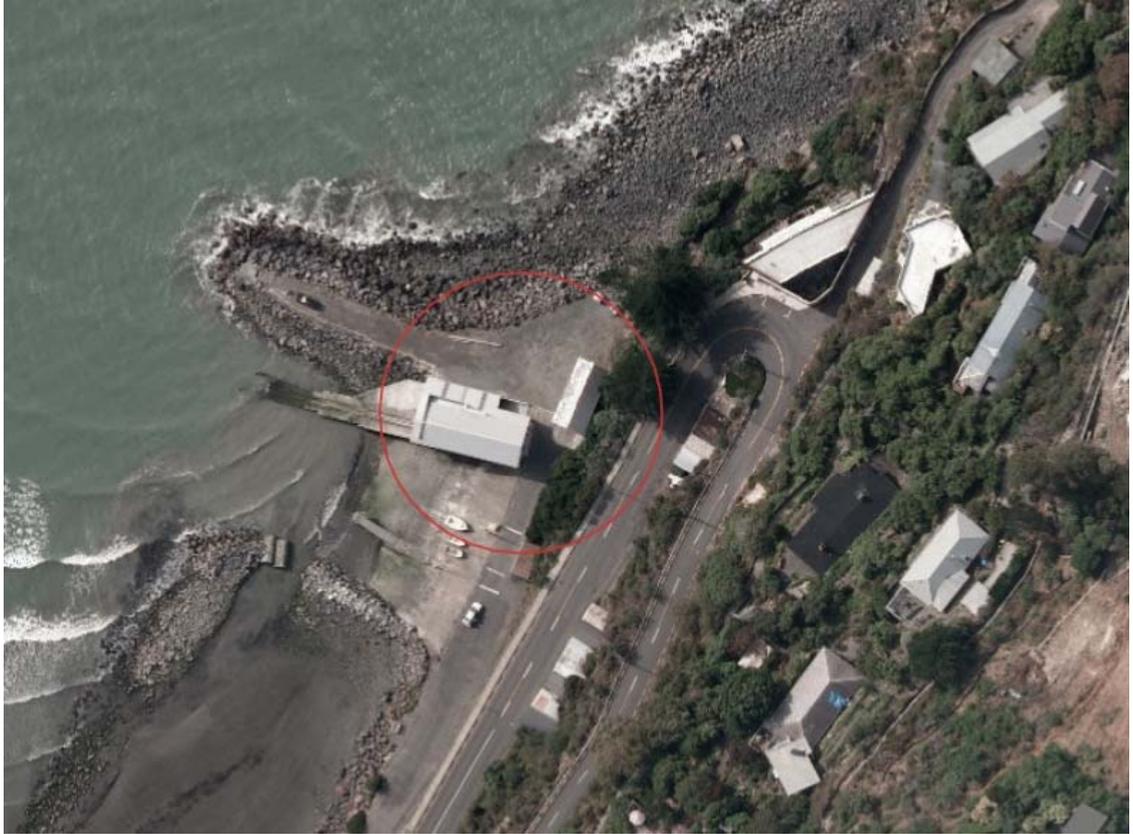
■ **Figure 4 – Aerial photography from 24 Feb 2011 (<http://viewers.geospatial.govt.nz/>)**

No damage to the structure, adjacent road and land can be observed from aerial photographs following the 22nd February 2011 earthquake event. Details of land damage are given in Section 5.8. No liquefied material is visible at the surface.

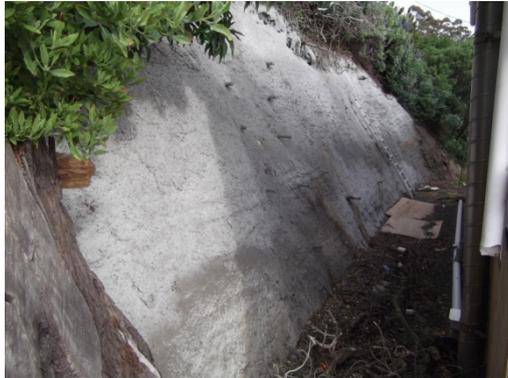
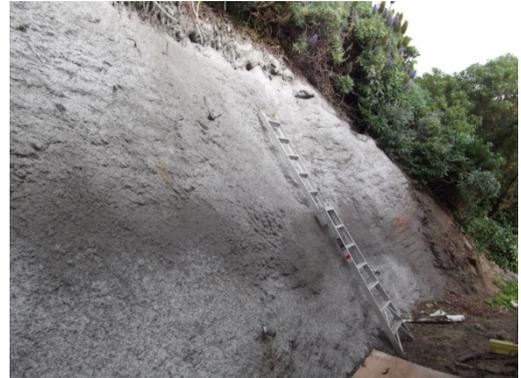
The slope behind the jet boat shed has been supported by Shotcrete (see Appendix B, Photos 1 and 2). The annotated aerial photo in Appendix C shows the location of the site walkover observations. The slope north and south of the jet boat shed is supported by dry stacked boulders. These appear to have performed satisfactorily with minimal movement adjacent to the boat shed, however, behind the historic boat shed to the south, the boulder wall collapsed during the 13 June event (see Appendix B, Photos 3 and 4).

Photo 1 – Shotcrete wall behind jet boat shed.

Photo 2 – Shotcrete wall behind jet boat shed

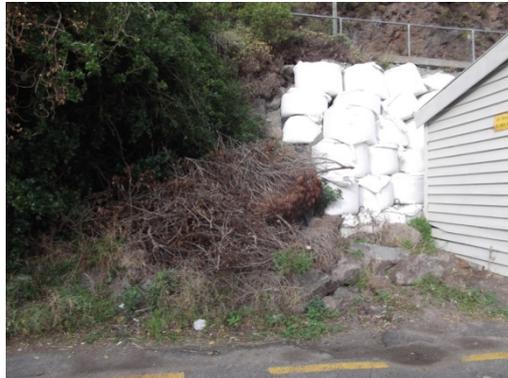
Photo 3 – Sand bags supporting dry stacked boulder wall that collapsed behind historic boat shed. Wall to right is still standing.

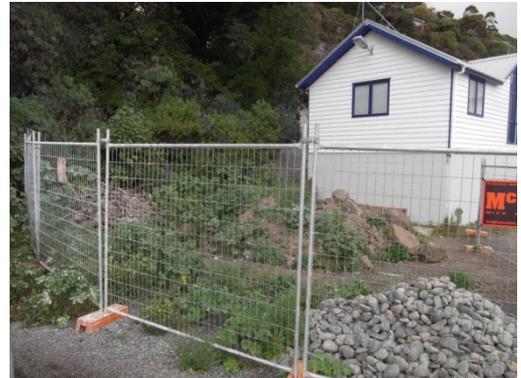
Photo 4 – Rubble removed from behind historic boat shed.

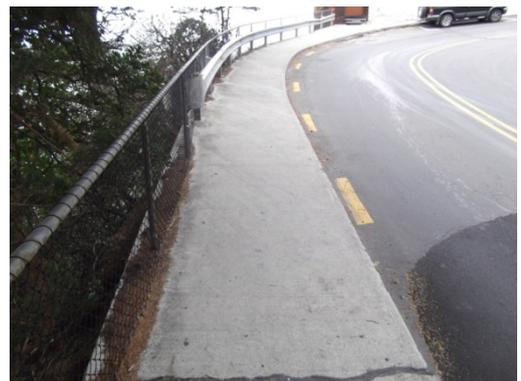
The road above at hairpin looks to have moved approximately 15mm (see Appendix B, Photos 5 and 6) northwest as shown by the crack in the footpath. This is likely to be related to movement of fill or damage of underground services and not an indication of large scale rock movement.

Photo 5 – 15mm offset in footpath due to movement of the cantilevered road section.

Photo 6 – Section of road which has moved approximately 15mm (looking north).
