CHRISTCHURCH CITY COUNCIL
PRK_2347_BLDG_002 EQ2
Travis Wetland Barn & Dairy Unit
280 Beach Road, Burwood

QUALITATIVE ASSESSMENT REPORT

- Rev B
- 24 September 2013

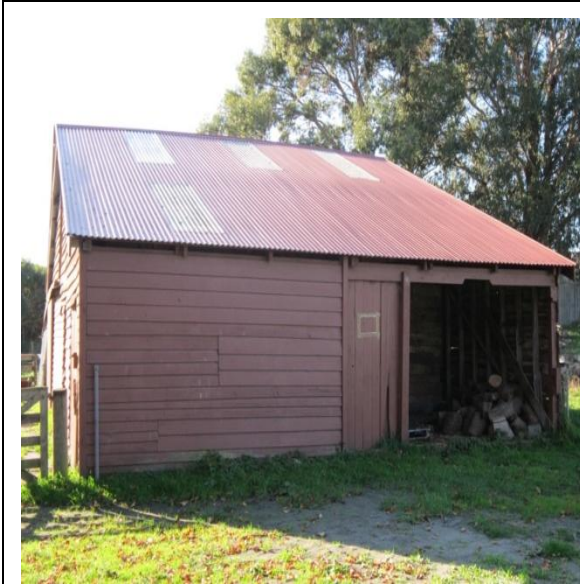
Photo 1: South elevation

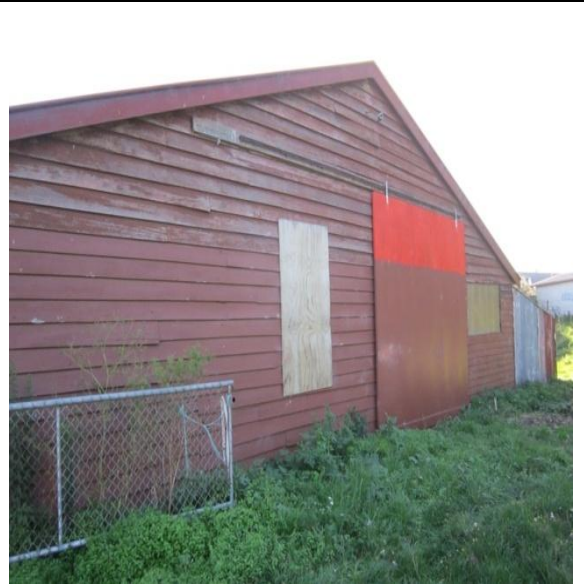
Photo 2: East elevation

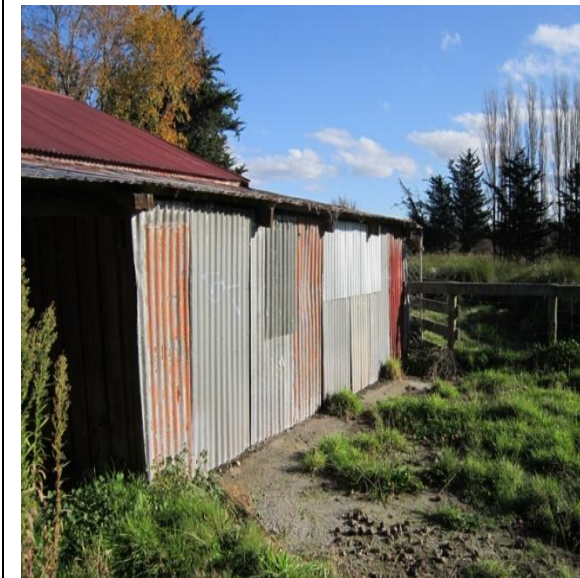
Photo 3: North elevation

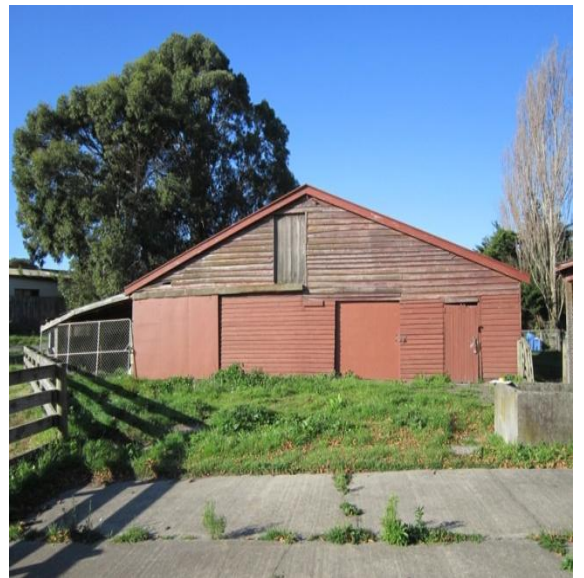
Photo 4: West elevation

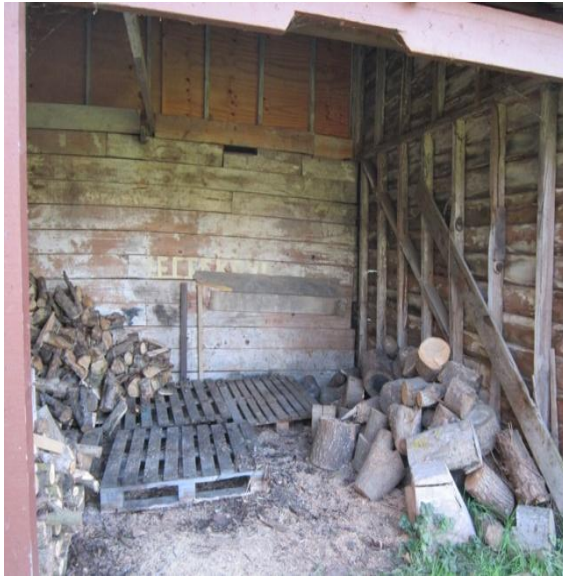
Photo 9: Opening on south side of building.

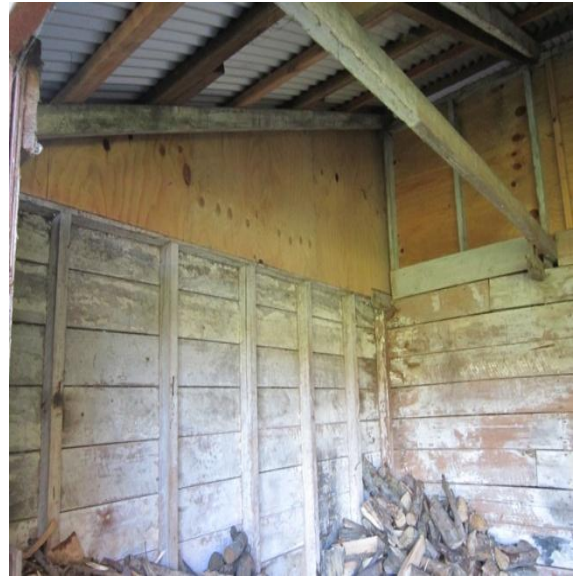
Photo 10: Internal timber walls with 150x50mm posts at 600mm spacing.

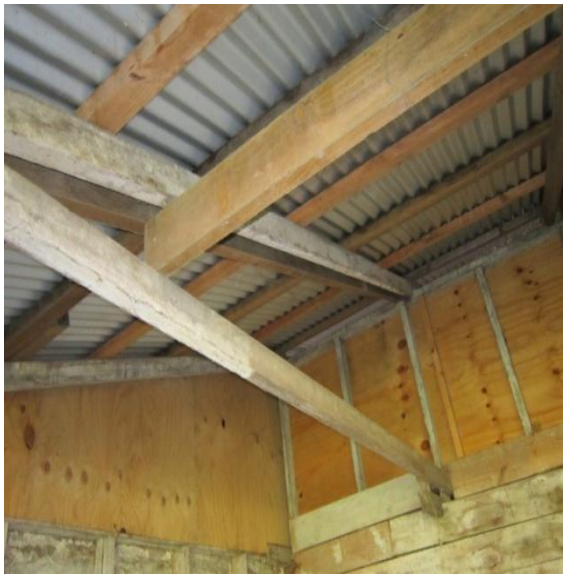
Photo 11: Timber roof rafters at 600mm spacing.

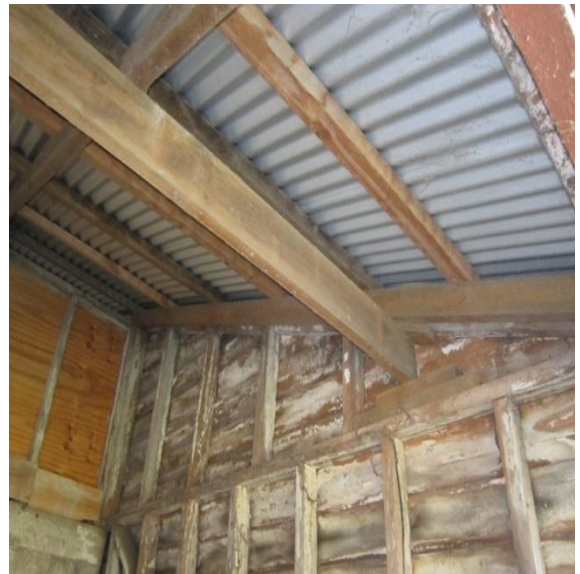
Photo 12: Timber roof rafters at 600mm spacing and external timber wall with 150x50mm posts at 600mm spacing.

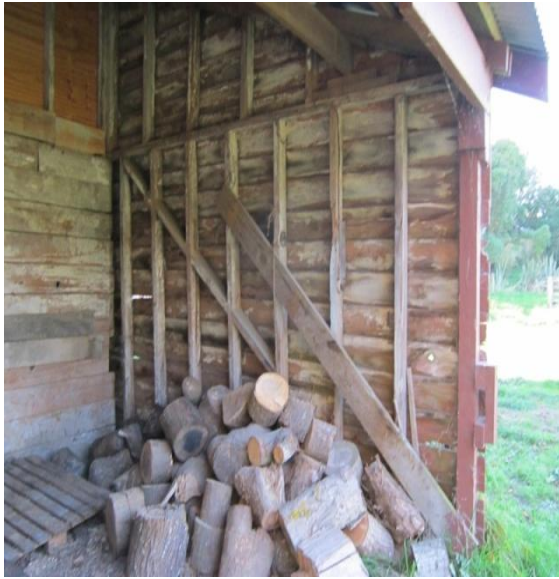
Photo 13: Timber wall in southeast corner of building with timber diagonal bracing.

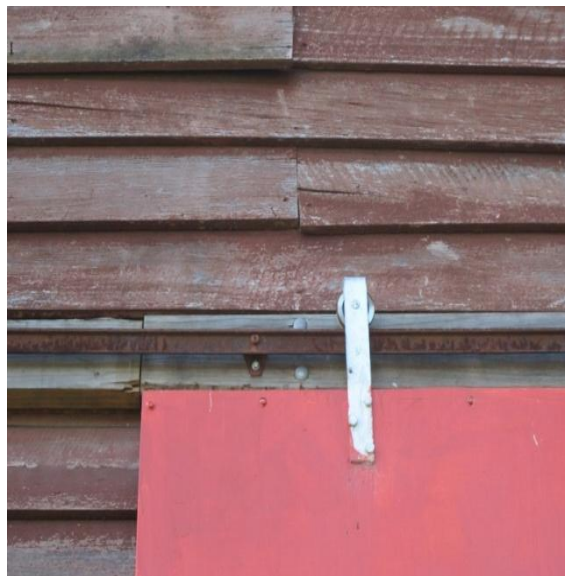
Photo 19: Bowed weatherboards on east timber wall and roller door entrance to building.

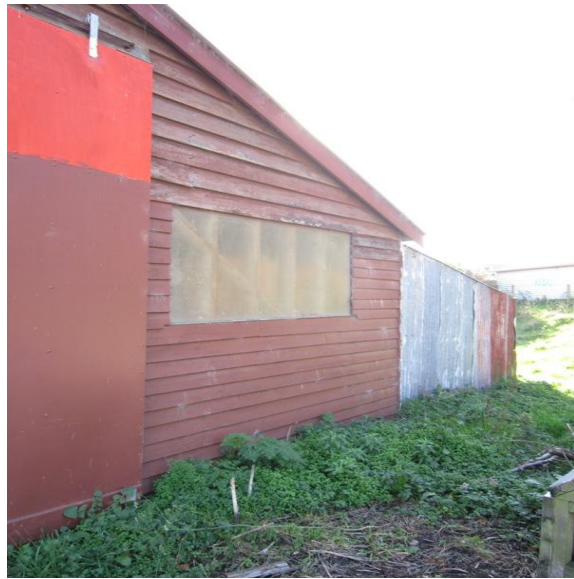
Photo 21: Northeast elevation with extension shown.

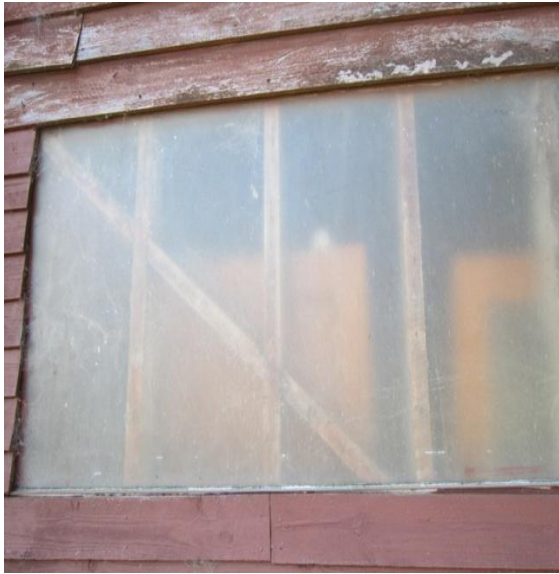
Photo 25: Window on east wall showing diagonal timber bracing member.

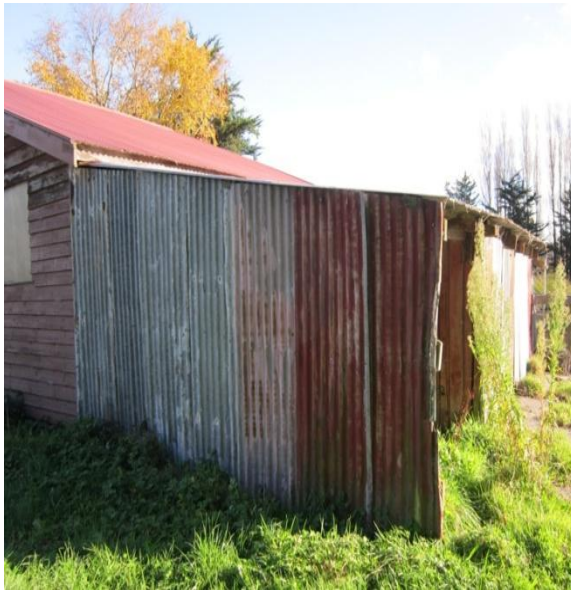
Photo 27: East wall of extension on the north side of the building.

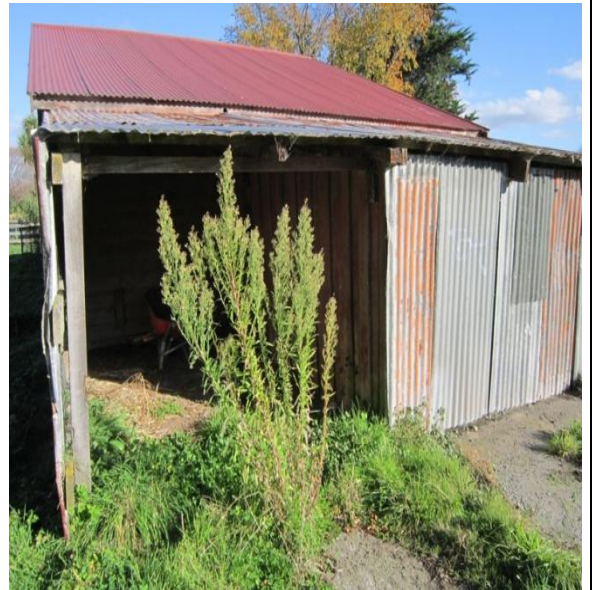
Photo 28: Entrance to corrugated sheeting extension on north side of building.

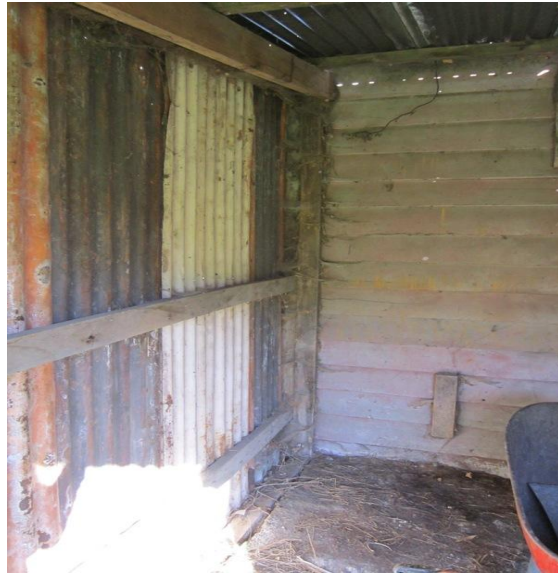
Photo 29: External corrugated metal and timber wall members of north extension.

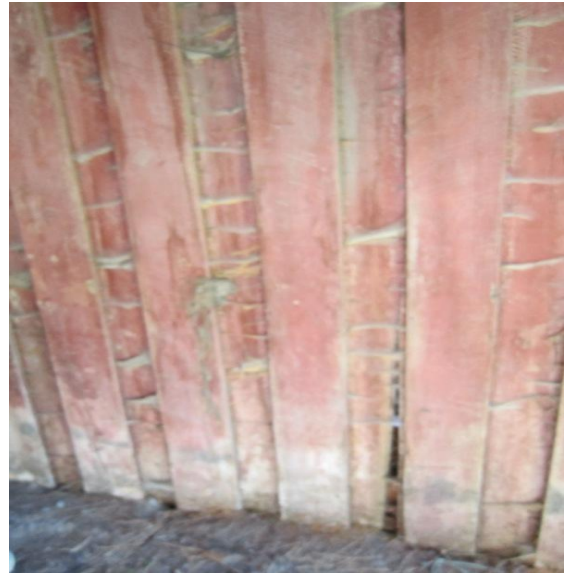
Photo 30: Internal timber wall of north extension.

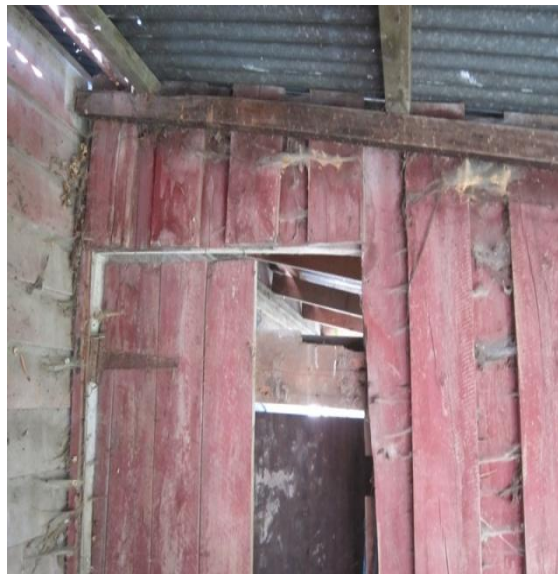
Photo 31: Internal wall and door in north extension.

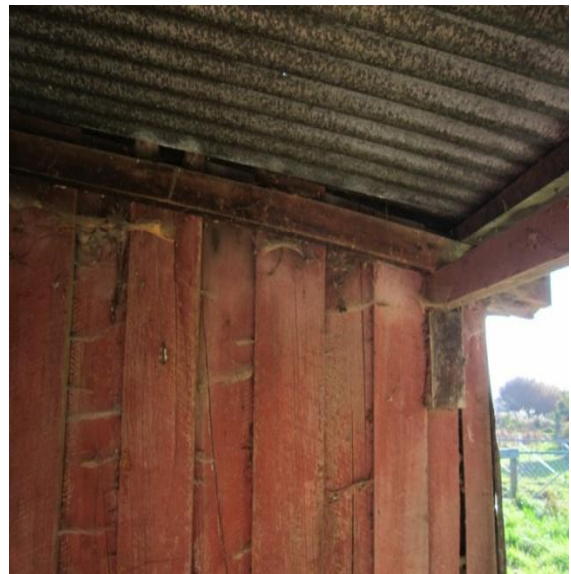
Photo 32: Internal timber wall of north extension with corrugated metal roof.

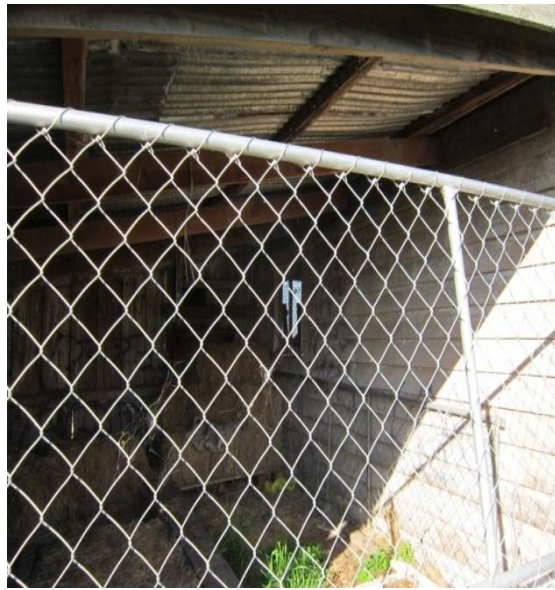
Photo 33: West entrance to north extension.

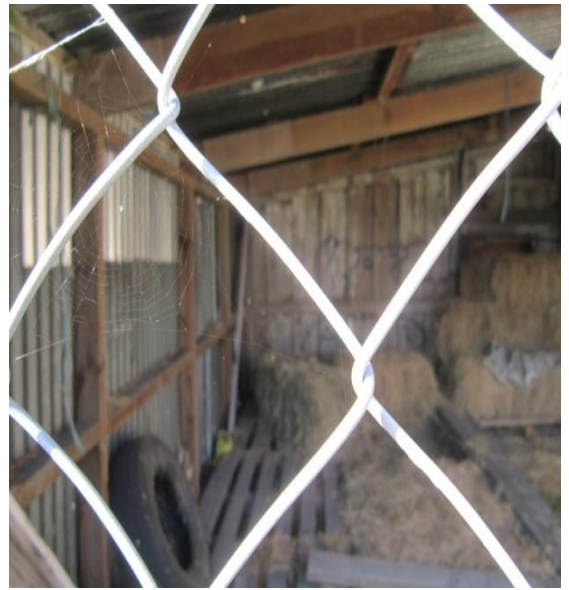
Photo 34: Internal layout of north extension showing corrugated metal external walls with timber posts and internal timber walls.

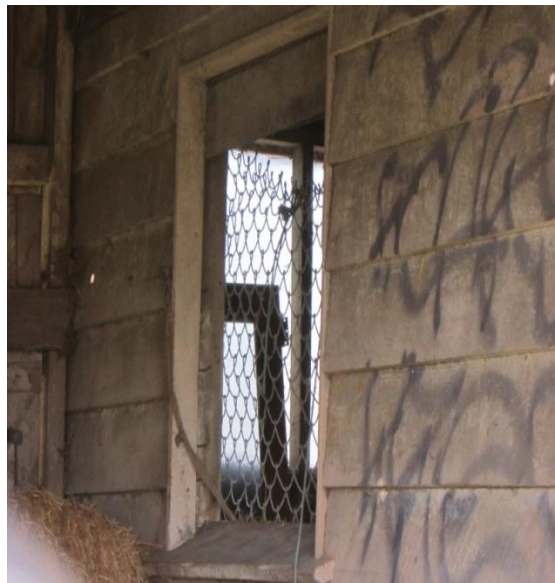
Photo 35: Opening on shared wall between original barn building and north extension.

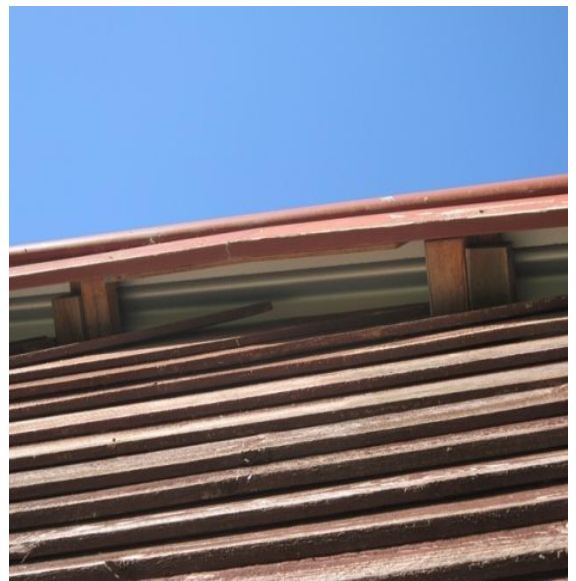
Photo 40: Soffit on west side with exposed corrugated roof sheeting and timber roof rafters.

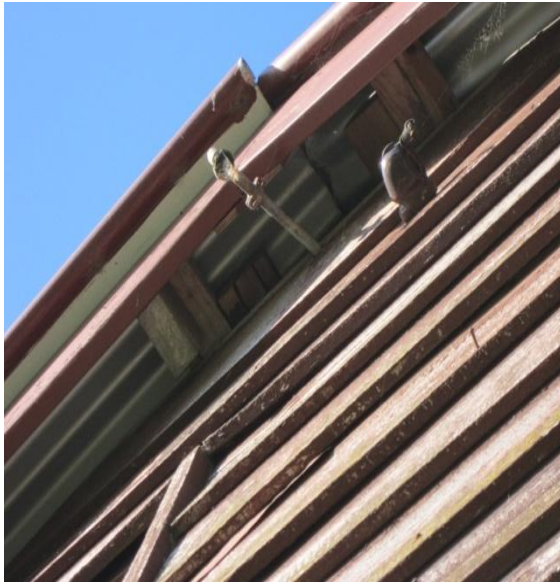
Photo 41: Soffit on west side with exposed corrugated roof sheeting and timber roof rafters.

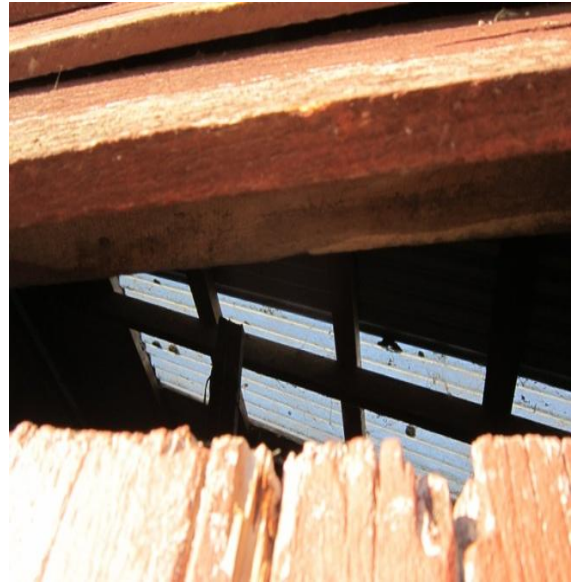
Photo 42: Gap between doors on west side showing timber roof rafters inside.

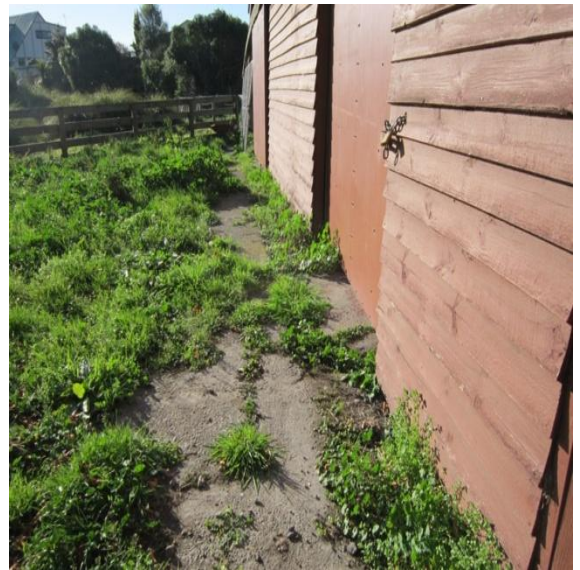
Photo 46: Base of west timber wall.

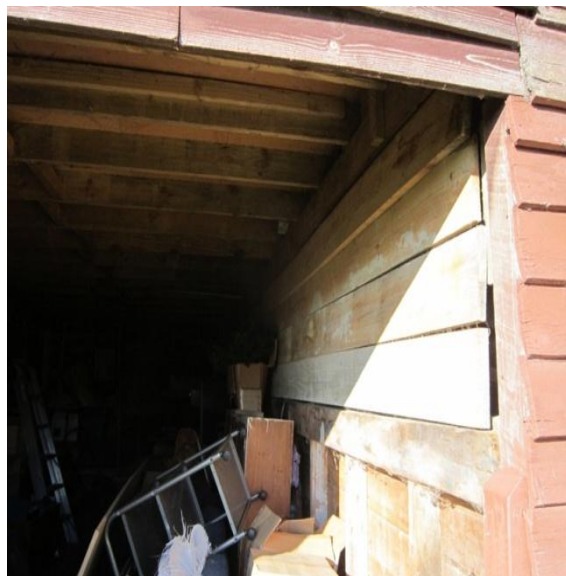
Photo 47: Internal timber wall by west door.

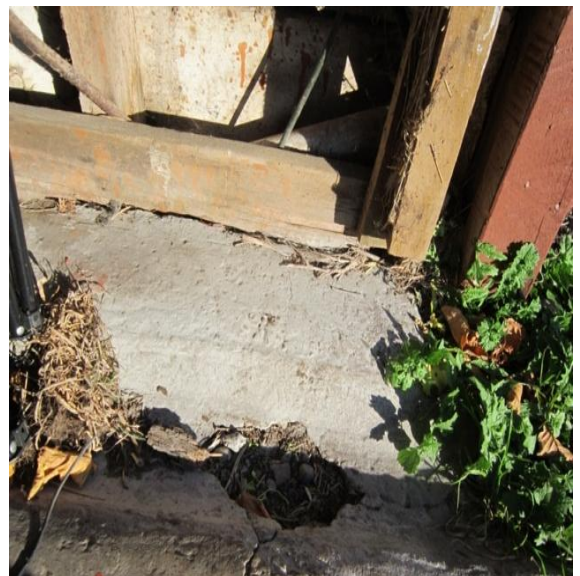
Photo 48: Concrete ground slab by west door.

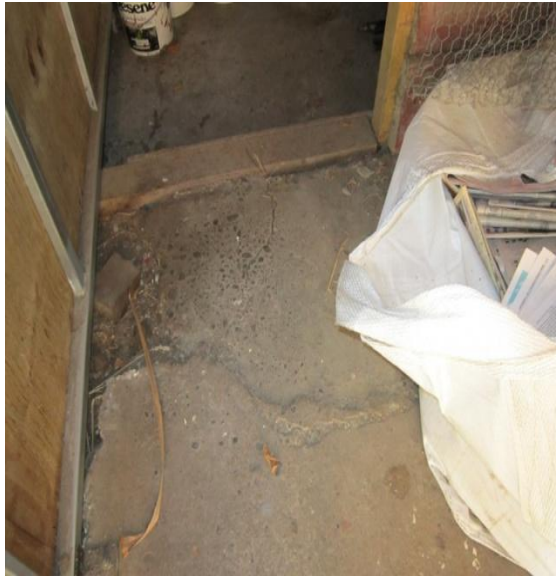
Photo 49: Unlevelled surface of concrete slab inside the barn.

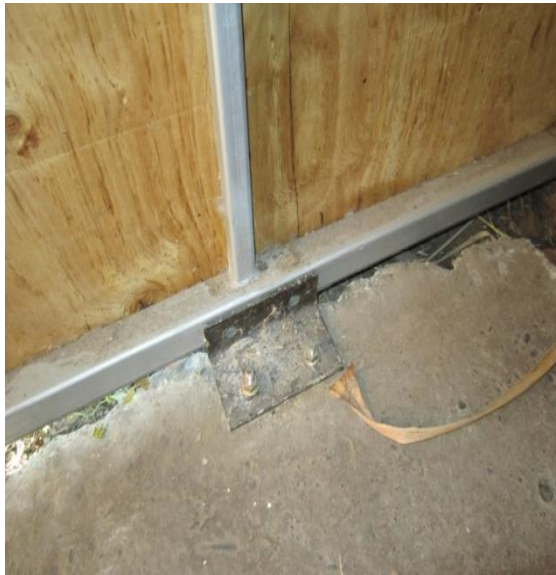
Photo 51: Anchors in concrete slab in west roller door support.

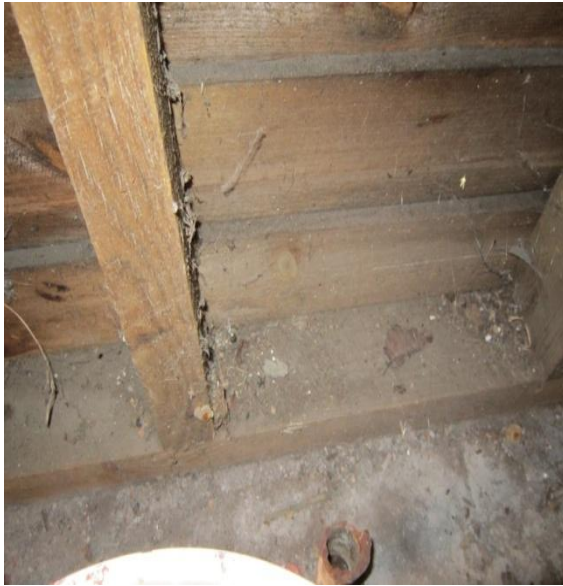
Photo 53: Base of timber wall on concrete slab.

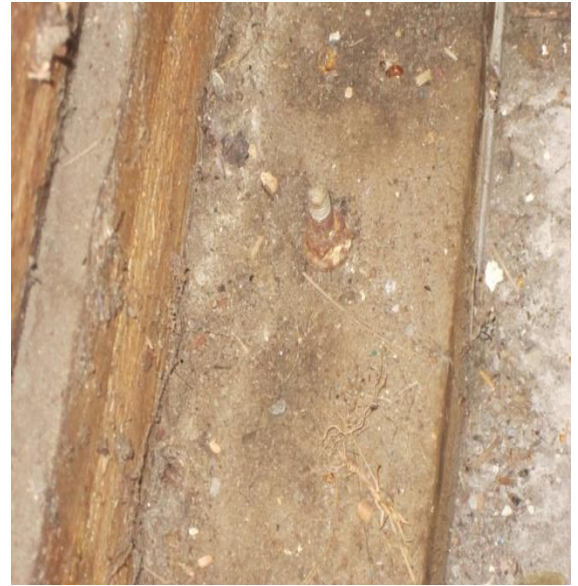
Photo 54: Timber wall base anchored into concrete slab.

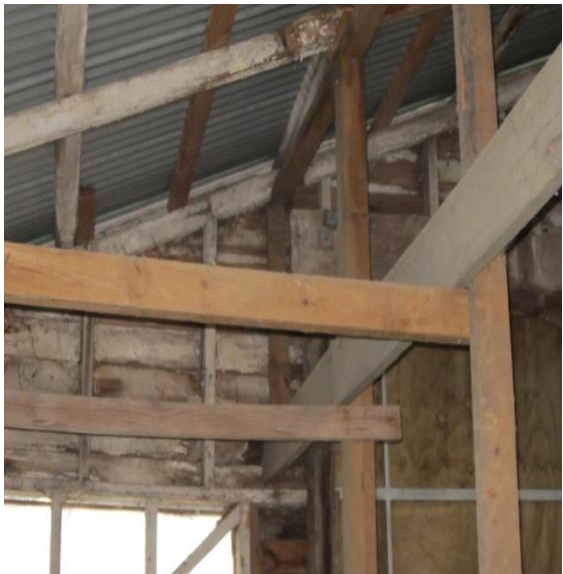
Photo 55: Exposed corrugated roof sheeting with timber roof rafters. Internal timber beams and columns also shown.

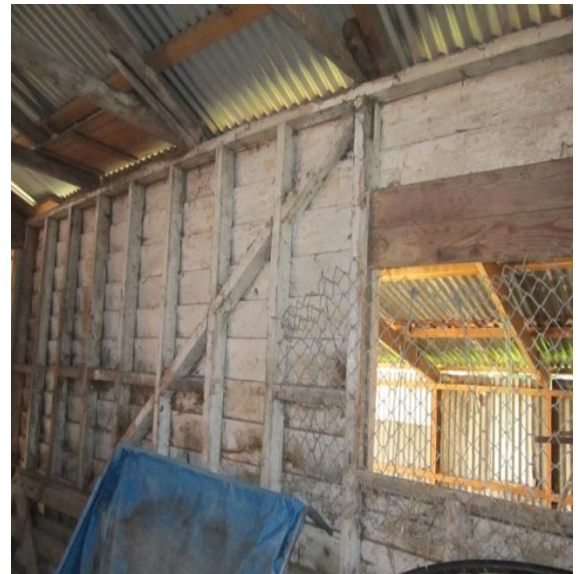
Photo 56: Diagonal timber wall brace on internal wall shown.

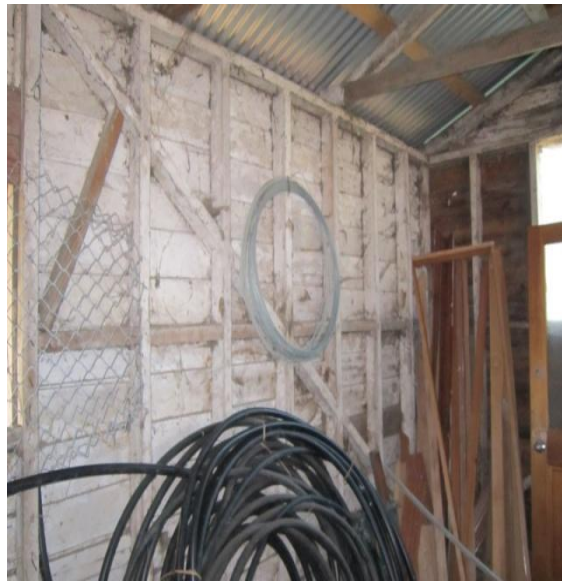
Photo 57: Diagonal timber wall brace on internal wall shown.

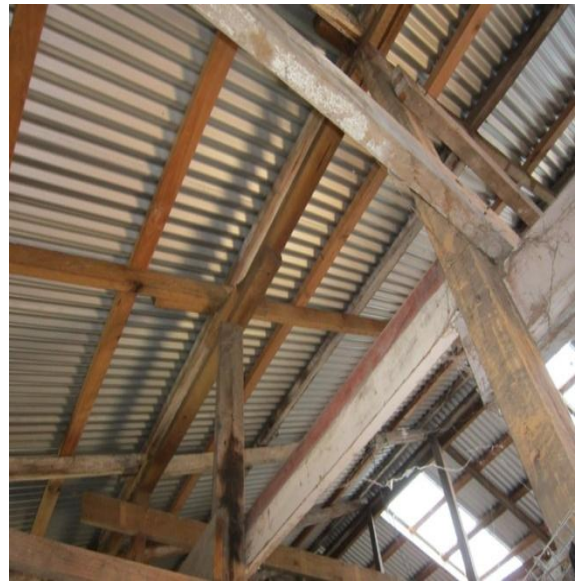
Photo 58: Exposed corrugated roof sheeting and timber roof rafters, with internal timber beams and columns shown providing support to the roof elements.

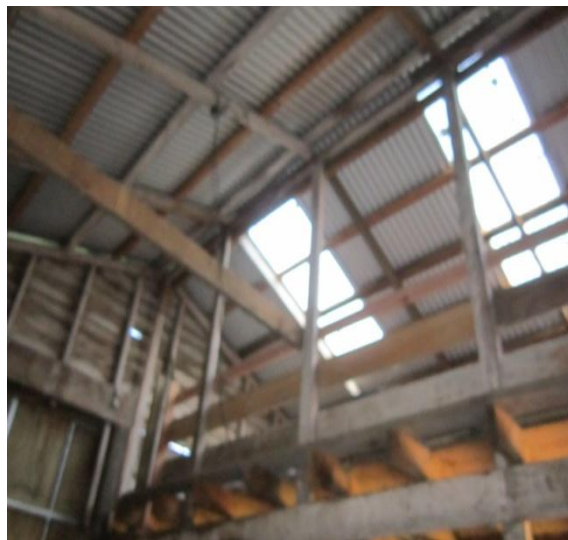
Photo 59: Exposed corrugated roof sheeting and timber roof rafters, with internal timber beams and columns shown providing support to the roof elements.

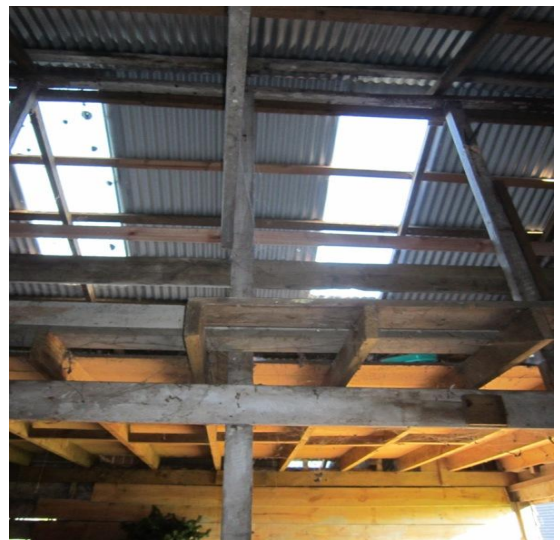
Photo 60: Exposed corrugated roof sheeting and timber roof rafters, with internal timber beams and columns shown providing support to the roof elements, by raised platform.

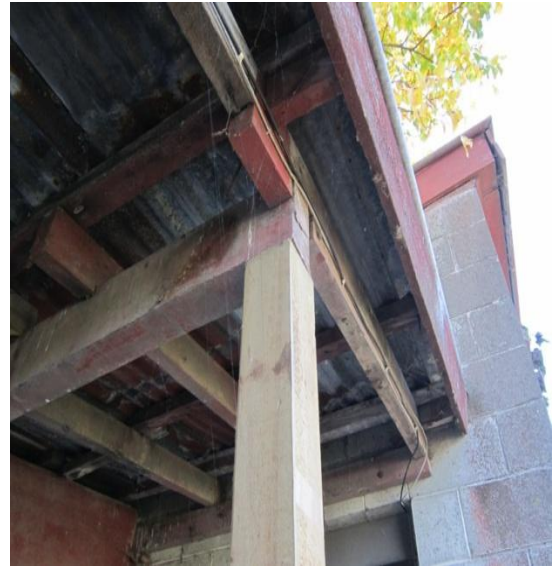
Photo 14: Timber column on east side of lean-to.

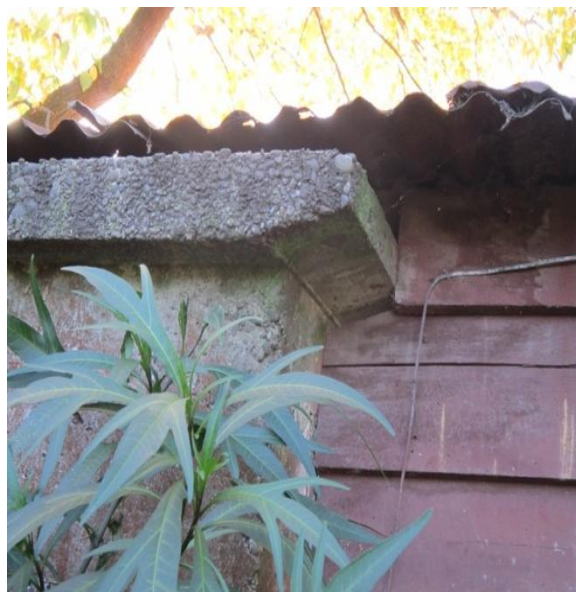
Photo 31: South timber wall joins with south concrete wall.

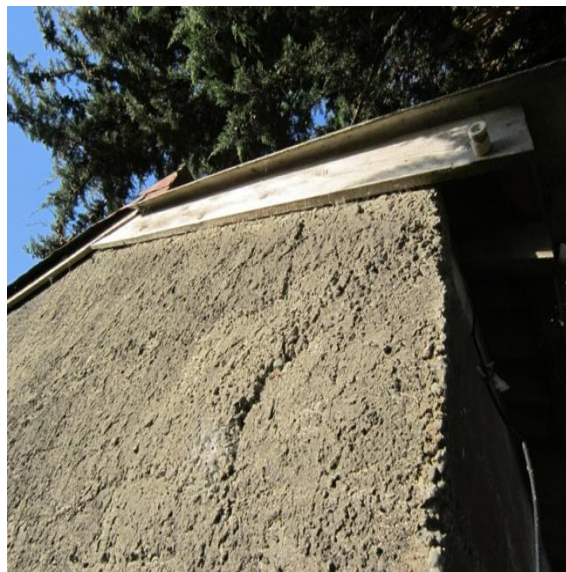
Photo 39: Large aggregate sizes in west concrete wall.

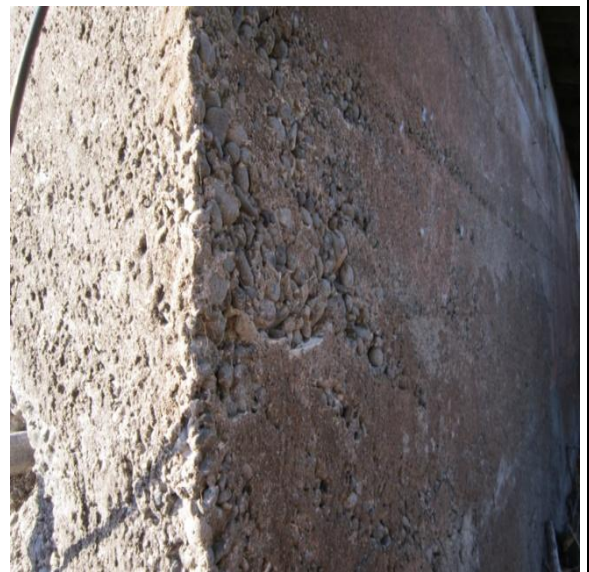
Photo 40: Large aggregate sizes in concrete wall on southwest corner.

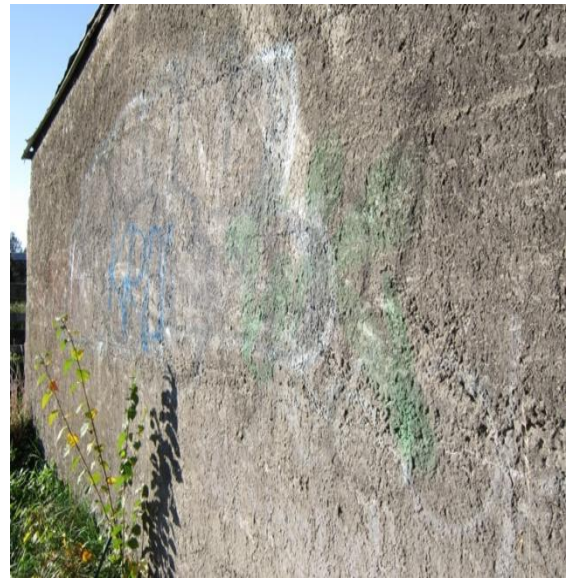
Photo 42: Large aggregate sizes in west concrete wall.

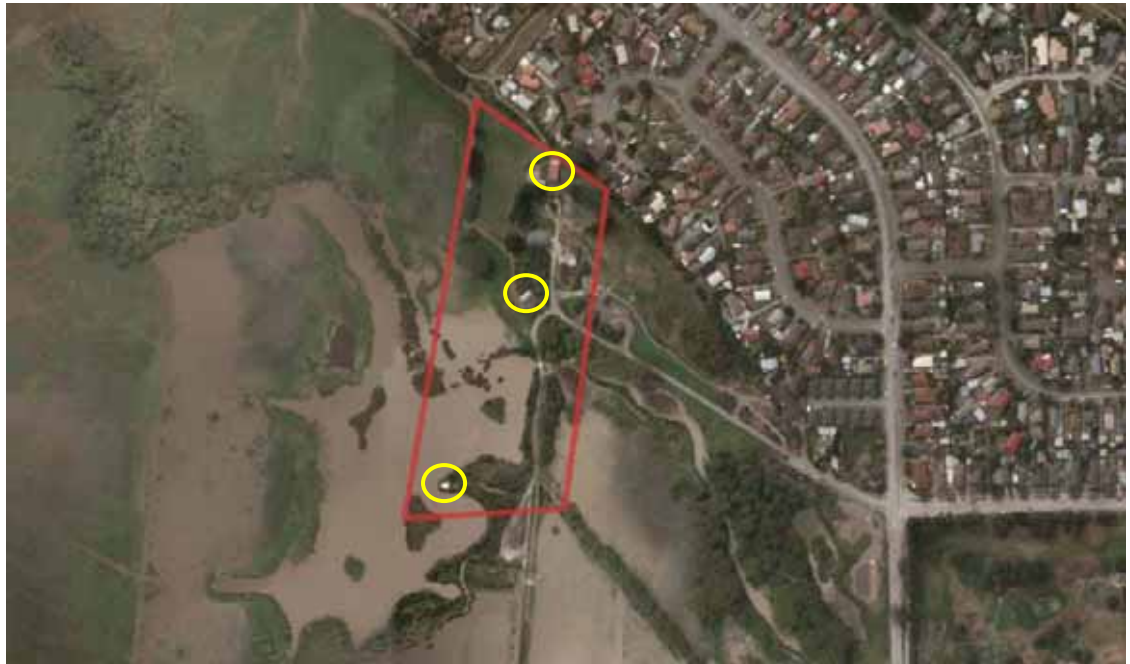
■ Figure 5 – Aerial photography from 24 Feb 2011 (<http://viewers.geospatial.govt.nz/>)

Liquefaction risk is expected to be moderate to severe for this site. Significant surface evidence of liquefaction on site as well as elevated water table could be seen from the aerial photographs. No evidence of liquefaction was noted during the site visit; however, this is most likely due to the significant lapse of time between the seismic event and the external site walkover undertaken. The density of the sand layer inferred to underlay the site is not known. However, it is likely that the sand layers, in particular the shallow layers, are susceptible to liquefaction. Even though there was no evidence of lateral spreading noted during the site walkover, there is future risk of lateral spreading on site due to the significant potential for liquefaction to occur on site and the presence of free faces caused by nearby waterways.

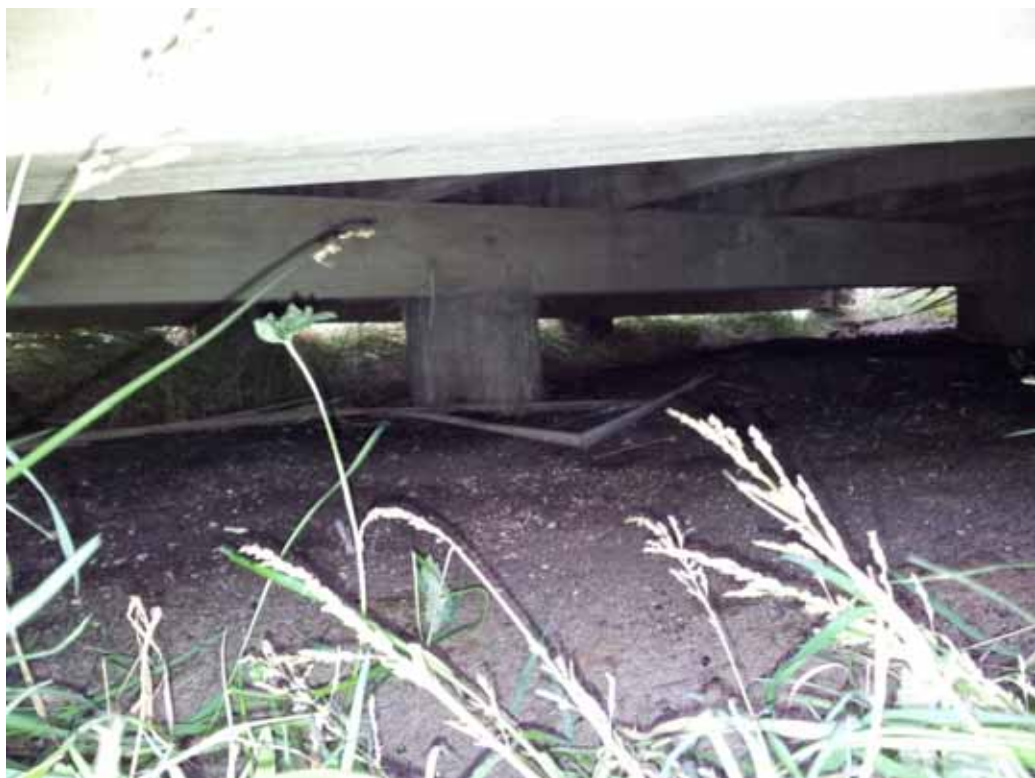
The information kiosk and bird hide buildings are a single storey timber framed building with timber pile foundations.

■ **Figure 13 – Foundation details of the bird hide**

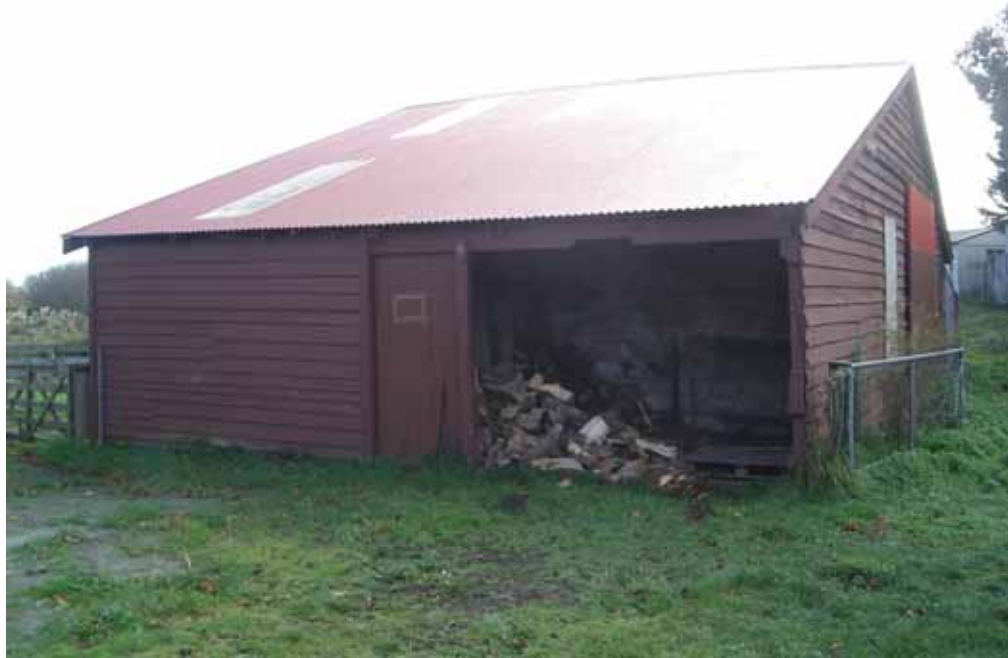
The Barn was noted to be a timber structure (frame and clad), with a corrugated iron lean to on the northern side. The roof was also noted to be an iron construction. The structure appears to be supported on a slab foundation at the western end only. There appears to be some significant cracks in the concrete but this could be not confirmed during the external site walkover.

■ **Figure 14 - Overview of the barn structure**

The performance to date suggests that in general the existing foundations are adequate for their current purpose. However some damage to the concrete slab supporting the barn structure was noted. From the site walkover it was noted that the shallow piled foundations in general performed better than the slab foundations.

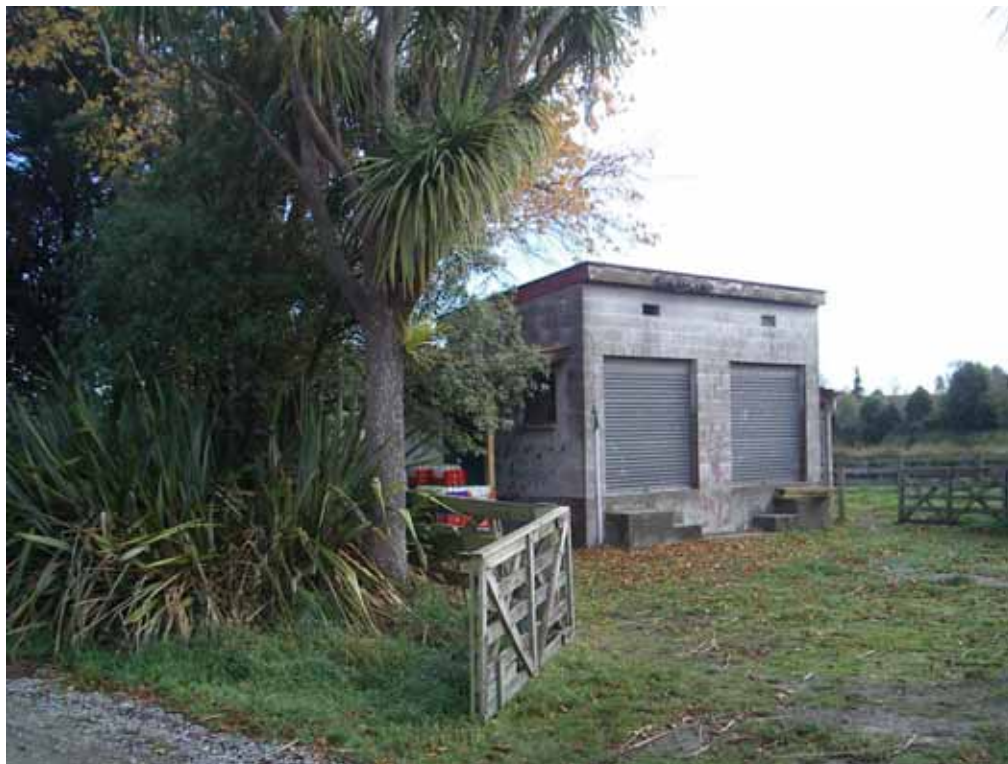
The dairy shed appears to be a masonry block construction at the eastern end with poured in situ concrete walls for the remaining parts of the structure. The roof was an iron sheet construction. Gapping, some cracking and differential movement of slabs was noted in the concrete paving outside. However, it is not clear how much of this damage is due to the earthquake event. No other significant cracking of blocks or any differential settlement of the structure was noted during the site walkover.

■ **Figure 15 - Overview of the Dairy shed**
